NERC Lessons Learned

Lockout Relay Component Failure Causes Misoperation and Reportable Event

Midwest Reliability Organization

July 30, 2020

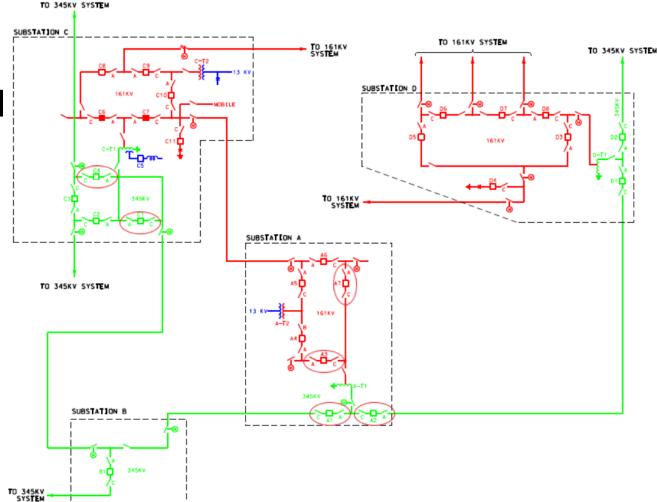
- An unnecessary trip caused BES equipment to be removed from service
- Caused by a misoperation of the lockout relay associated with a 345 kV breaker at Substation A
- Tripped (2) lines and XFMR
- A faulty lighted nameplate control circuit was found to be responsible

Figure 1: Diagram showing the breakers affected (circled) by the misoperation of the lockout relay [1]

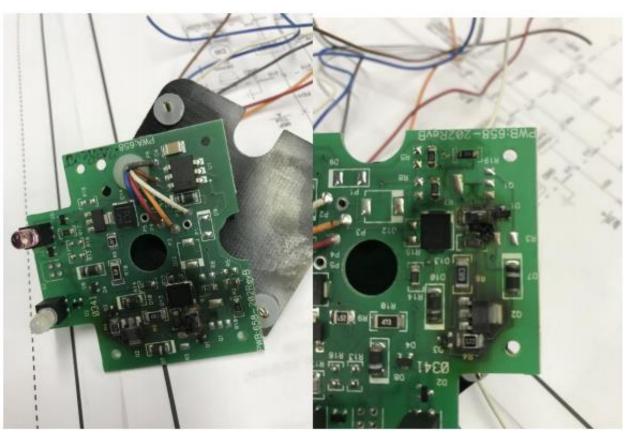
- A 2014 product advisory note was found detailing potential issues with the circuit board
- The entity had no record of receiving the notice
- The entity surveyed to determine the locations of the affected products
- Replacement of either the circuit board or the entire lockout relay was done

Figure 2: Diagram showing the faulty lighted nameplate control circuit board [1]

- Reach out to manufacturer for more information when needed from a product advisory to determine system risk and required corrective actions
- Develop procedures to log and review future advisory notes
- Survey manufacturers to ensure that all advisories are received, logged, and reviewed
