Sub Regional RTEP Committee Western Region ATSI

September 28, 2018

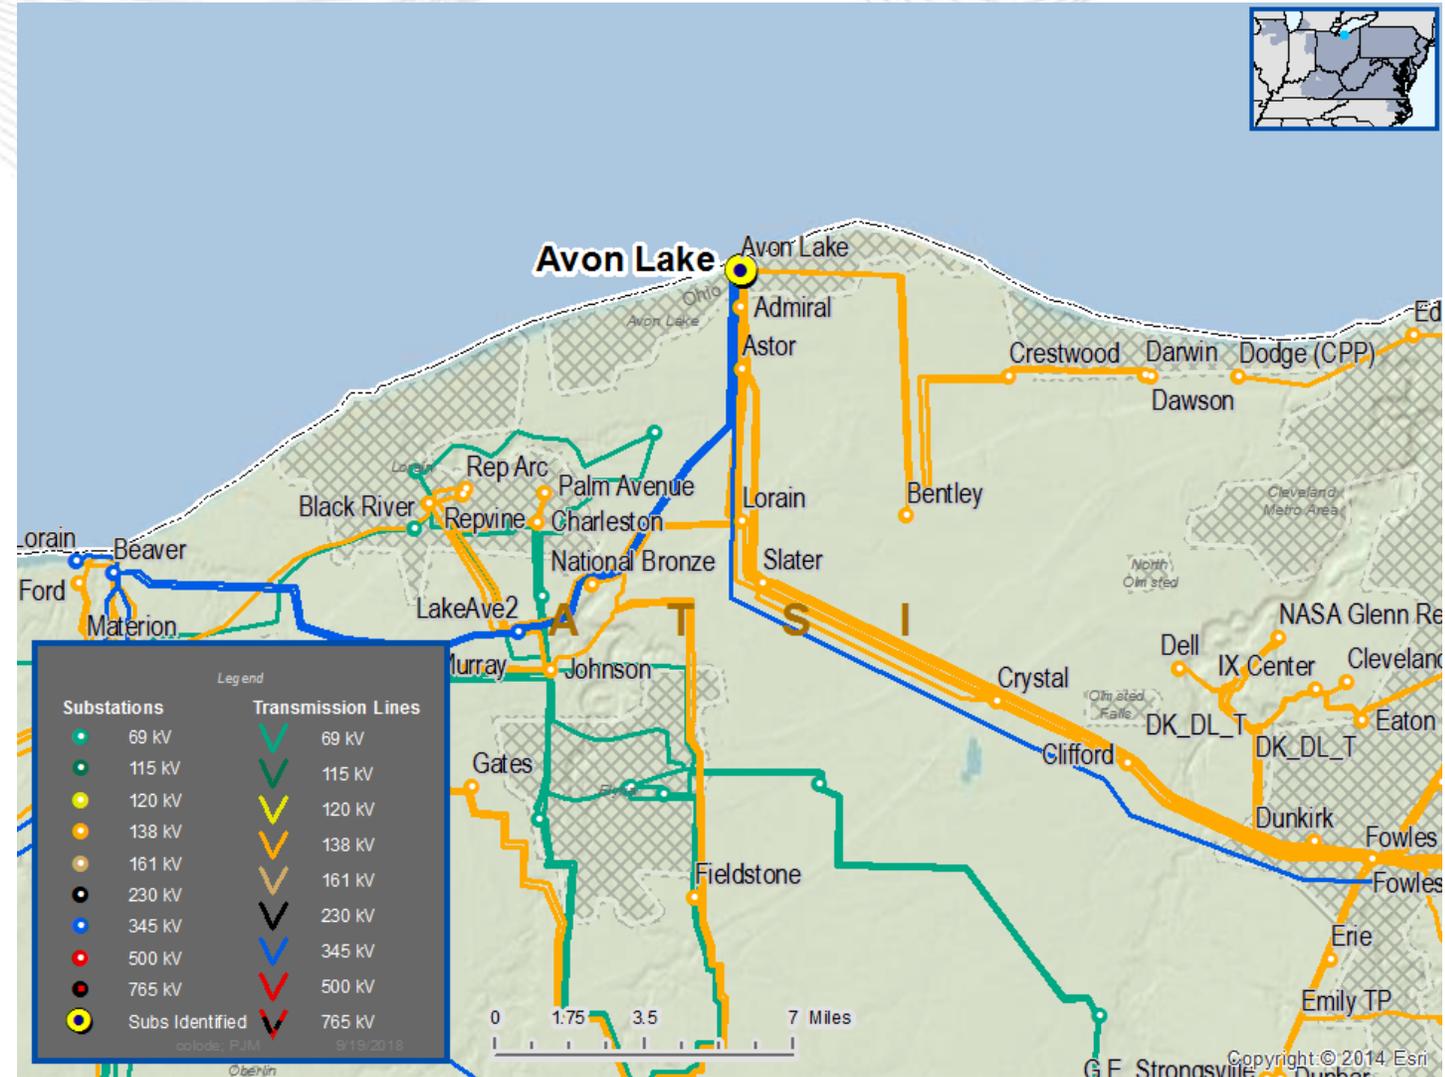
Problem Statement
 Avon 345 / 138 kV 448 MVA #91 Transformer

- Transformer is gassing at an increasing rate
- Oil condition is degraded
- Leaks – Not cost effective to repair
- Severe loading history
- Cooler condition is degraded

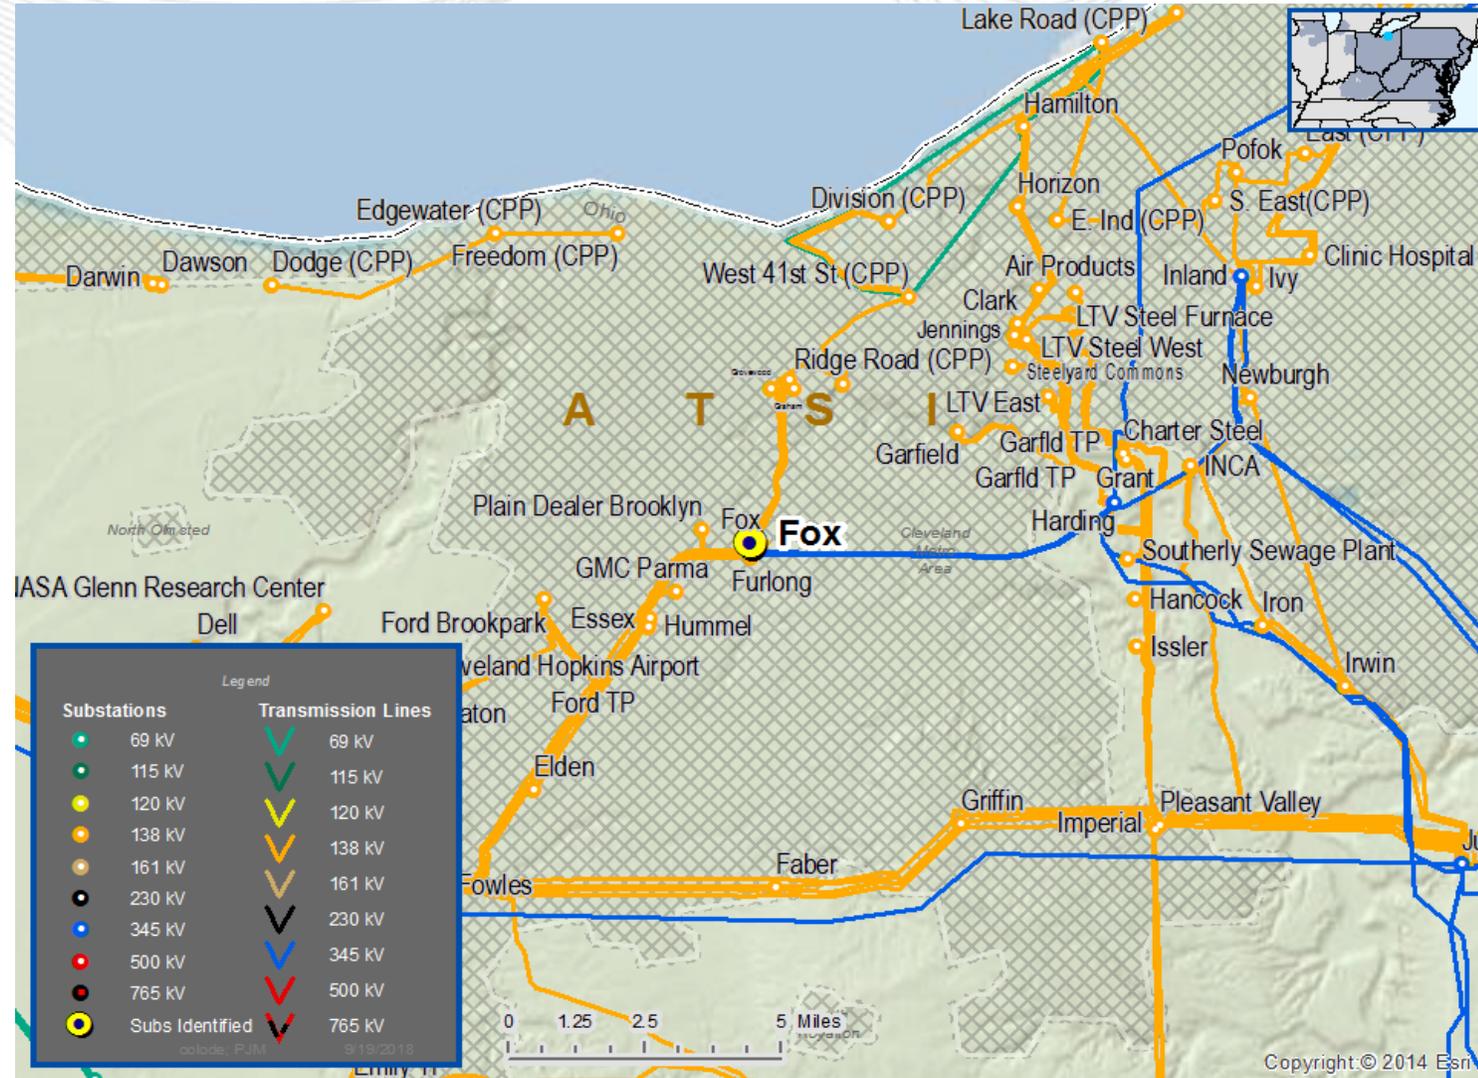
Fox 345 / 138 kV 224 MVA #5 Transformer

- Oil Pump/cooler maintenance
- Aging/deteriorating bushings
- Increased failure risk

- Mechanism issues
- Aging/deteriorating bushings
- Spare part availability/vendor support limitations
- Negative impact on equipment health (transformer)

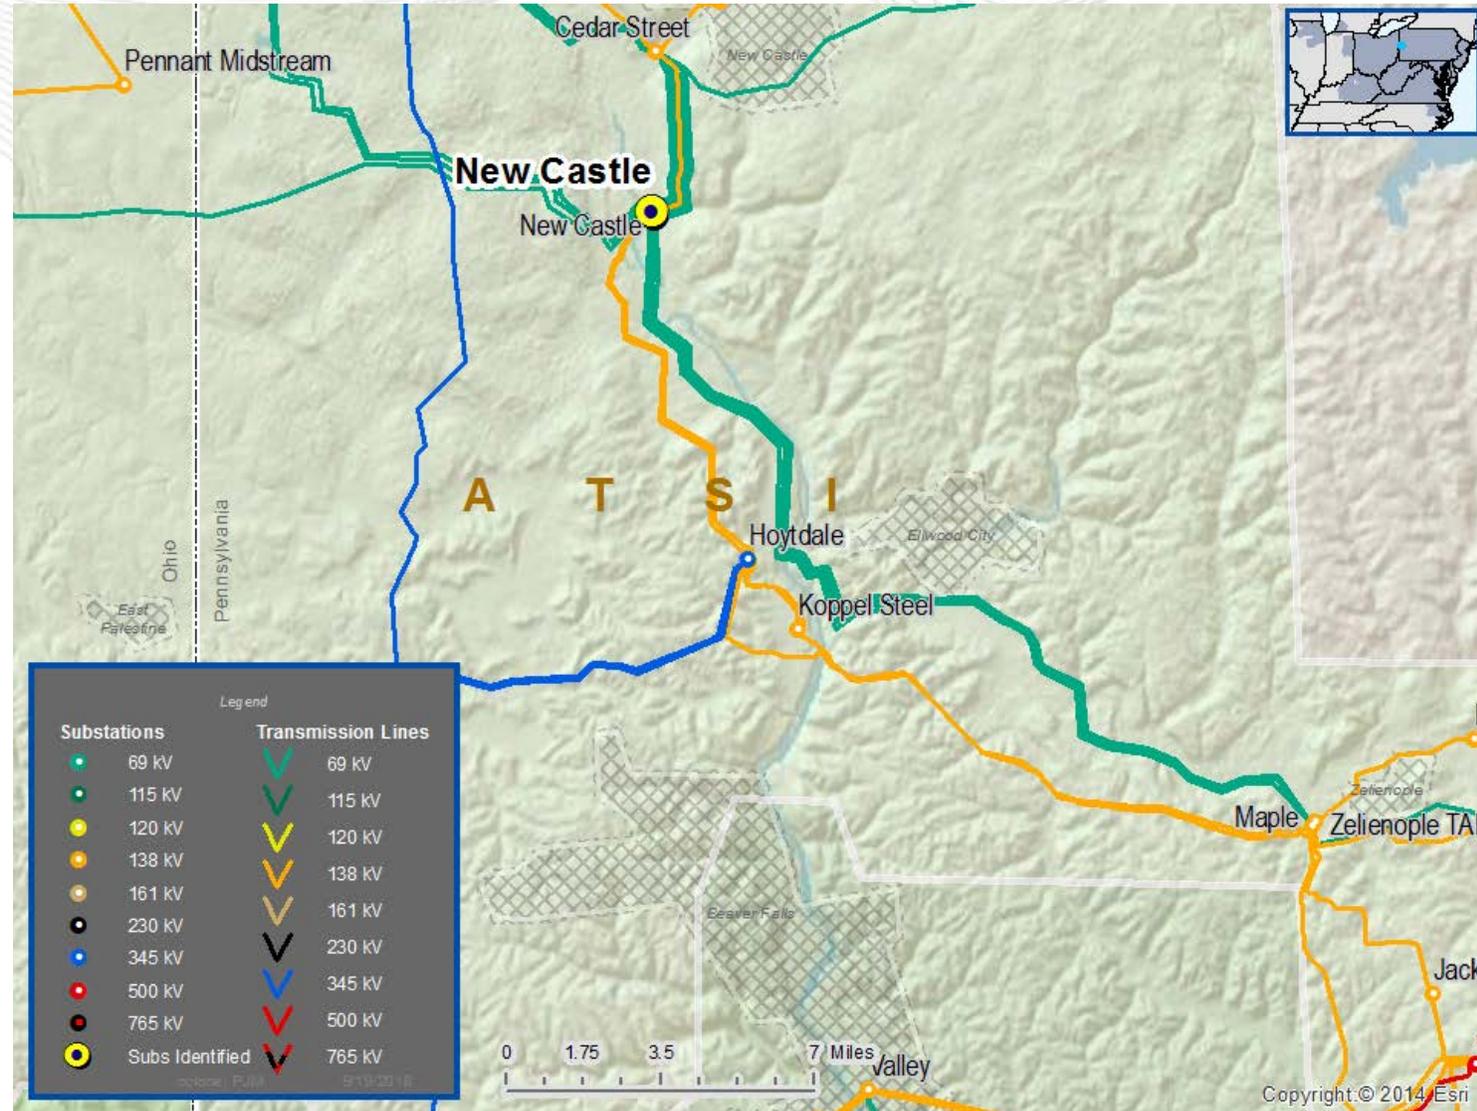
New Castle 138 / 69 kV 75 MVA #7 Transformer

- Oil Leaks/moisture ingress
- Aging/deteriorating bushings
- Increased failure risk

- Mechanism issues
- Aging/deteriorating bushings
- Spare part availability/vendor support limitations
- New breaker will offer improved transformer protection

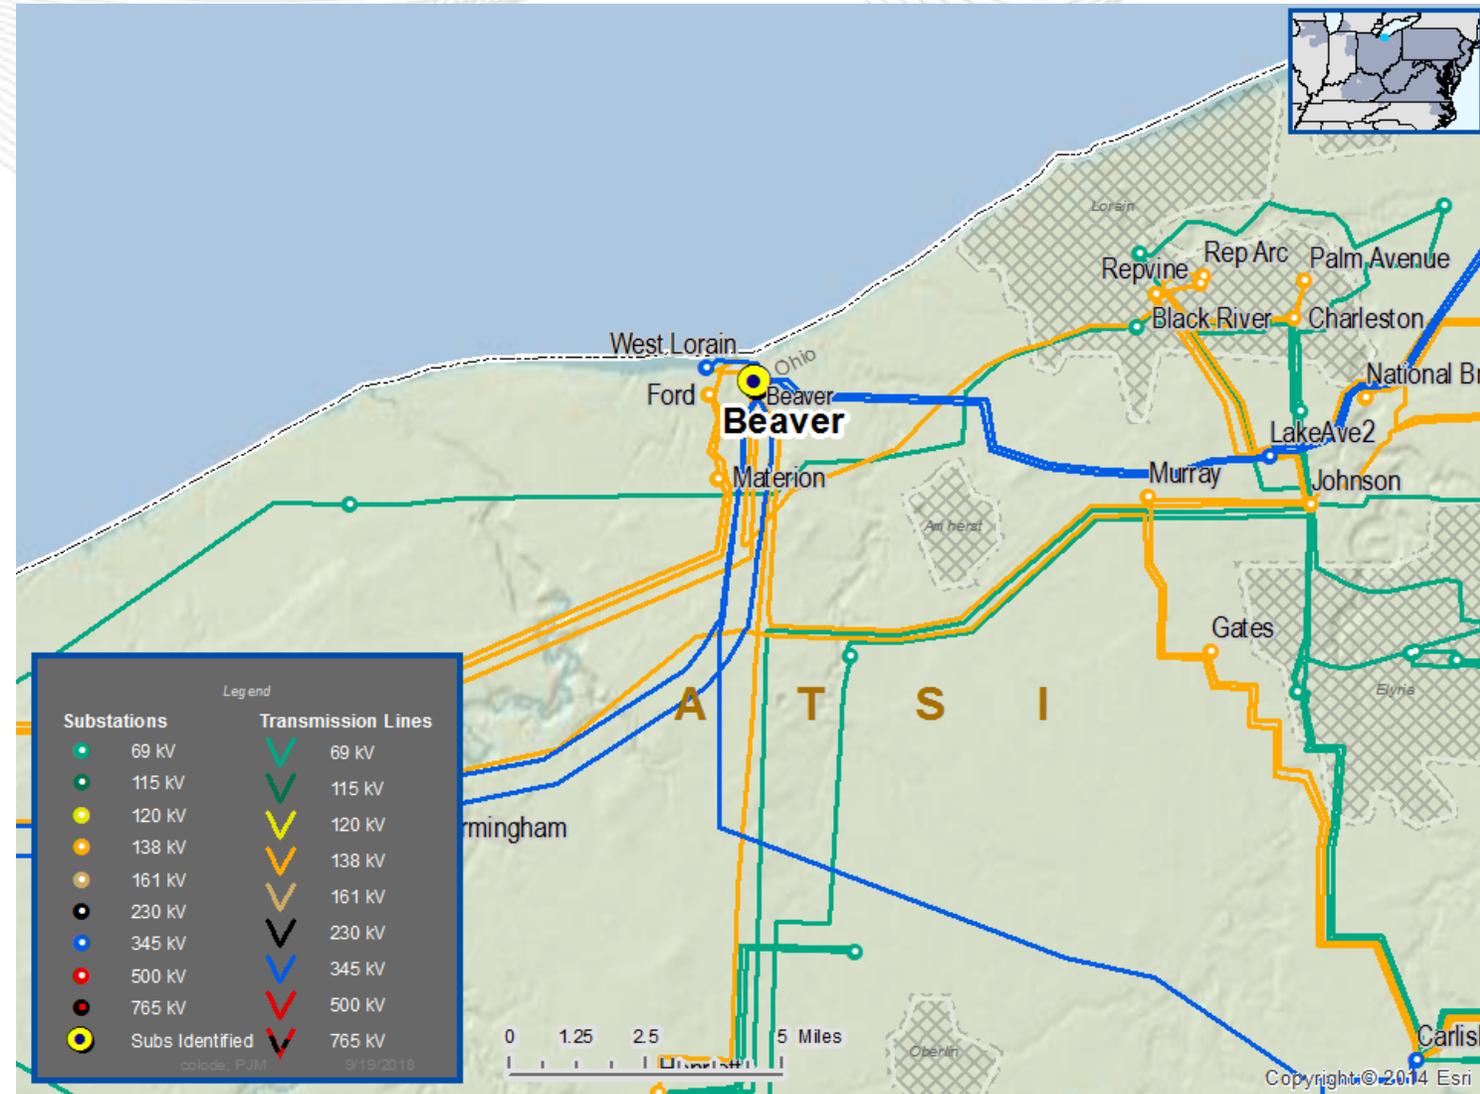
Beaver 345 / 138 / 13.2 kV 392 MVA #1 Transformer

- Oil Pump issues and maintenance
- Increased failure probability
- Aging/deteriorating bushings

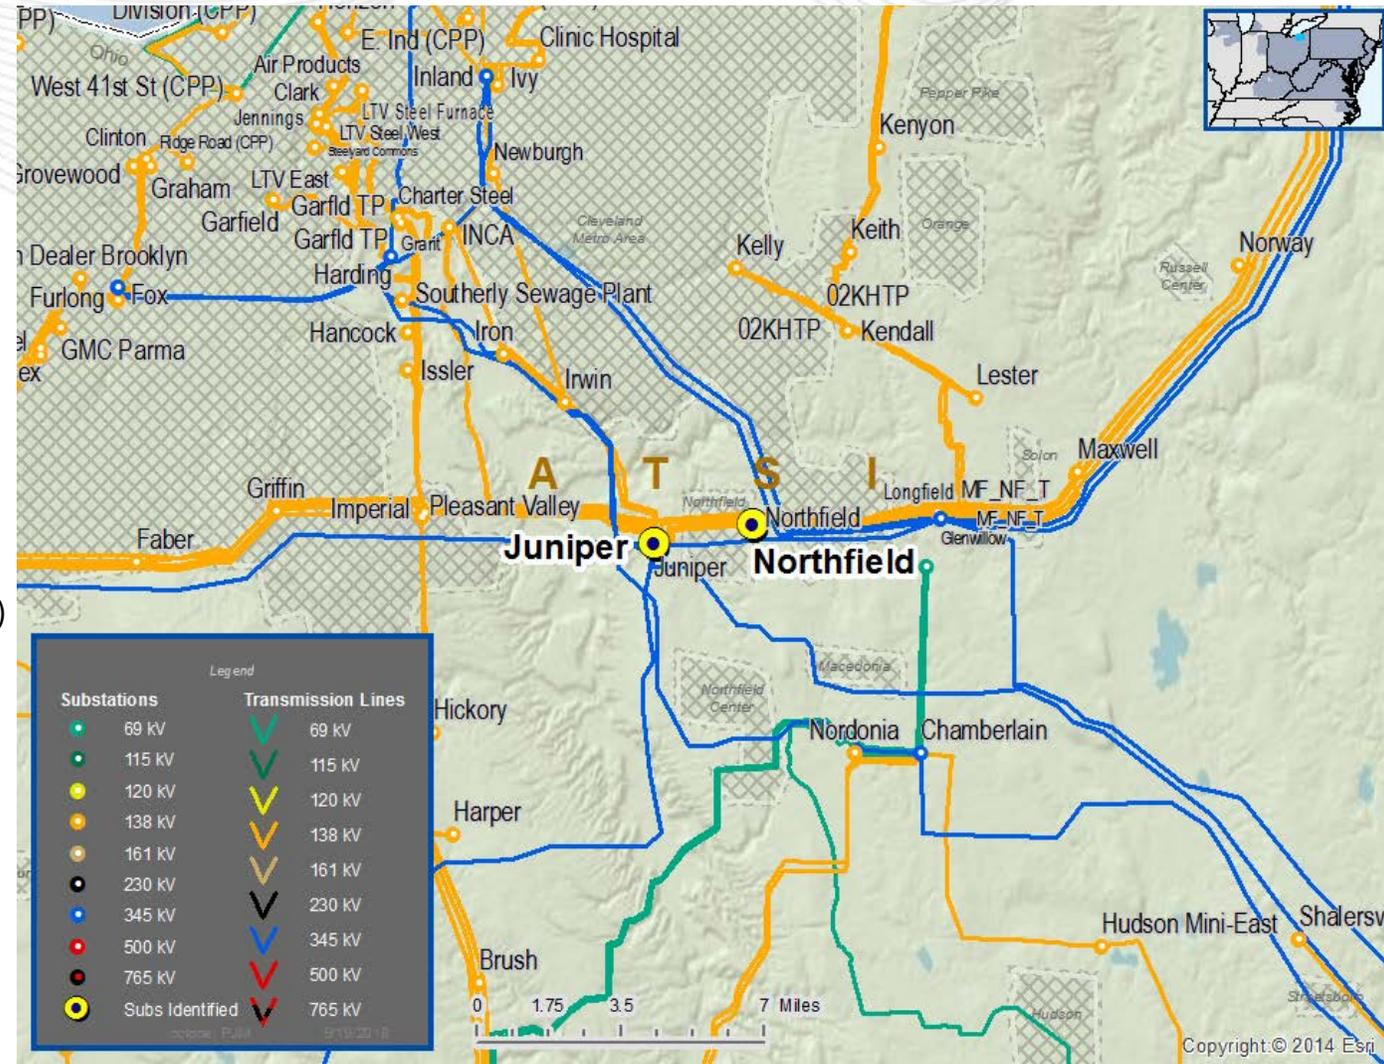
Northfield 138 kV Bus 2 and Bus 4

- Deteriorated bushings and insulators, increased failure risks
- Reliability issues, EM relaying mis-operations

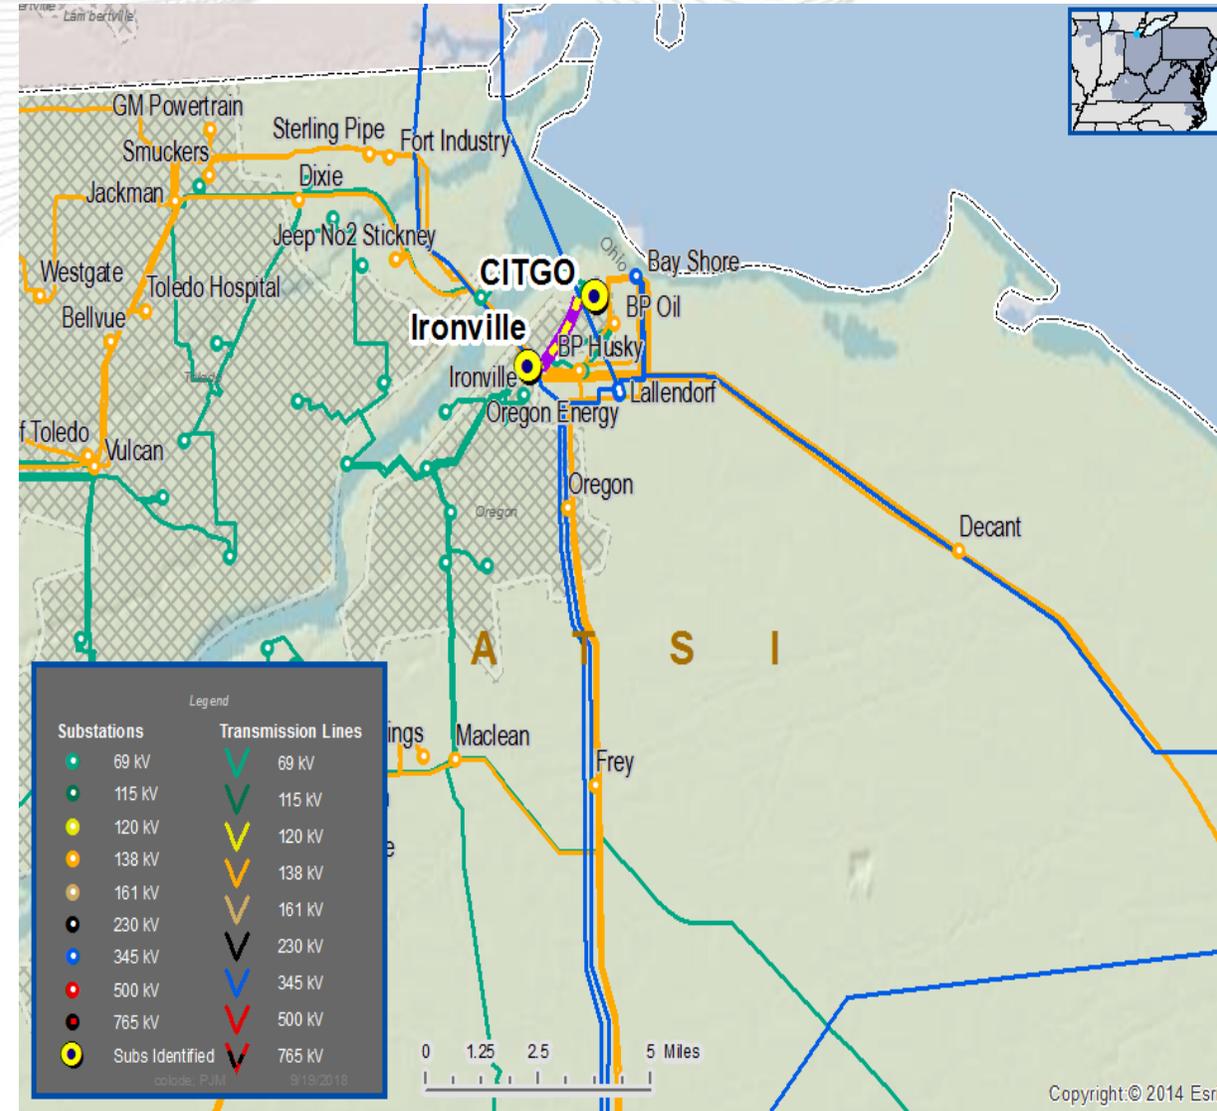
Ironville-Citgo 69 kV Condition Assessment (Approximately 4 miles)

- Identified obsolete and deteriorated equipment.
 - 60-68 year old construction; poor inspection results, 89 % rejection rate.
 - Approximately 2 repair records over the past 5 years.
- Multiple transmission delivery points (3) impacted; back-up source to (4) transmission delivery points.

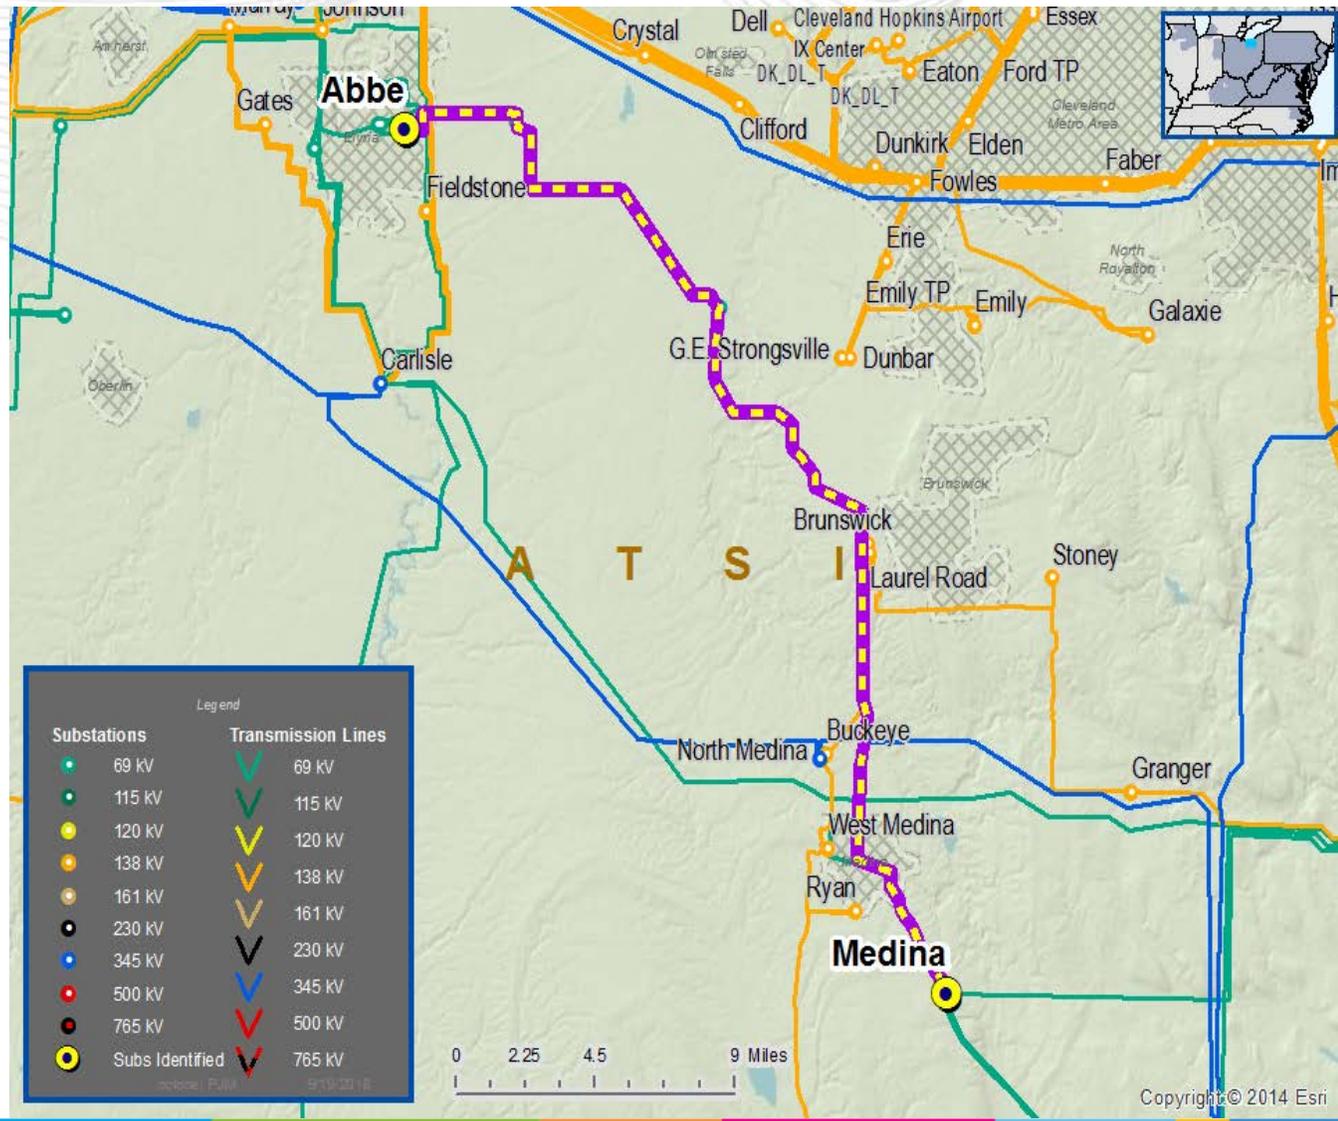
Abbe-Medina 69 kV Condition Assessment (Approx. 30 miles)

- Identified obsolete and deteriorated equipment.
 - 62 year old construction; poor inspection results.
 - Negative outage history over past 5 years.
 - Approximately 17 repair records over the past 5 years; increasing trend .
- Multiple transmission delivery points (8) impacted.
- Need to upgrade to current standards

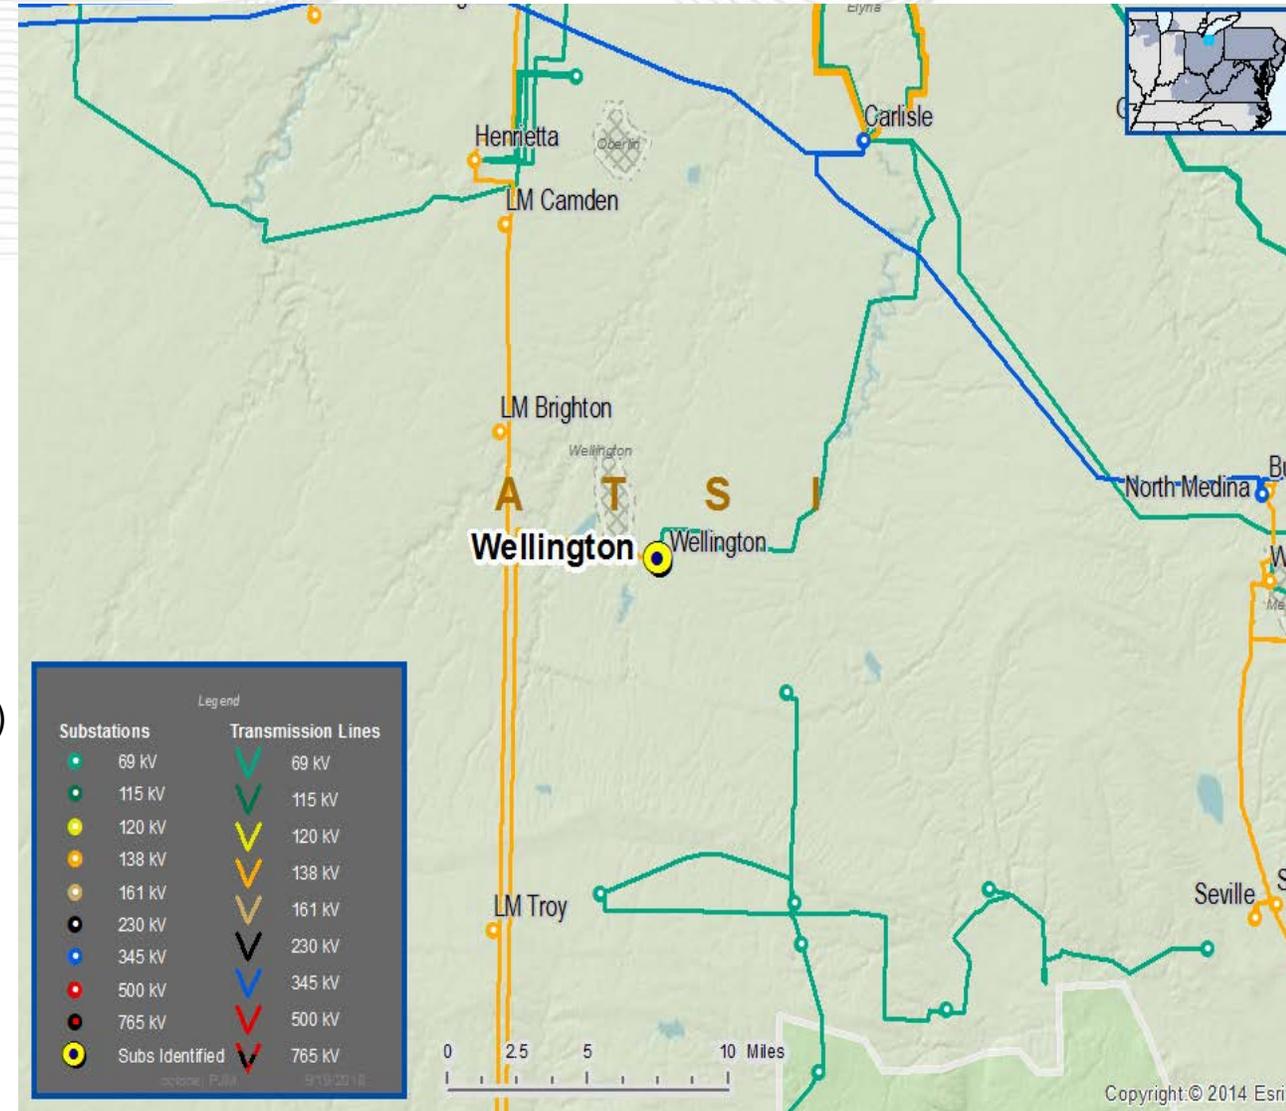
Wellington-Hanville-Steuben 69 kV Condition Assessment (Approx. 33 miles)

- Identified obsolete and deteriorated equipment.
 - 50 to 56 year old construction; poor inspection results.
 - Negative outage history over past 5 years;
 - Previous radial line (now networked) with 5 distribution delivery points.
 - Approximately 13 repair records over the past 5 years; increasing trend.
- Multiple transmission delivery points (5) impacted.
- Need to upgrade to current standards

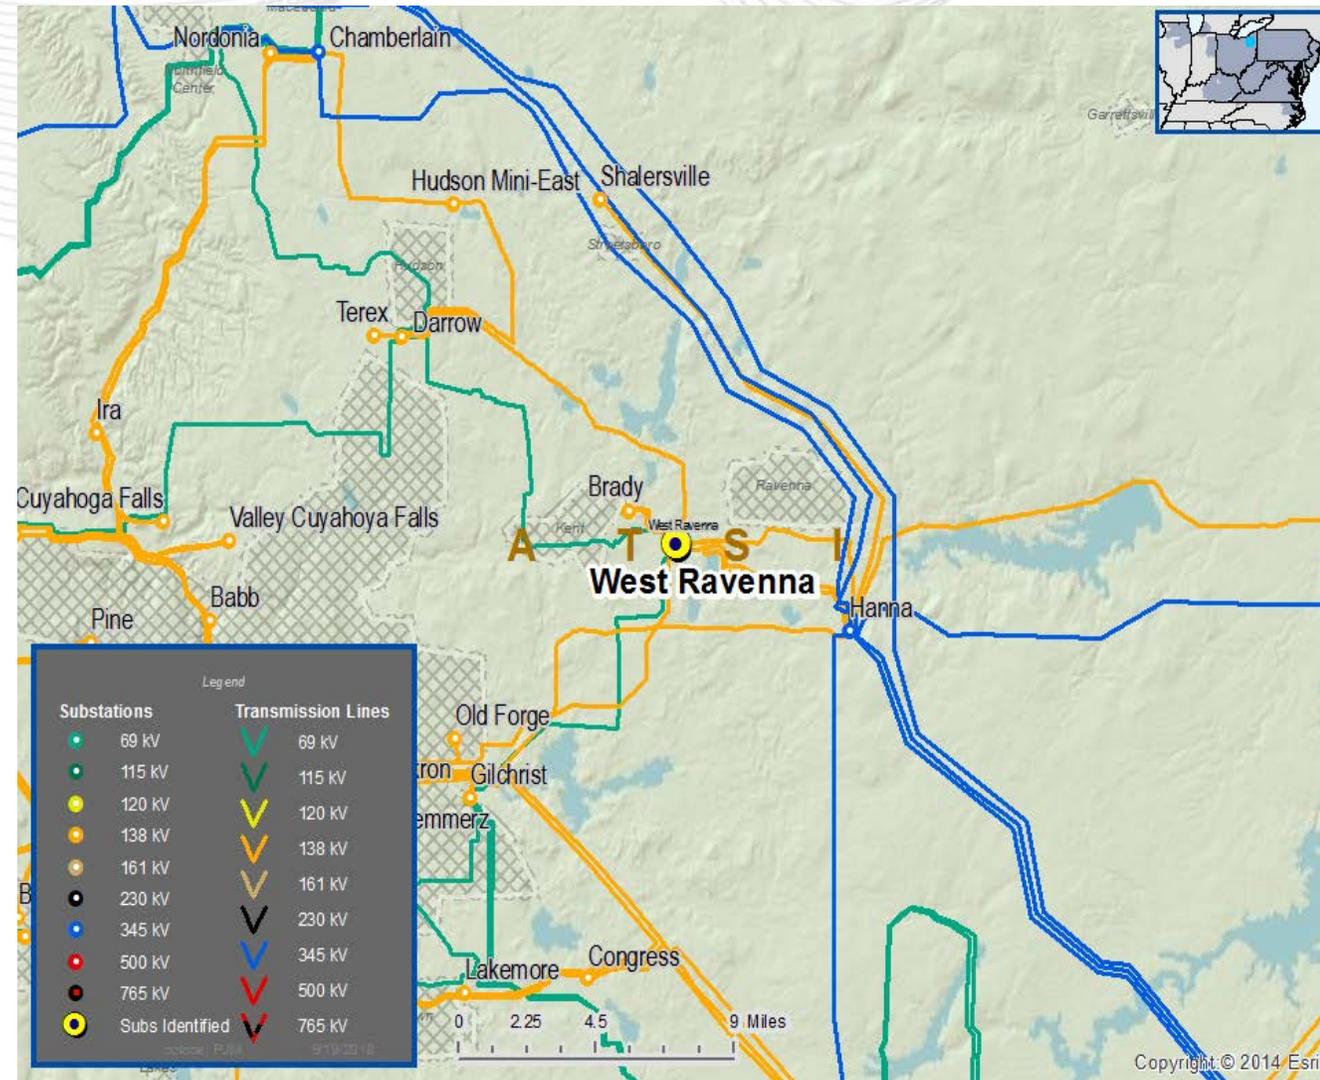
Ravenna-West Ravenna #2 69 kV Condition Assessment (Approx. 4 miles)

- Identified obsolete and deteriorated equipment.
 - 50 year old construction; poor inspection results, 94 % rejection rate.
 - Negative outage history over past 5 years;
 - Approximately 21 repair records over the past 5 years; increasing trend.
- Need to upgrade to current standards

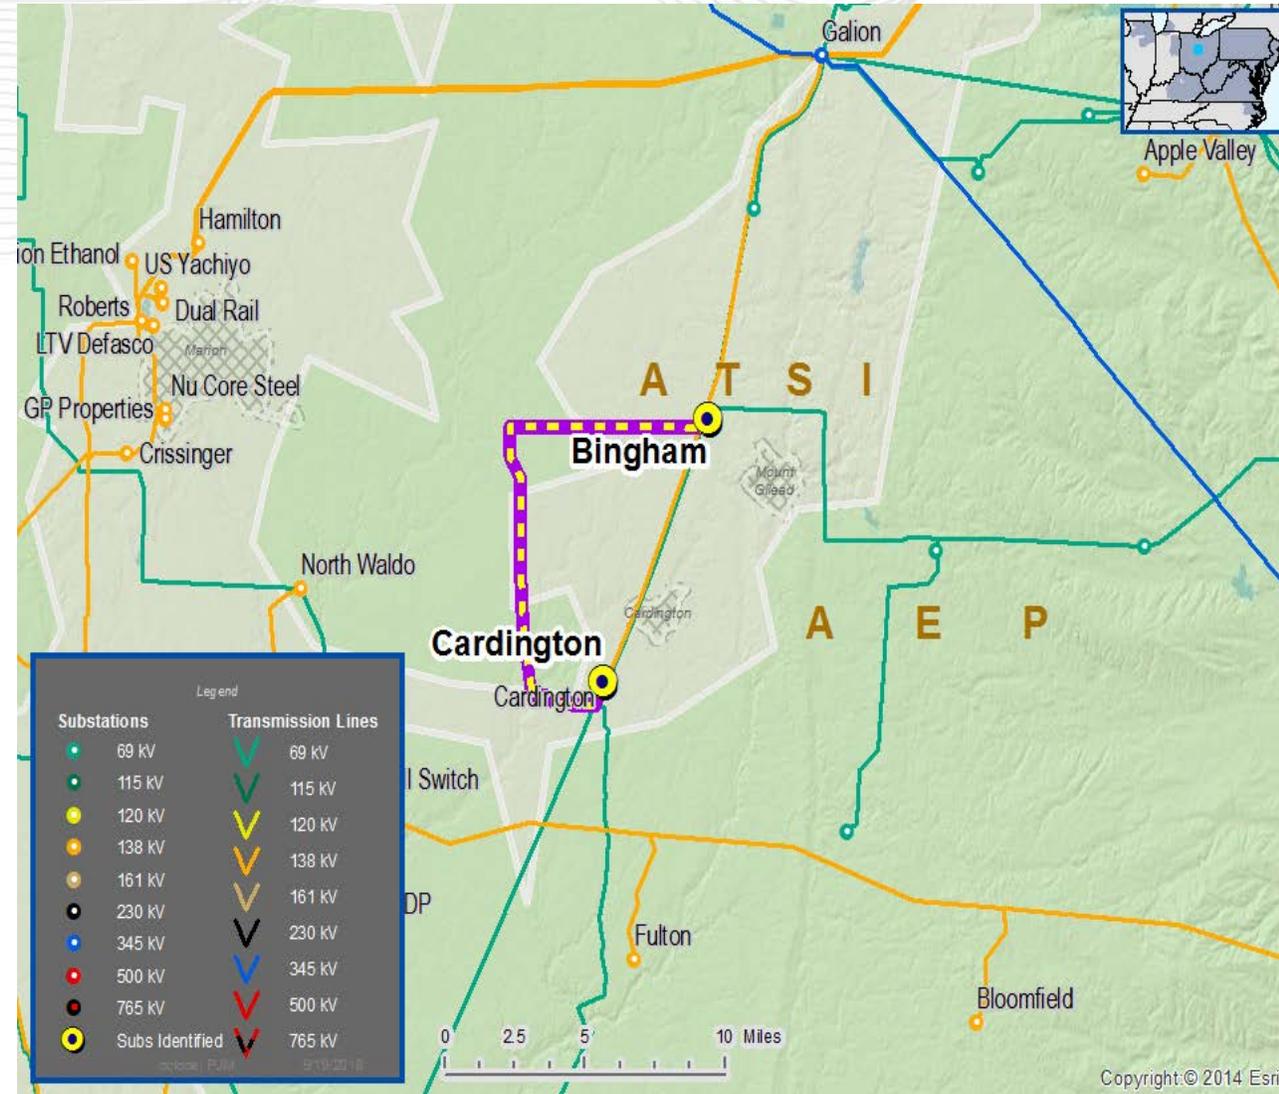
Bingham-Cardington (Schaff) 69 kV Condition Assessment (Approx. 15 miles)

- Identified obsolete and deteriorated equipment.
 - 45-62 year old construction; poor inspection results, 92 % rejection rate.
 - Negative outage history over past 5 years;
 - Approximately 10 repair records over the past 5 years; increasing trend.
- Need to upgrade to current standards

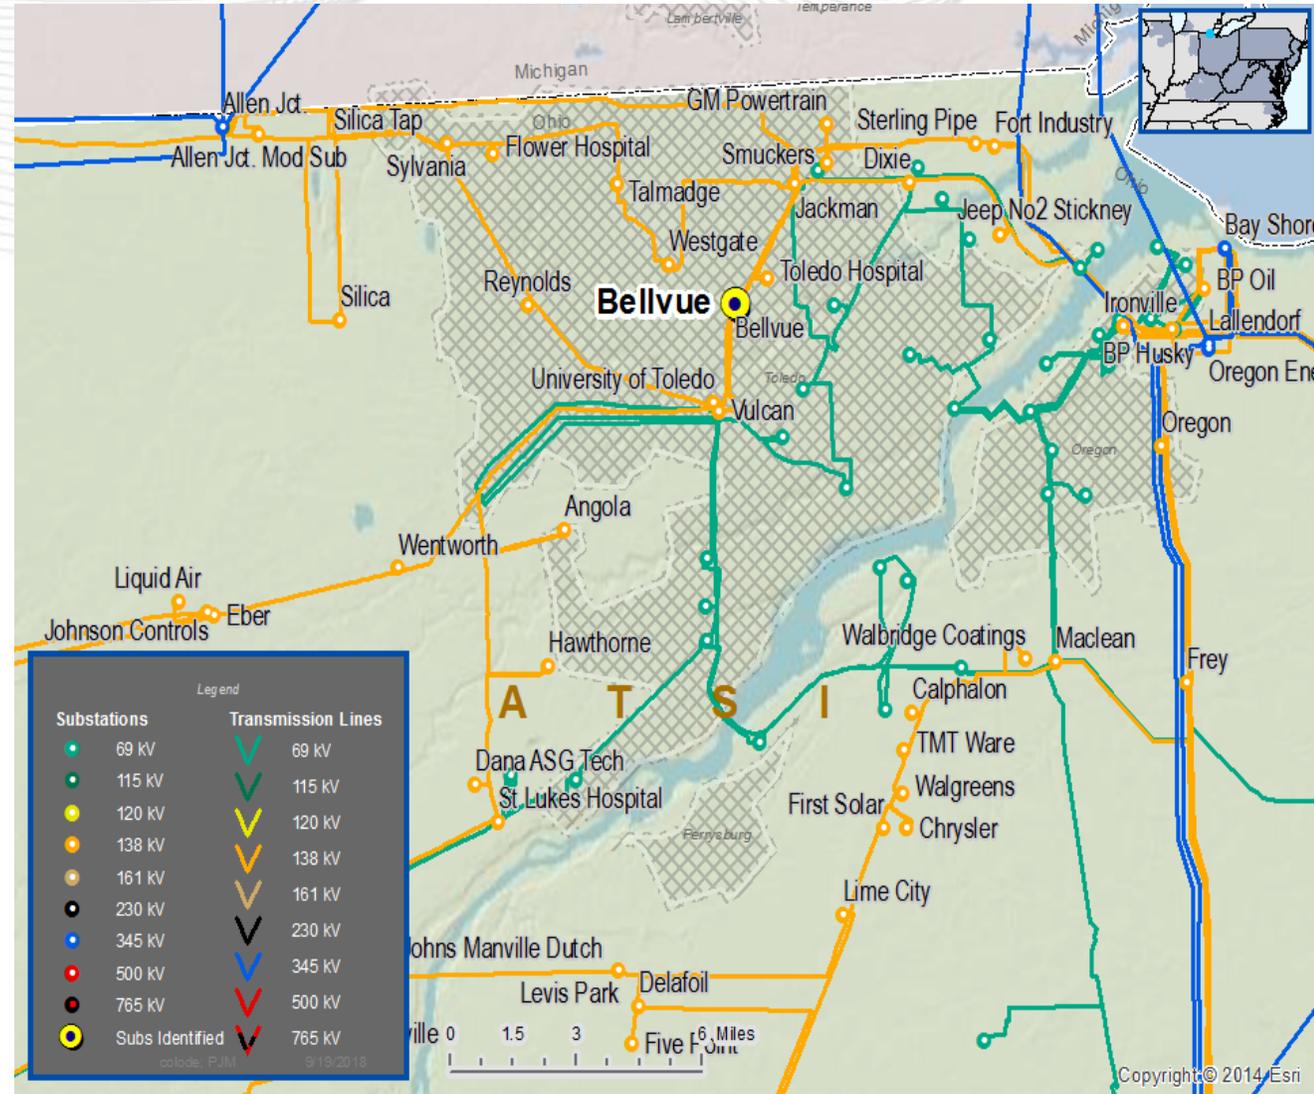
Bellevue-Carriage 69 kV Condition Assessment (Approximately 13 miles)

- Identified obsolete and deteriorated equipment.
 - 48 year old construction; poor inspection results, 62 % rejection rate.
 - Negative outage history over past 5 years;
 - Approximately 9 repair records over the past 5 years; increasing trend.
 - Sections of older 3/0 CU conductor.
- Multiple transmission delivery points (7) impacted.
- Need to upgrade to current standards

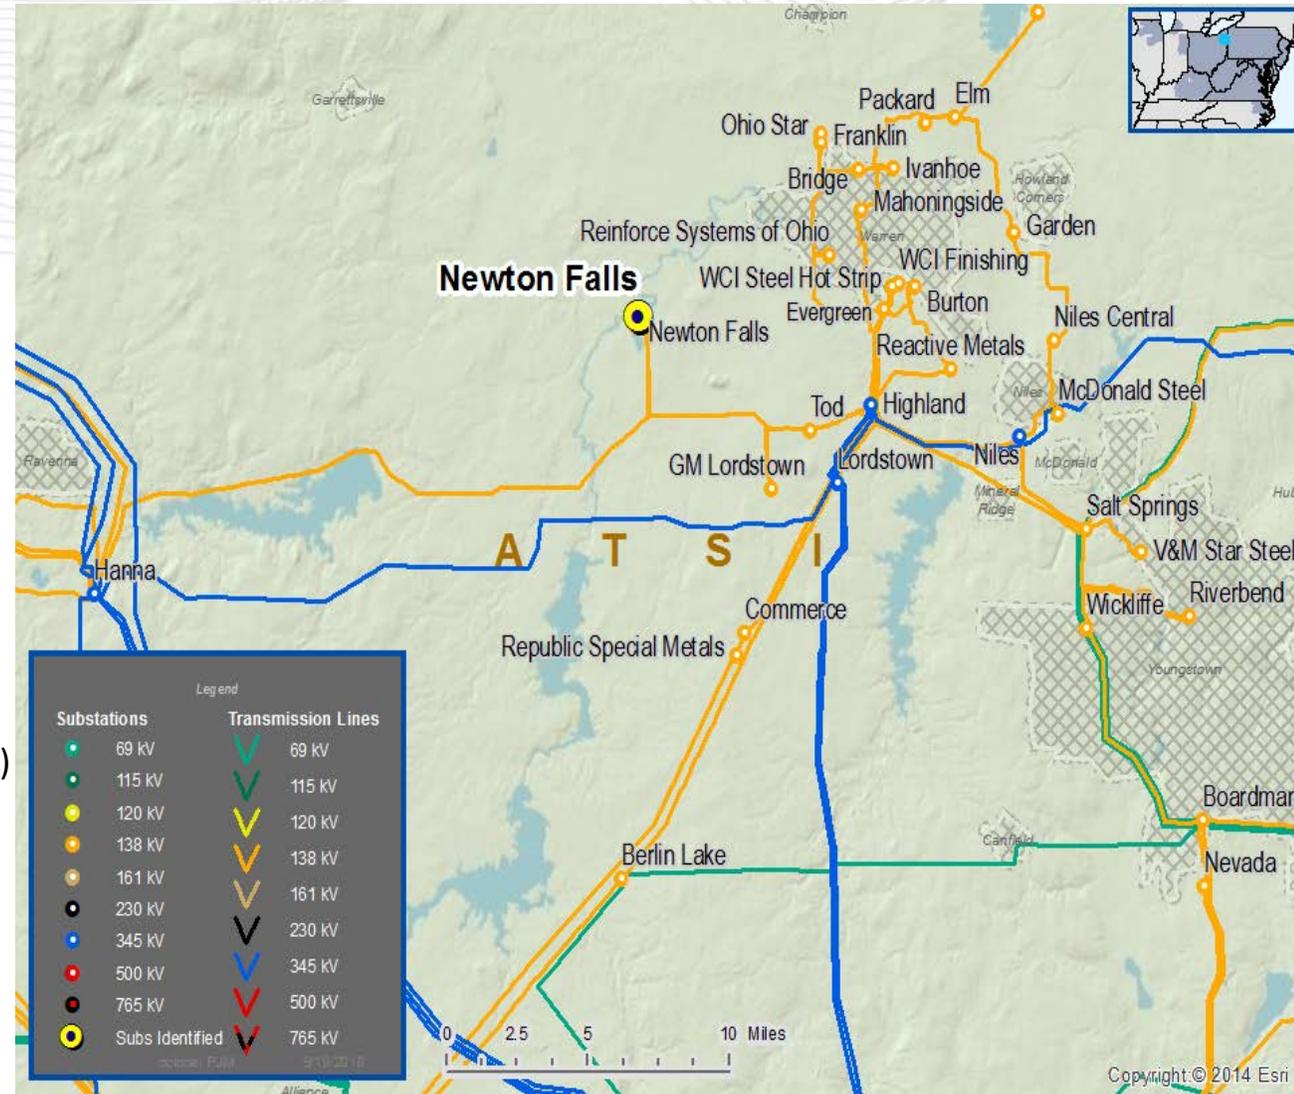
Hanna-Newton Falls 138 kV Condition Assessment (Approximately 20 miles)

- Identified obsolete and deteriorated equipment.
 - 62 year old construction; poor inspection results, 87 % rejection rate.
 - Negative outage history over past 5 years;
 - Approximately 45 repair records over the past 5 years; increasing trend.
- Need to upgrade to current standards

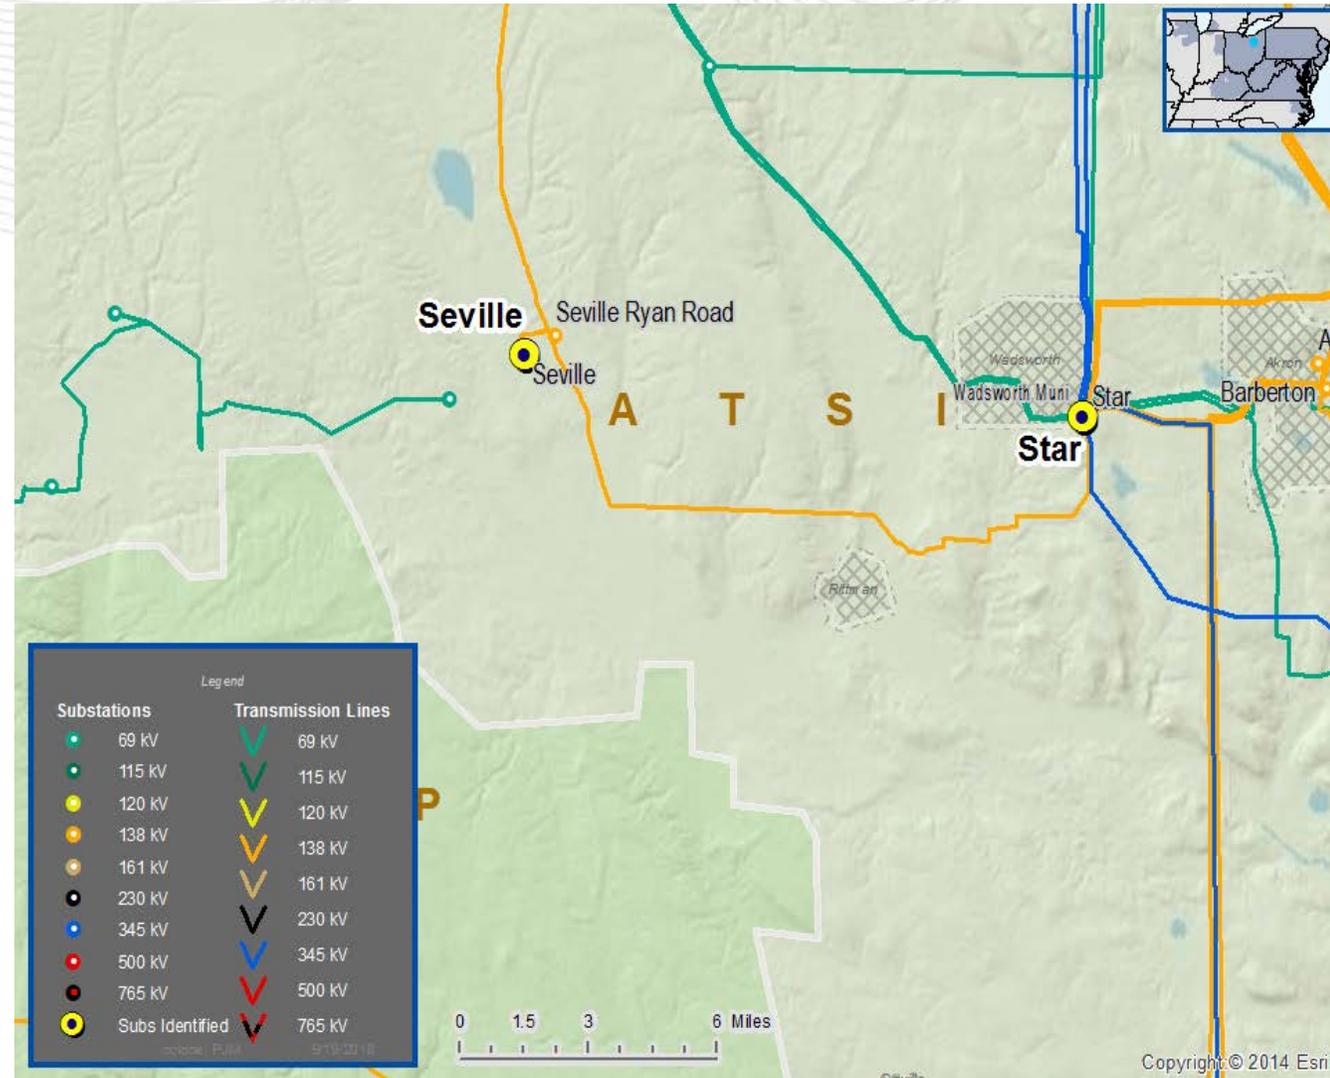
Star-Seville (Rittman) 69 kV Condition Assessment (Approximately 18 miles)

- Identified obsolete and deteriorated equipment.
 - 56 year old construction; poor inspection results, 82 % rejection rate.
 - Negative outage history over past 5 years;
 - Approximately 30 repair records over the past 5 years; increasing trend.
- Multiple transmission delivery points (3) impacted.
- Radial 69 kV transmission line with approximately 30 MWs and approximately 7,700 customer at risk.

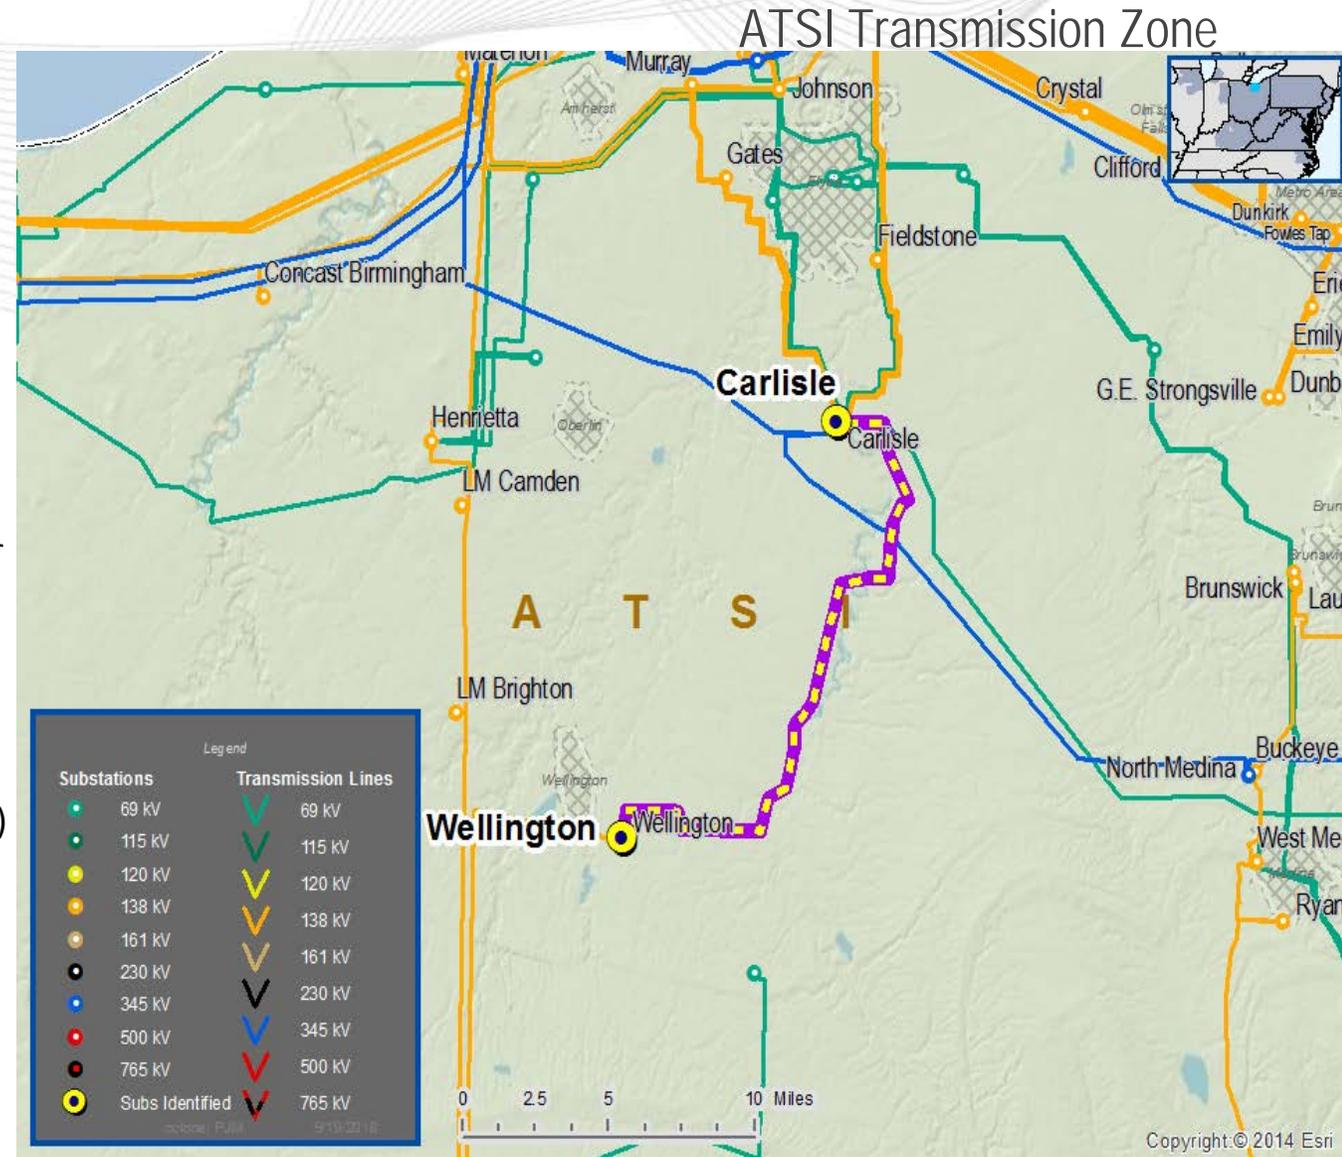
Carlisle-Wellington 69 kV Condition Assessment (Approximately 29 miles)

- Identified obsolete and deteriorated equipment.
 - 50-75 year old construction; poor inspection results, 75 % rejection rate.
 - Negative outage history over past 5 years;
 - Approximately 29 repair records over the past 5 years; increasing trend.
- Multiple transmission delivery points (9) impacted.
