Sub Regional RTEP Committee Western Region ATSI

September 28, 2018

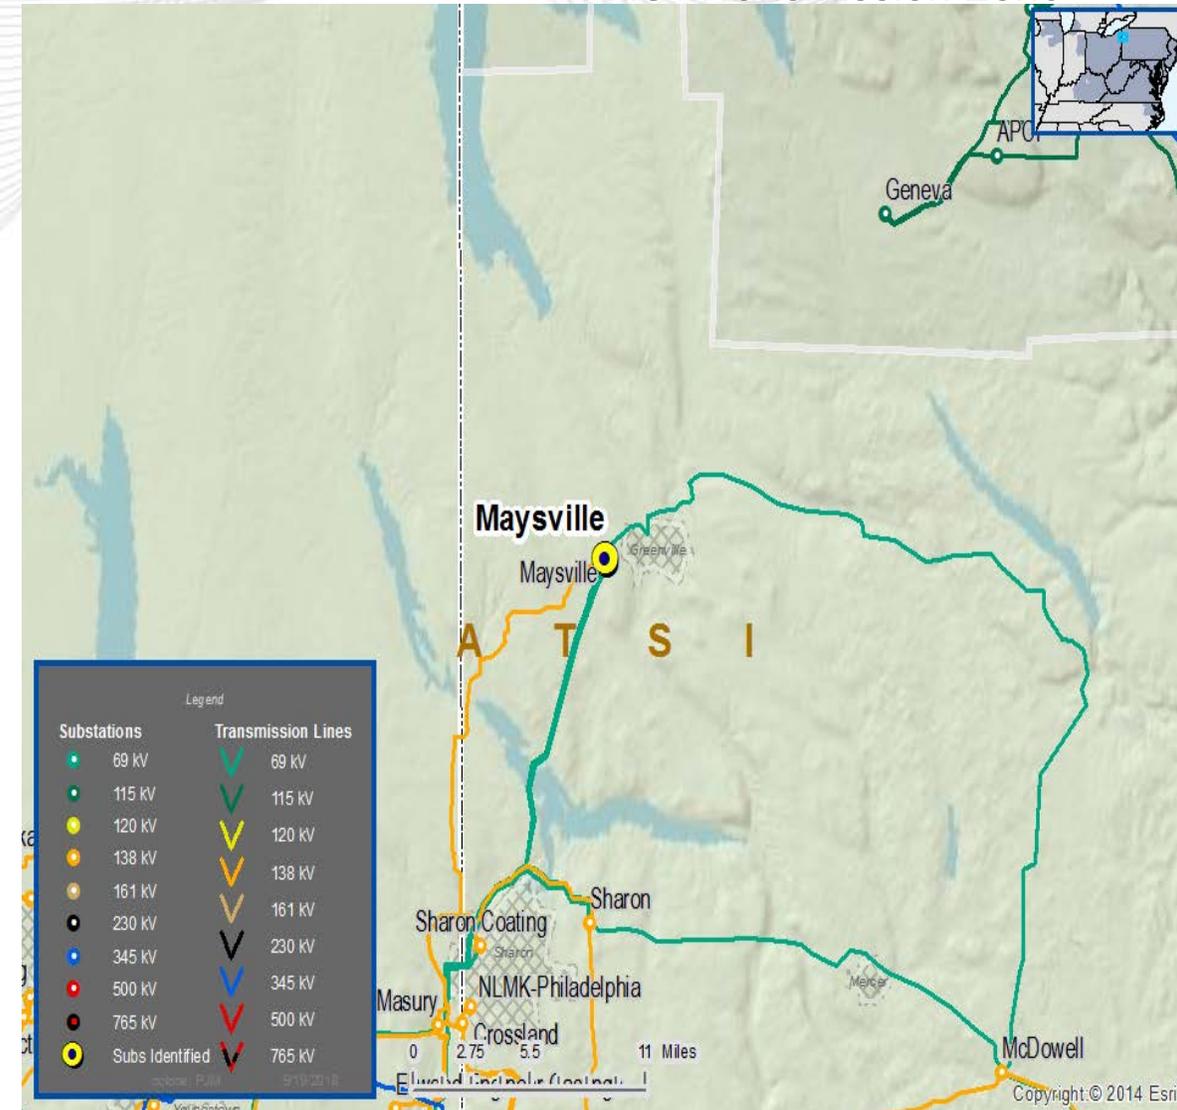
Canal-Maysville (Greenville) 69 kV Condition Assessment (Approximately 1.5 miles)

- Identified obsolete and deteriorated equipment.
 - 61 year old construction; poor inspection results, 100 % rejection rate.
 - Approximately 4 repair records over the past 5 years.
- Radial 69 kV transmission line with 16 MWs and approximately 6,800 customer at risk.

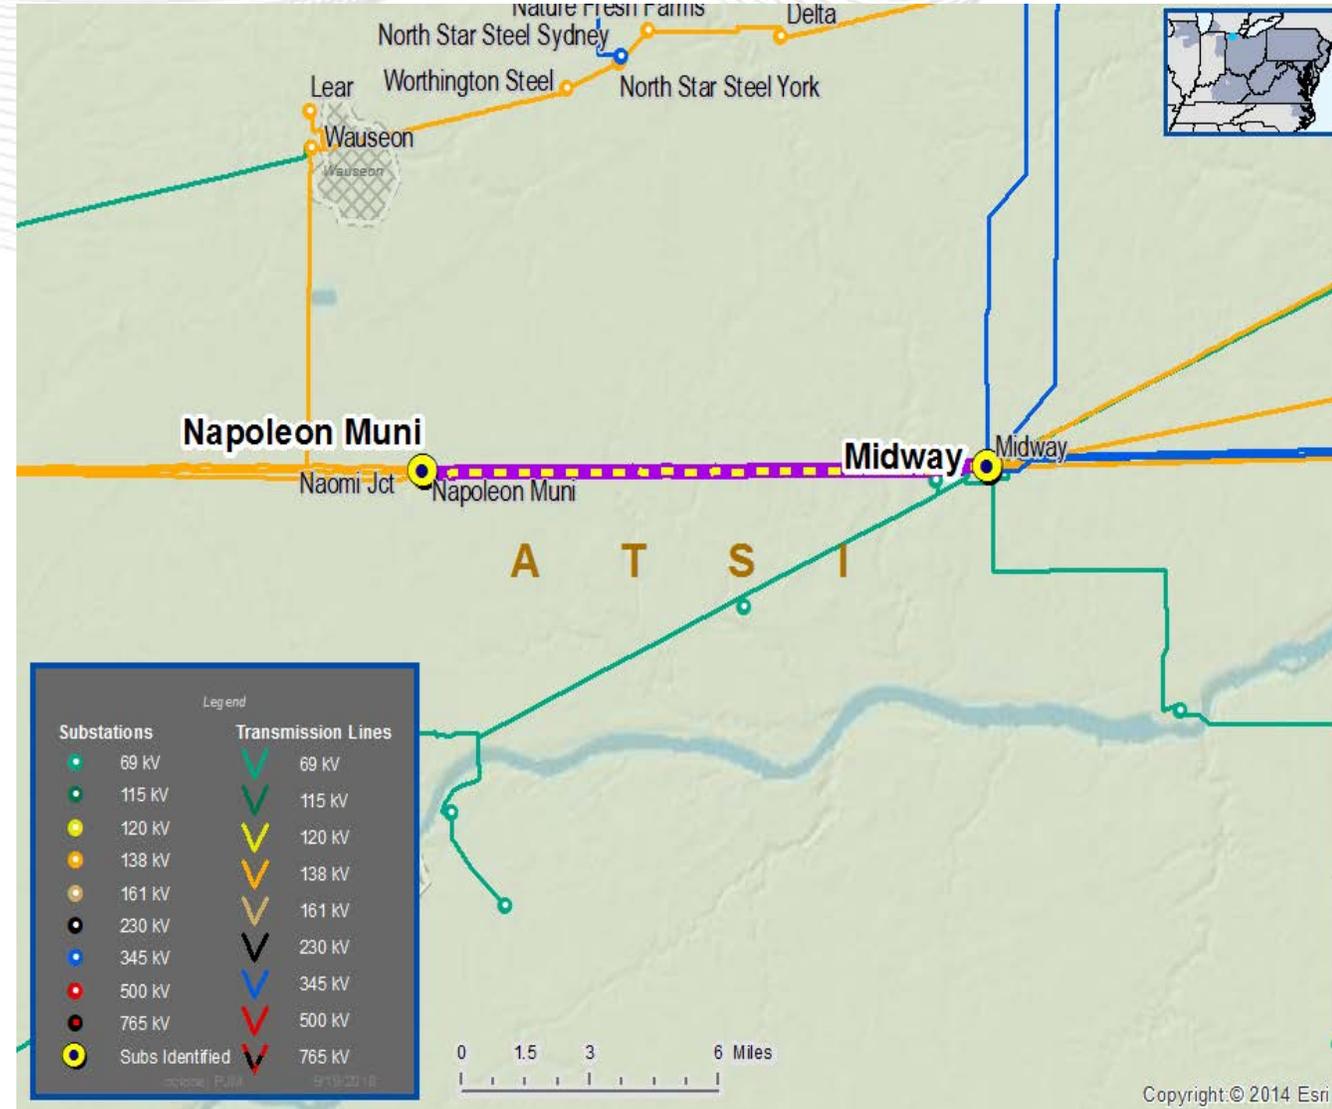
Midway-Napoleon 69 kV Condition Assessment (Approximately 11 miles)

- Identified obsolete and deteriorated equipment.
 - 42-52 year old construction; poor inspection results, 60 % rejection rate.
 - Approximately 8 repair records over the past 5 years; increasing trend.
 - 4/0 ACSR conductor
