NERC Lessons Learned

Misoperation of 87N Transformer
Ground Differential Relays Causing
Loss of Load

Northeast Power Coordinating Council

April 14, 2020

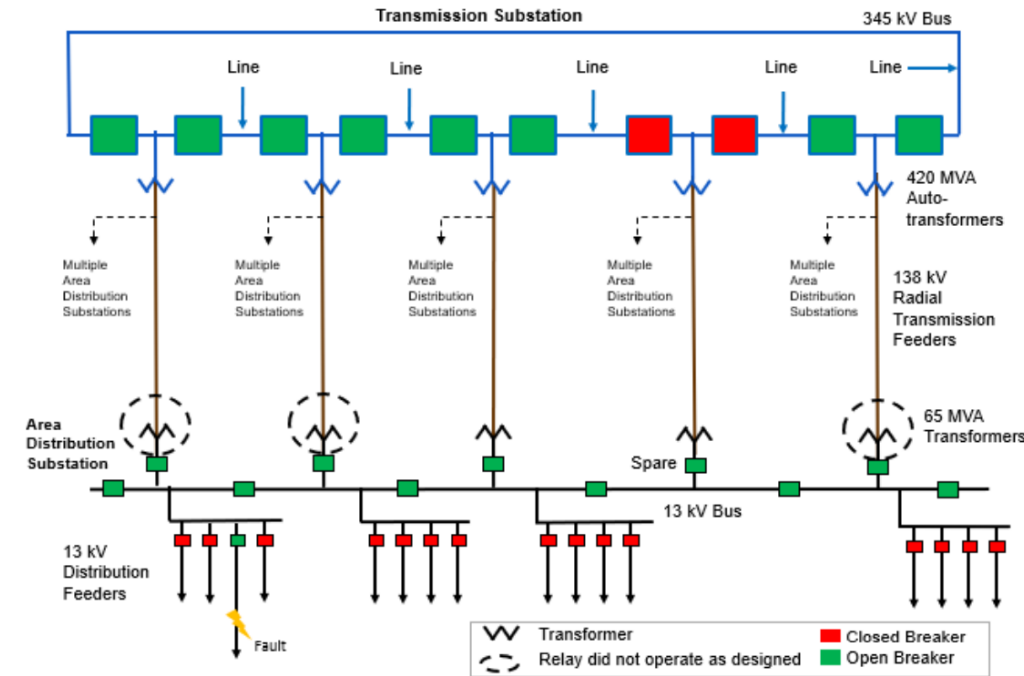
Figure 1: One-line Diagram of Transmission and Area Substations [1]

- 345 kV ring bus with 4 in-service XFMRs (1 standby)
- 13 kV feeder fault
- (3) 87N neutral/ground diff relays misoperated clearing the XFMRs
- Remaining XFMR overloaded before standby could be switched in
- (1) 345 kV path stayed in service
- Loss of load

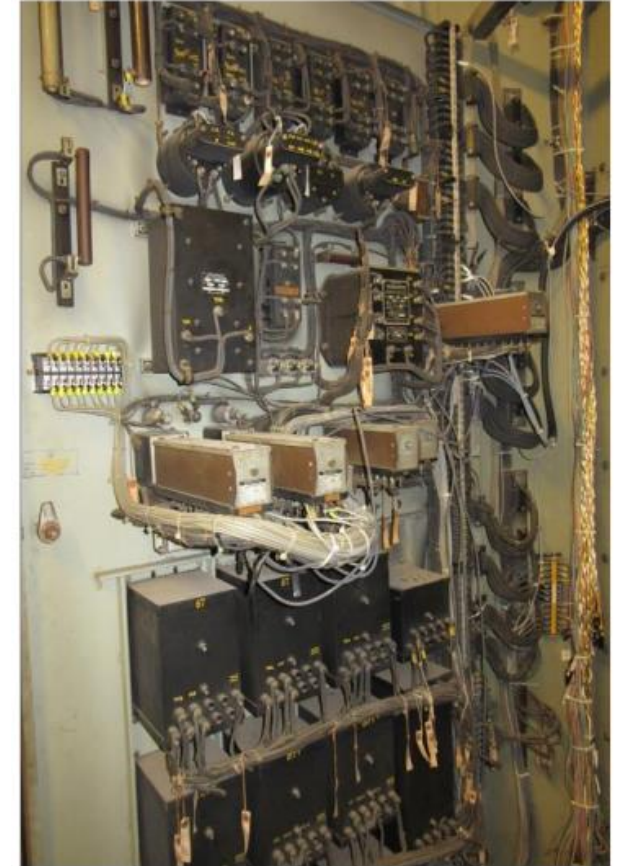
Figure 2: Wiring in Rear of Relay Panel [1]

- 87N relays misoperated from open or missing connection between the 13 kV transformer CTs and the neutral auxiliary CT that supplies each 87N relay
- Missing connection unbalances the differential configuration
- Missing neutral connection occurred during a 13 kV breaker retrofit program
- Original overall schematic not used
- Separate crew found issue later on 4th XFMR

- Missing wiring was corrected
- Process developed to redraw AC circuits with templates
- Standardization of commissioning testing for substation equipment and relay protection systems
- Provide feedback to supervision and engineering when problems are encountered

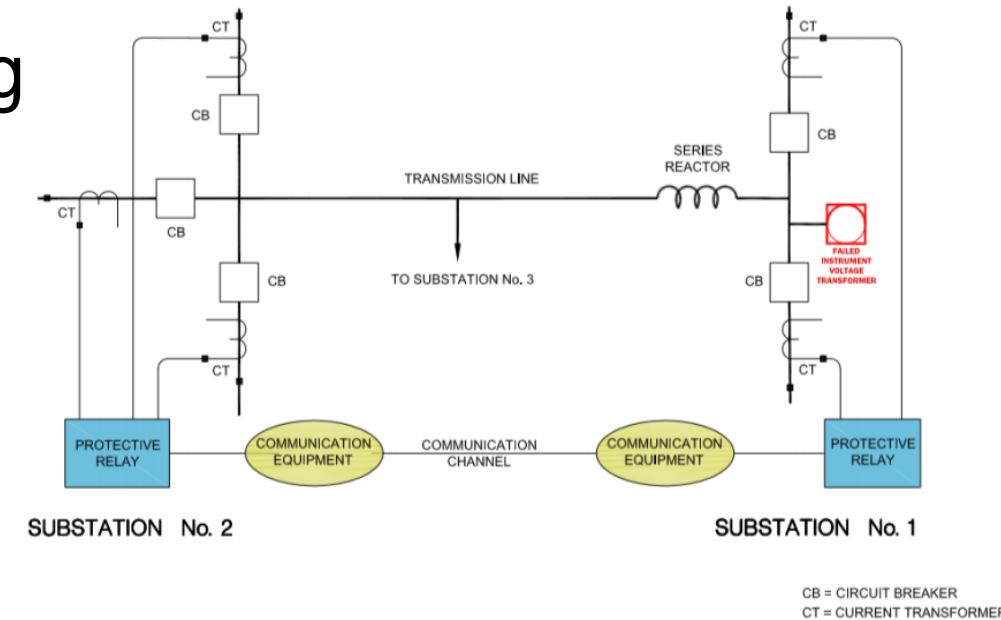
Figure 4: One Line Diagram of Faulted Circuit and Line Differential Protection [2]

- Single-phase-to-ground fault on CCVT
- Output temporarily isolated but coupling capacitors remained connected
- Communications equipment shut down because of an electrical transient associated with the fault
- Loss of communications prevented the line differential relaying from properly detecting the fault
- Remote back-up relays slow to detect fault for multiple reasons

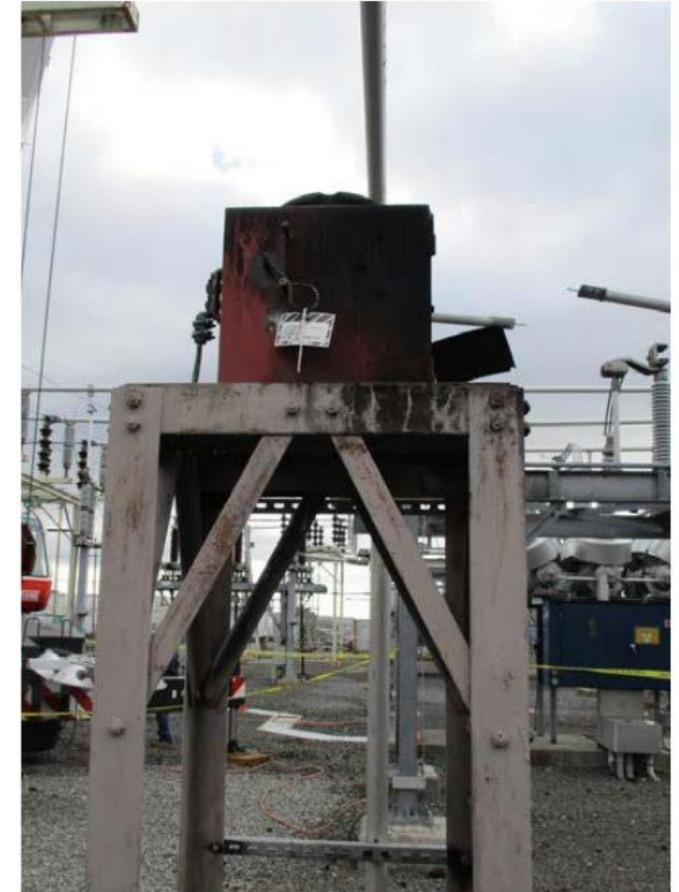
Figure 5: Failed C Phase CCPD [2]

- Fault was not cleared by either the primary or the back-up relay protection
- Four multiplexers (with 8 power supplies) automatically shut down from transient
- Control scheme intended to protect the power supply from overloading
- Transient generated coupled into the 125V DC battery supply
- Continuity between two adjacent ground grids

- All damaged equipment replaced
- DC supply for multiplexers shortened
- Ground grids reinforced
- Extent of condition review conducted system-wide to replace power supplies modified to disable shutdown scheme
- Diversify primary and backup equipment
- Equipment out of service should be completely isolated
