Culture of Reliability Excellence: Surry Nuclear Power Station Tornado Event

Case Study: Surry Nuclear Power Station

Tornado Damage (EFT-3)
April 16, 2011

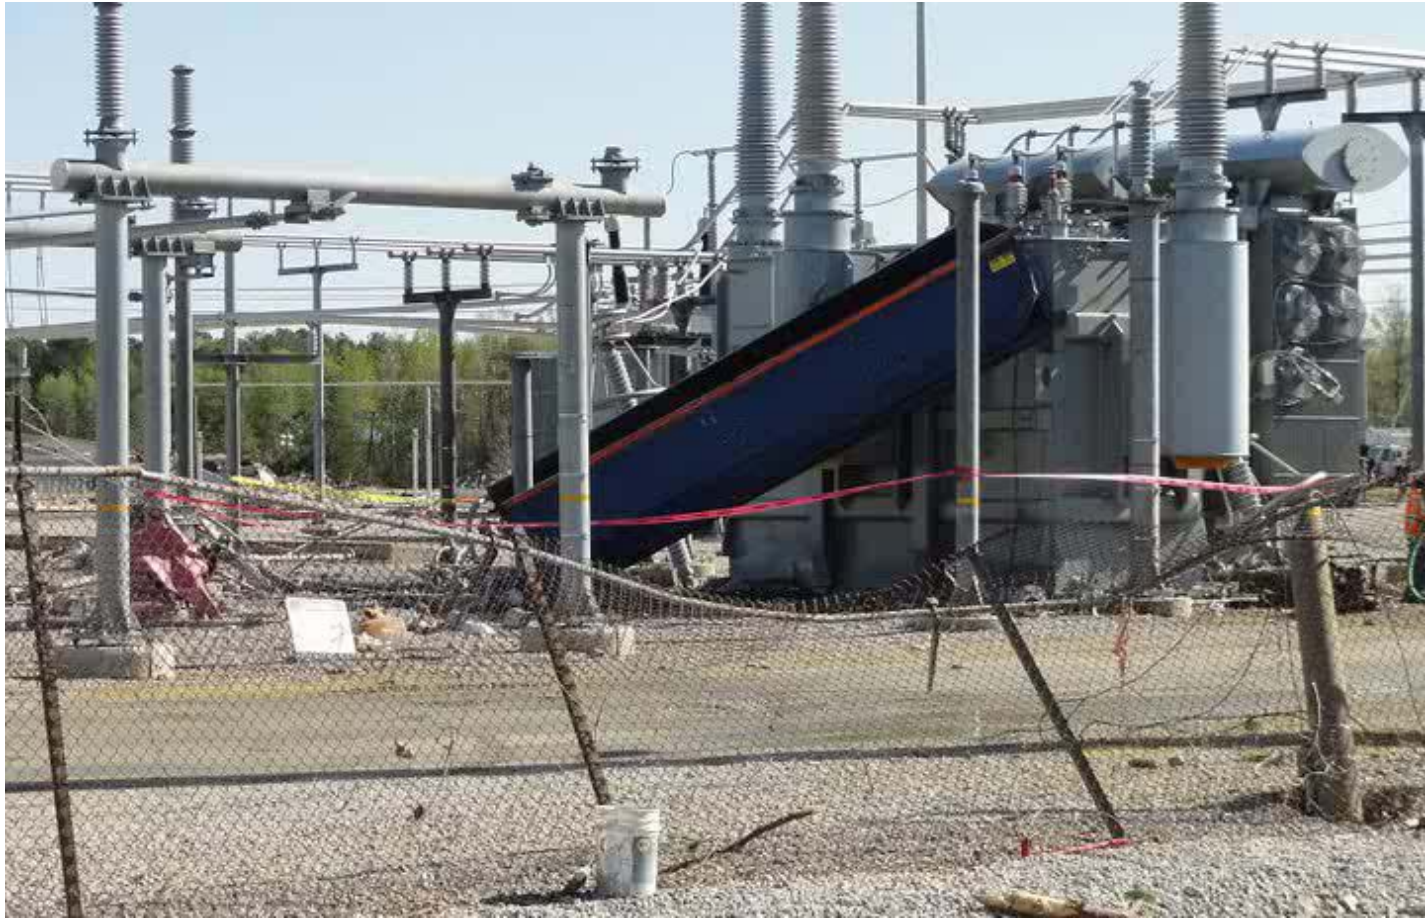
Container travelled approximately 100 yards to land against transformer

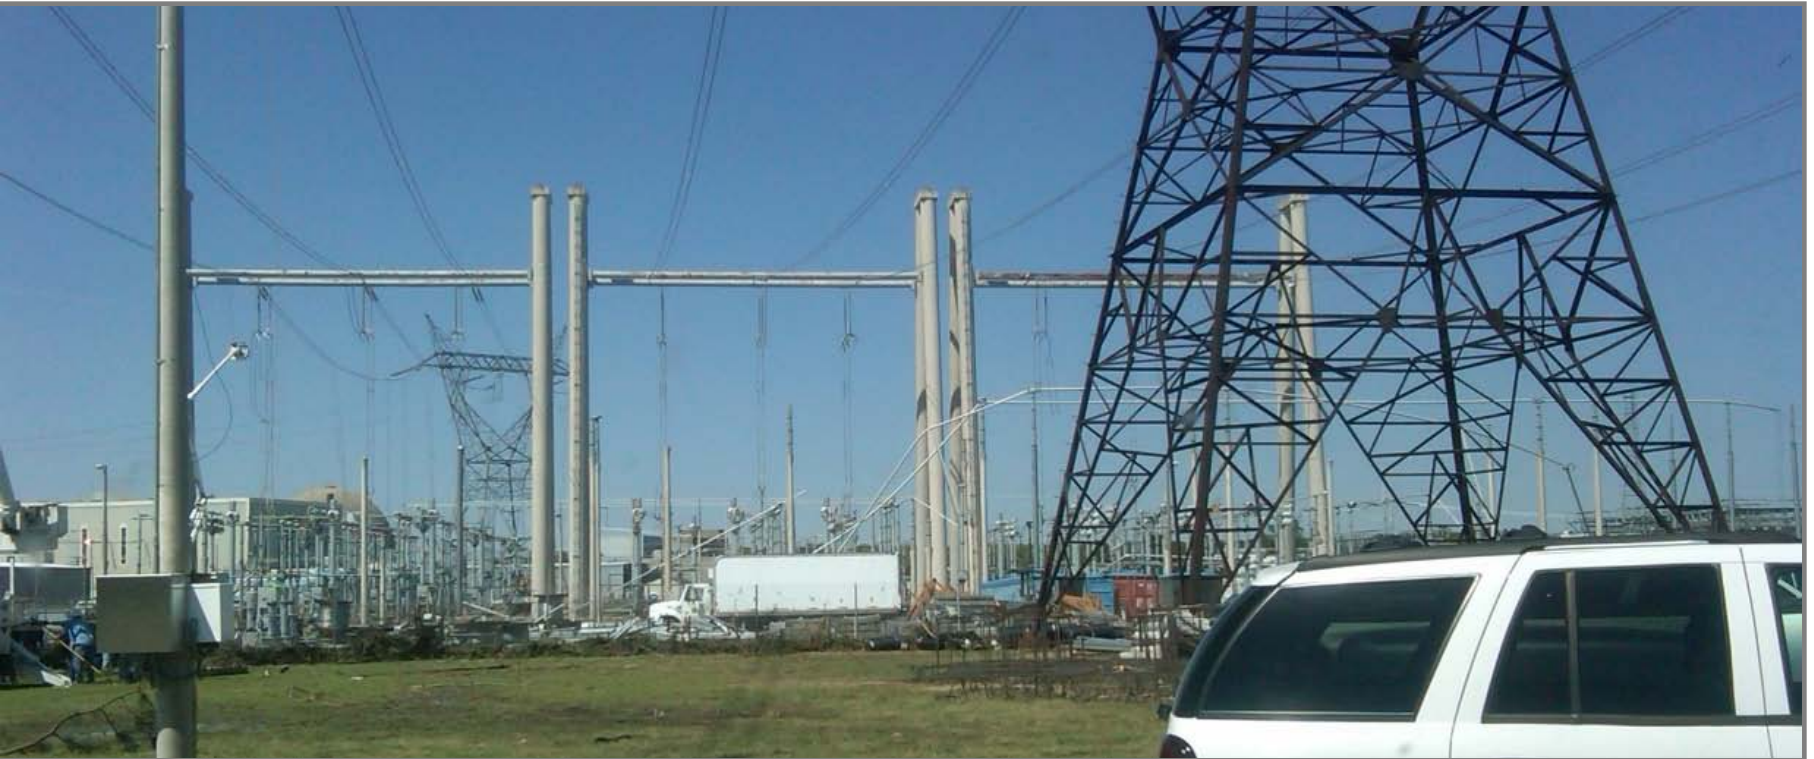
Electrical Switchyard: Splintered Bus Work

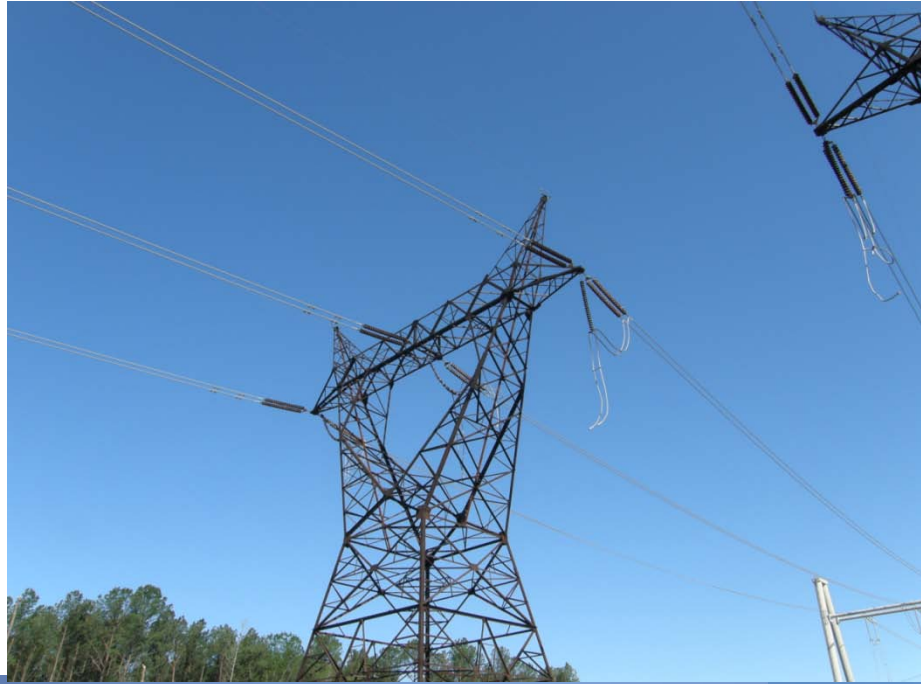
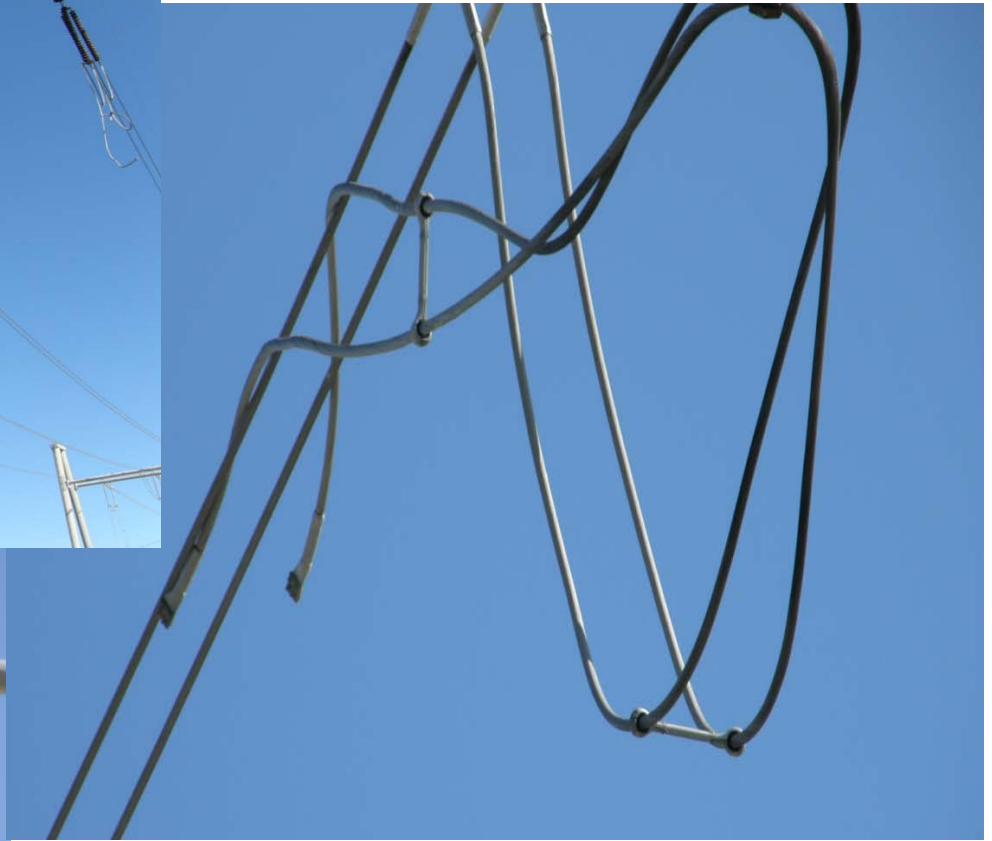
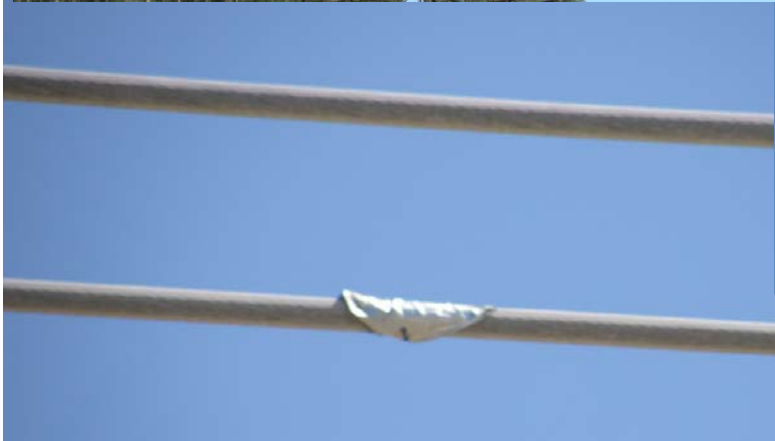
Transmission Line Damage

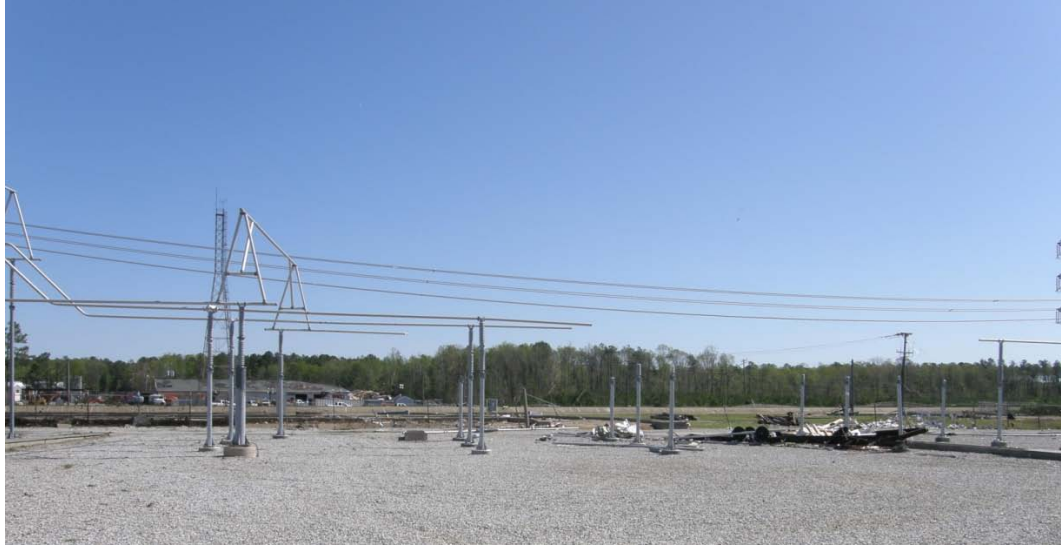
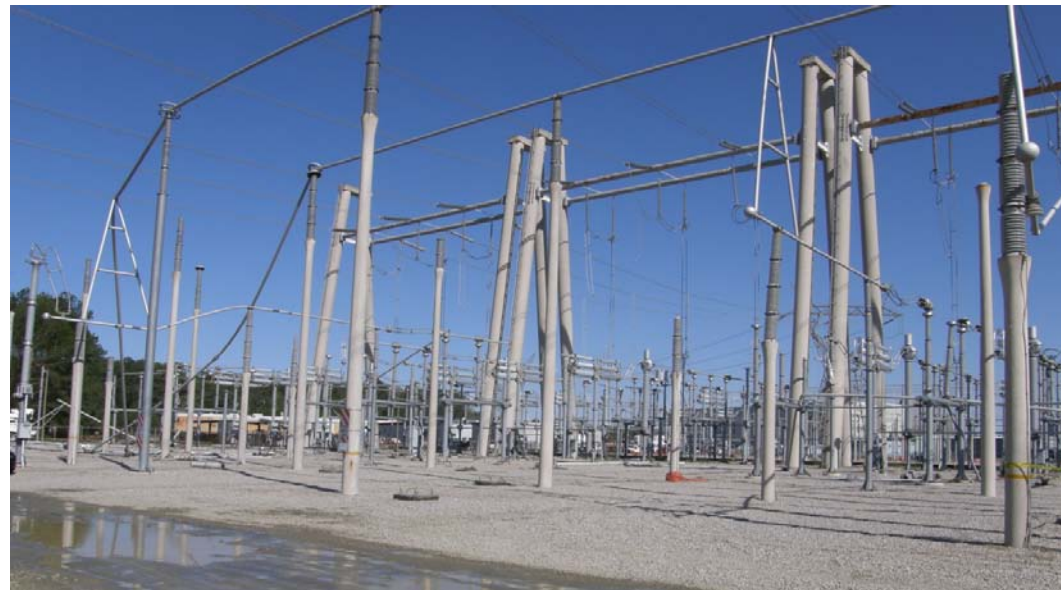
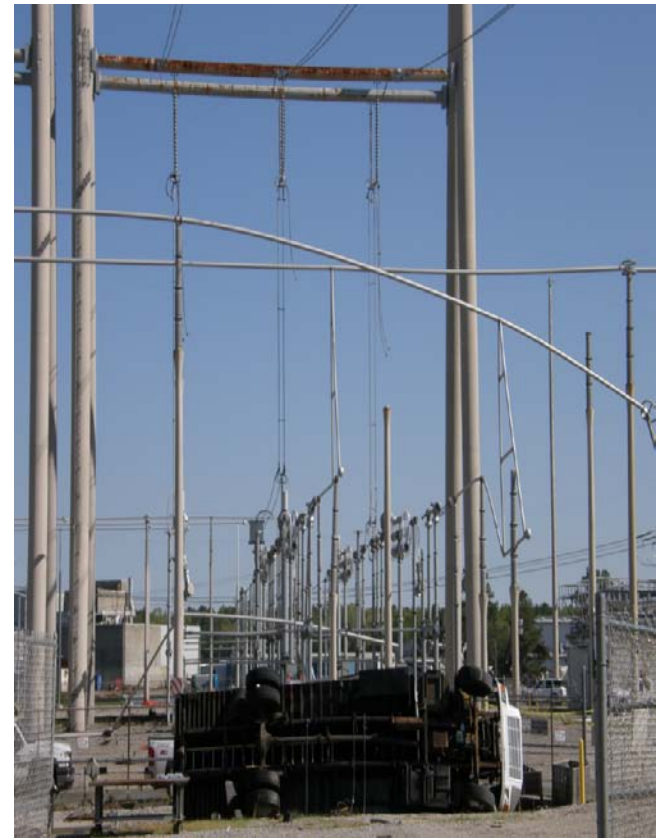
Electrical Switchyard: Bus Damage

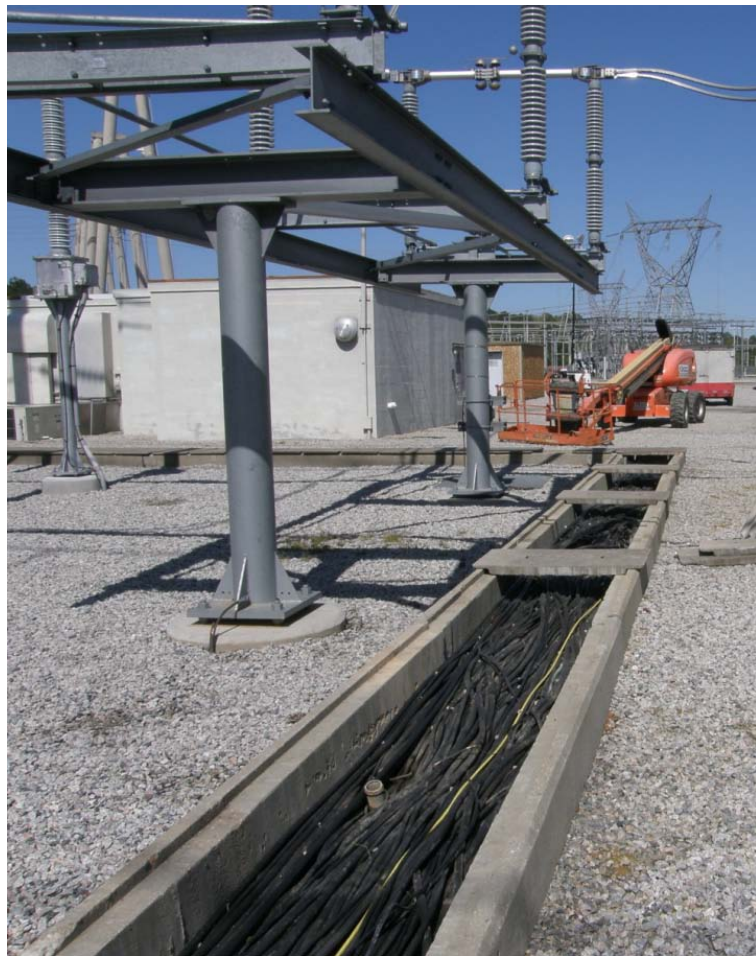
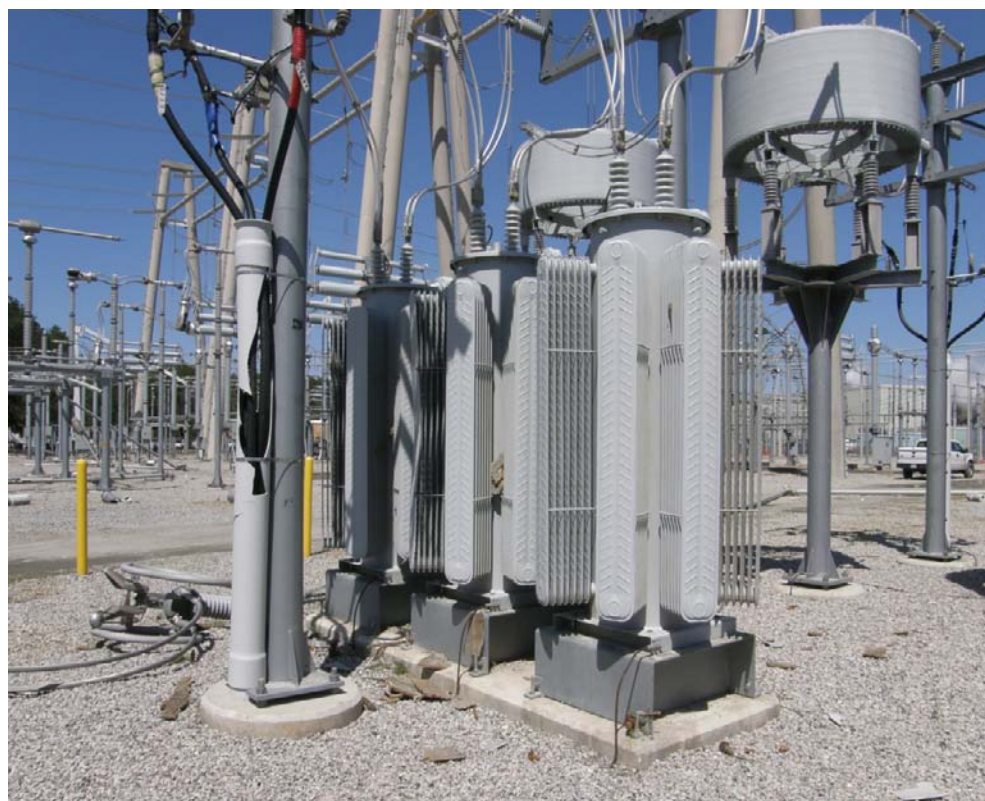
Electrical Switchyard: Flying Debris

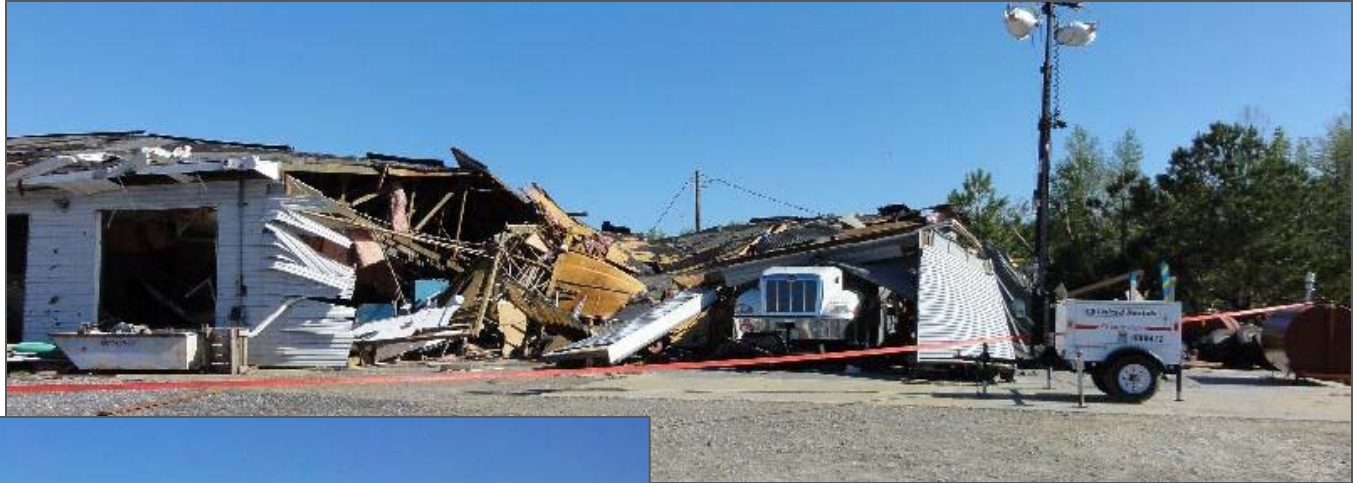
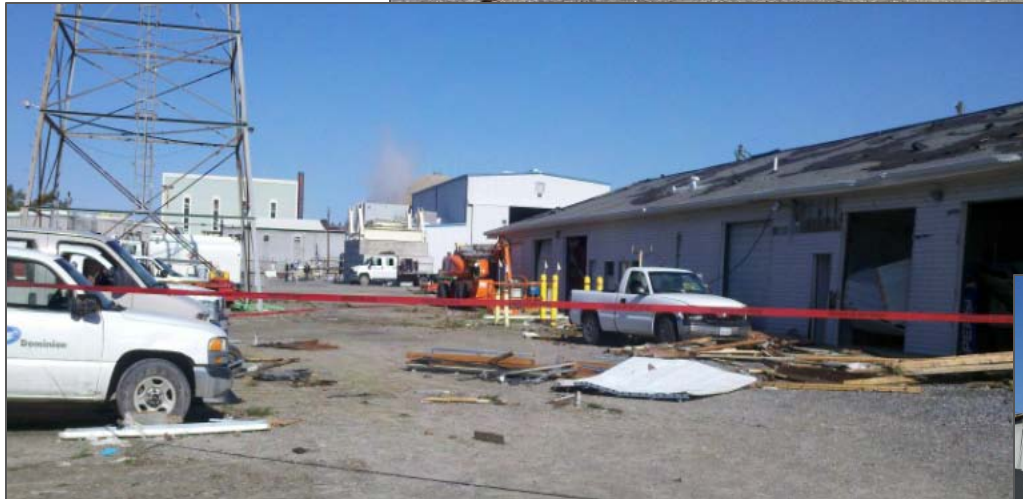
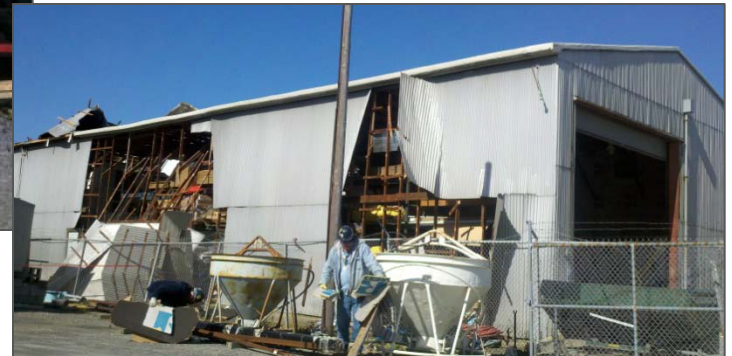
Vehicle Maintenance and Carpenter Shop

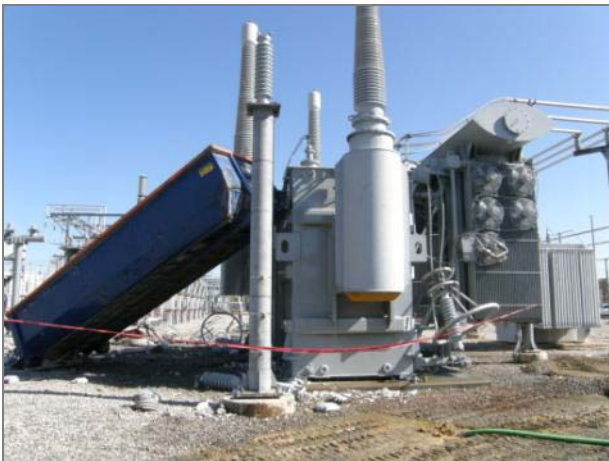
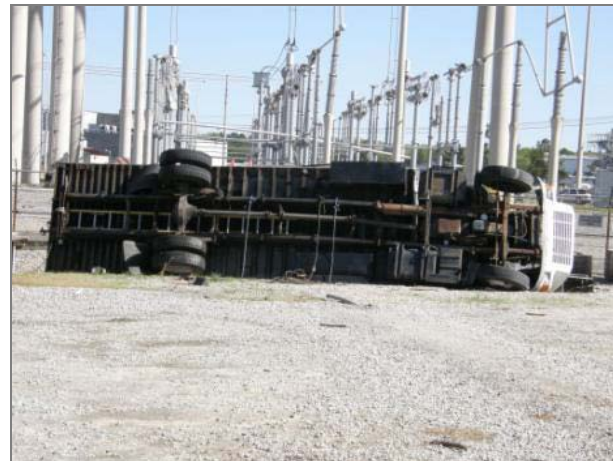
- ❑ The loss of digital relays due to water was not a significant issue in this event but if more damage had occurred it could have created a different restoration time line.
- ❑ New air conditioned facilities did not allow for an equilibrium of pressure and rubberized roof membrane was breached. Review design of existing control houses to improve their ability to handle high winds.
- ❑ Work trailers although tied down with concrete blocks could not be restrained. Use of vehicles in critical locations will need to be considered.
