# Subregional RTEP Committee – Mid-Atlantic FirstEnergy Supplemental Projects

JCPL Transmission Zone

**Need Number:** JCPL-2026-013

**Need Number:** JCPL-2026-014

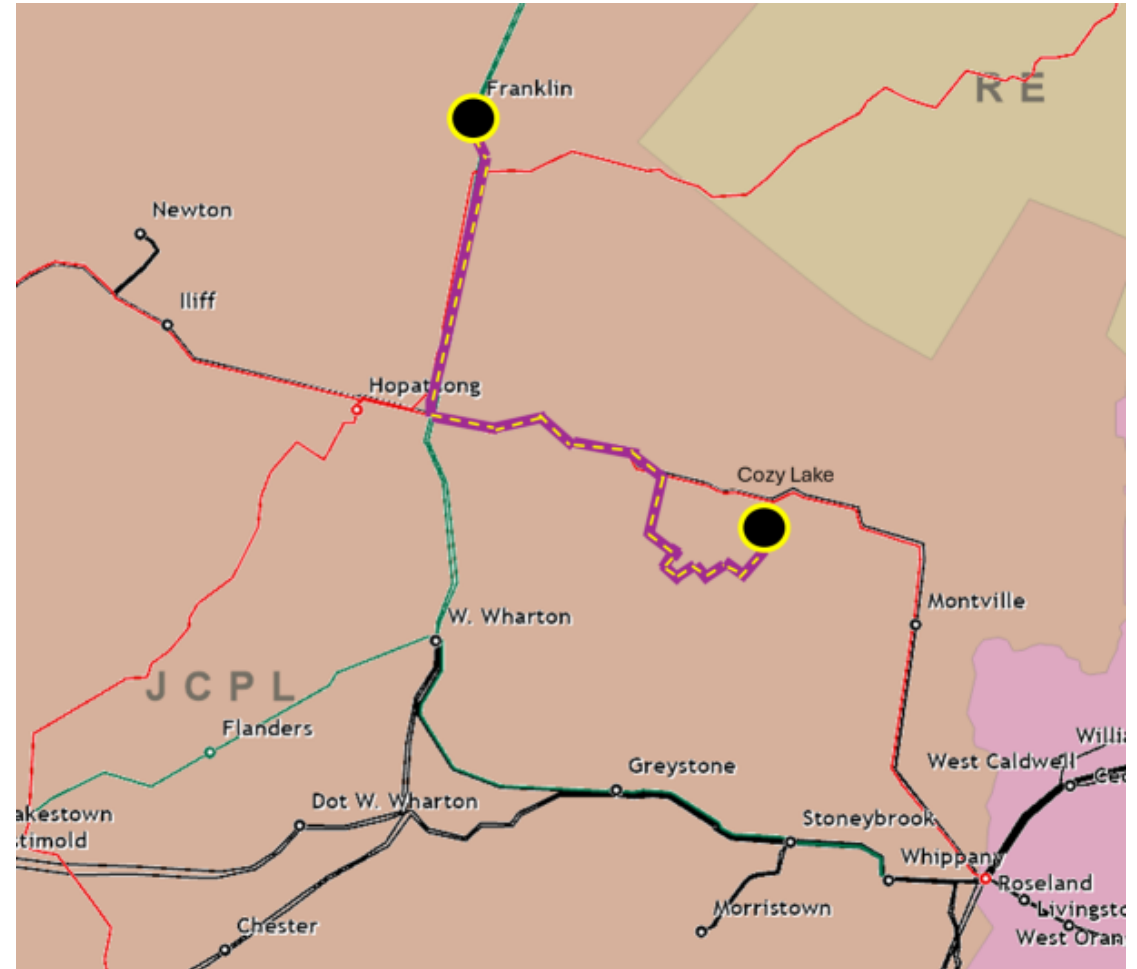
The Cozy Lake - Franklin 34.5 kV S747 Line was constructed approximately 70 years ago and is approaching end of life. It is approximately 14 miles long with 451 wood pole transmission line structures.

Per recent inspections, the line is exhibiting deterioration. Inspection findings include:

- 269 structures failed inspection due to sound, woodpecker damage, top rot, decaying cross-arms, and missing ground wires.

In the last five years, the line has had 23 unscheduled, sustained outages.

The line is currently limited by the transmission line conductor.

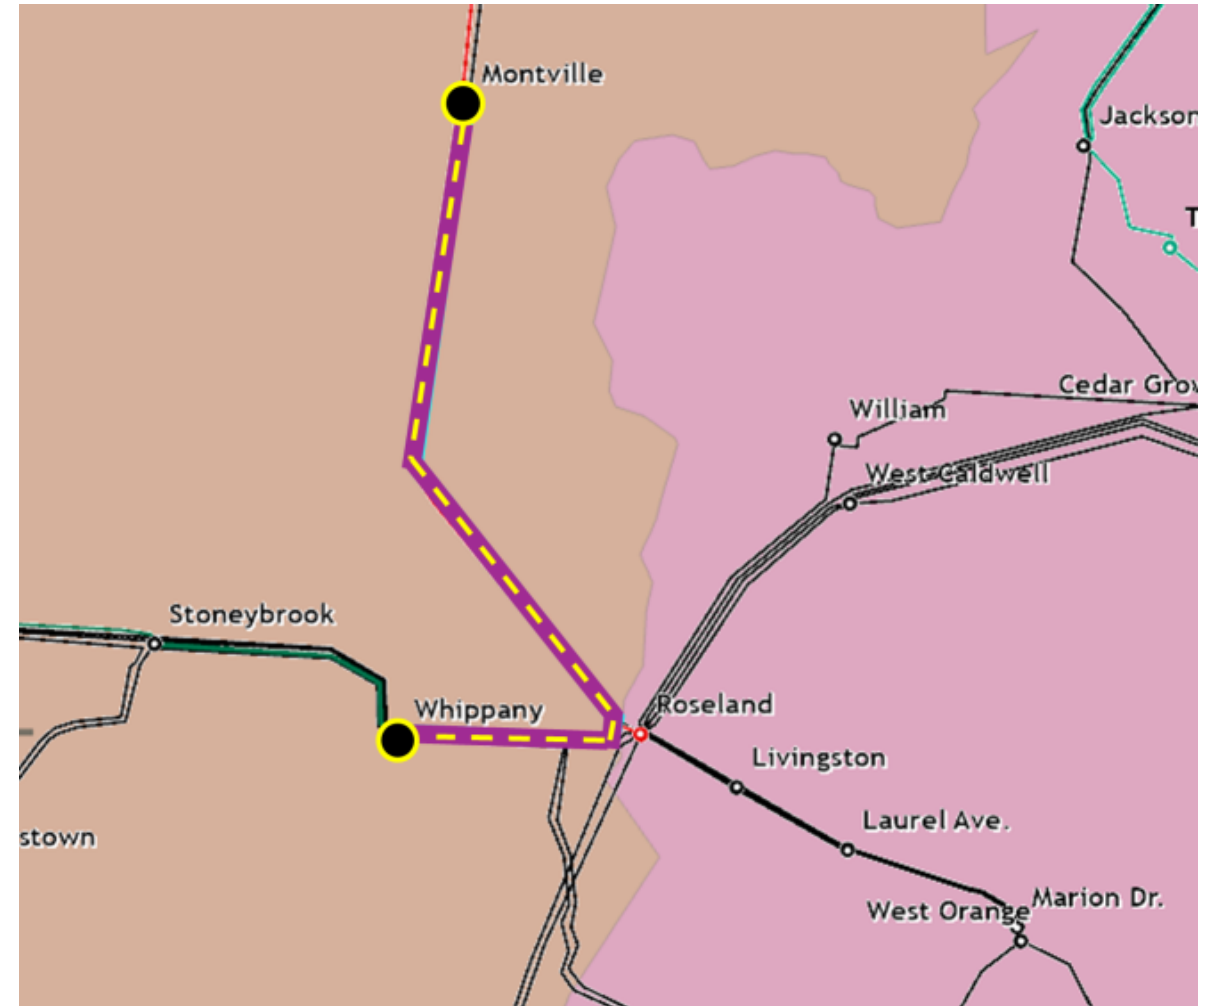
The Montville - Whippany 34.5 kV D4 Line was constructed approximately 70 years ago and is approaching end of life. It is approximately 12 miles long with 374 wood pole transmission line structures.

Per recent inspections, the line is exhibiting deterioration resulting in increased maintenance costs. Inspection findings include:

- 324 structures failed inspection due to sound, woodpecker damage, decaying cross-arms, and missing ground wires.

In the last five years, the line has had 25 unscheduled, sustained outages.

The line is currently limited by the transmission line conductor.
