# BGE 2024

Submission of Supplemental Projects for  
Inclusion in the Local Plan

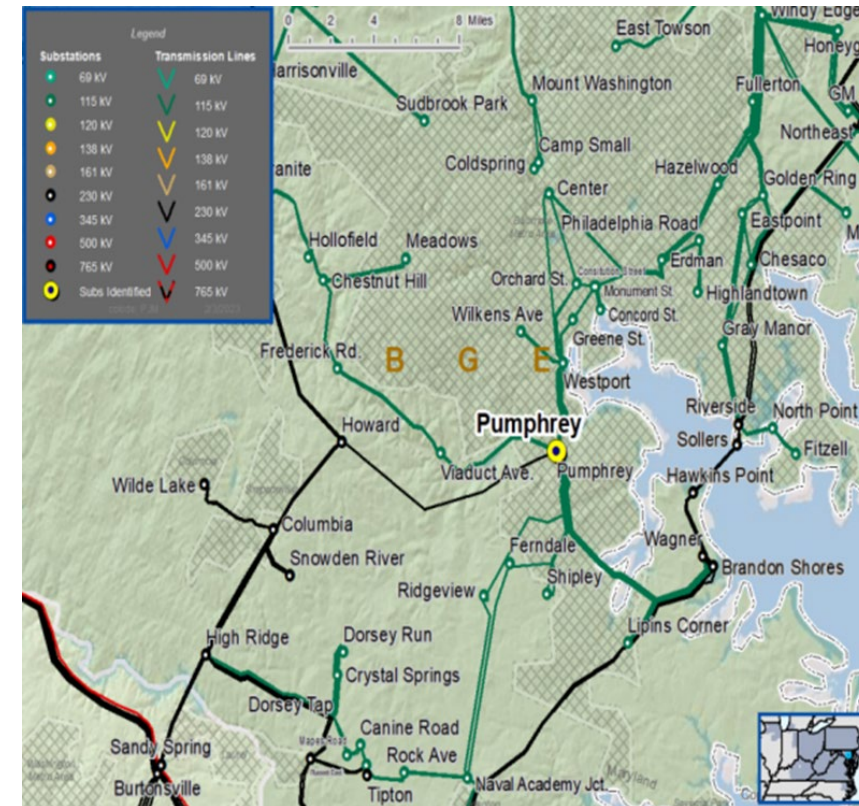
- Pumphrey 115kV circuit breaker #B5 installed in 1979 is in deteriorating condition and has elevated maintenance costs

**Selected Solution:**  
Replace Pumphrey circuit breaker B5

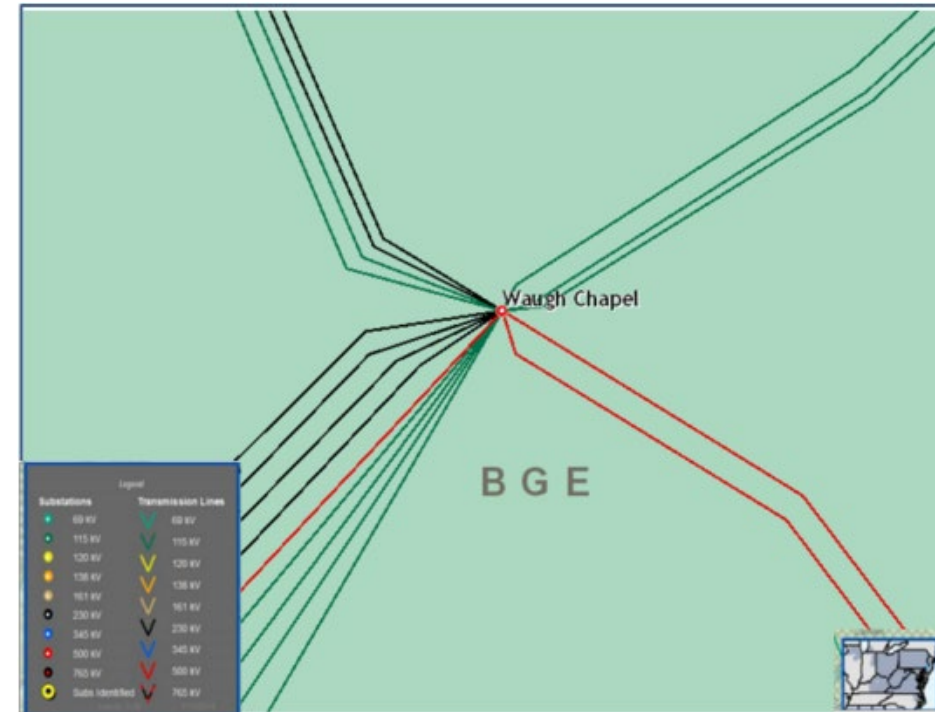
- Waugh Chapel 115kV circuit breaker #B9 installed in 1996 is in deteriorating condition and has elevated maintenance costs

**Selected Solution:**  
Replace Waugh Chapel circuit breaker B9

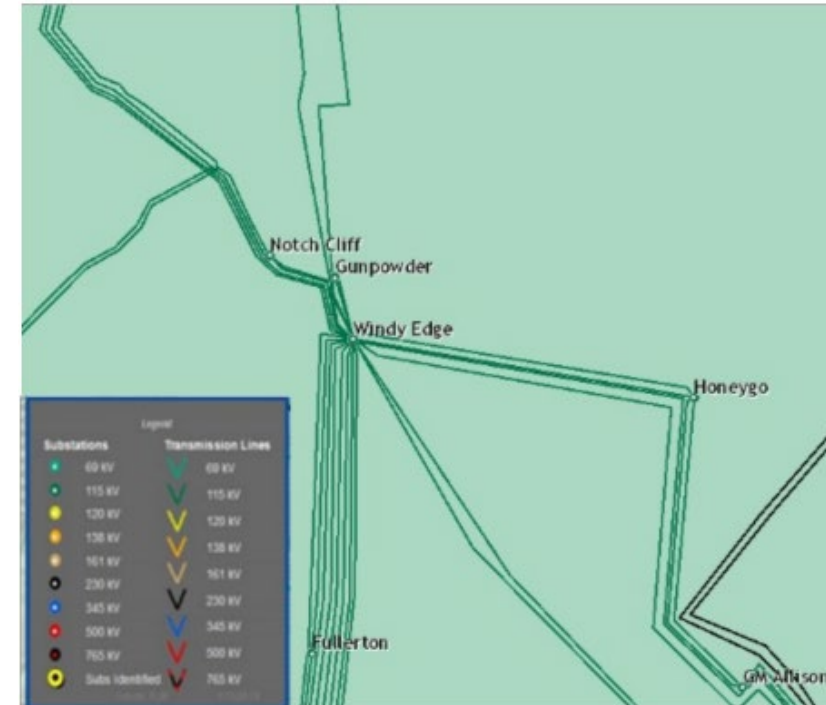
- Windy Edge 115kV circuit breaker #B19 installed in 1961 is in deteriorating condition and has elevated maintenance costs

**Selected Solution:**  
Replace Windy Edge circuit breaker B19

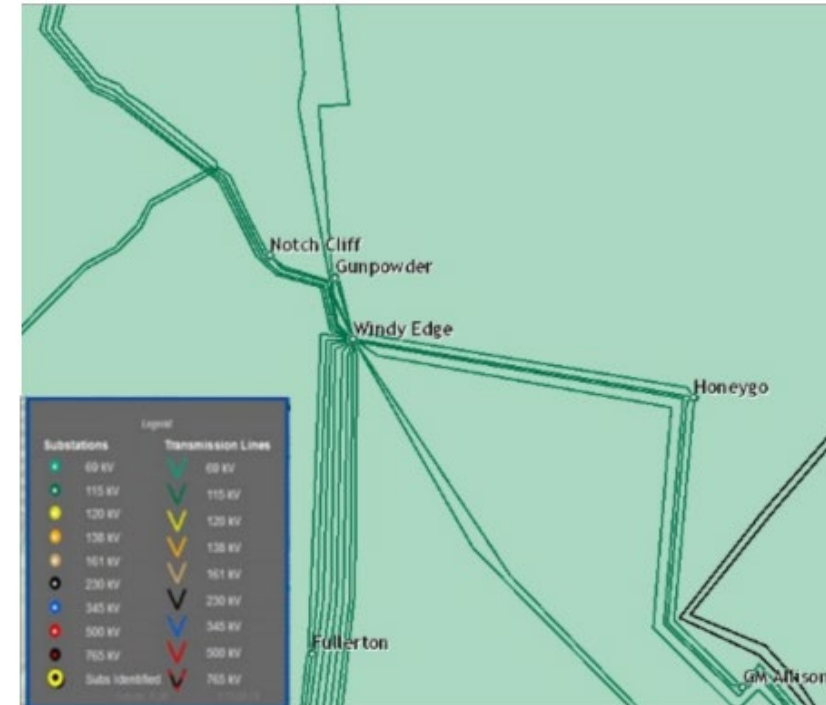
- Windy Edge 115kV circuit breaker #B20 installed in 1961 is in deteriorating condition and has elevated maintenance costs

**Selected Solution:**  
Replace Windy Edge circuit breaker B20
