# Subregional RTEP Committee - Western FirstEnergy (ATSI) Supplemental Projects

April 20, 2020

# ATSI Transmission Zone M-3 Process Magellan New Customer-Need

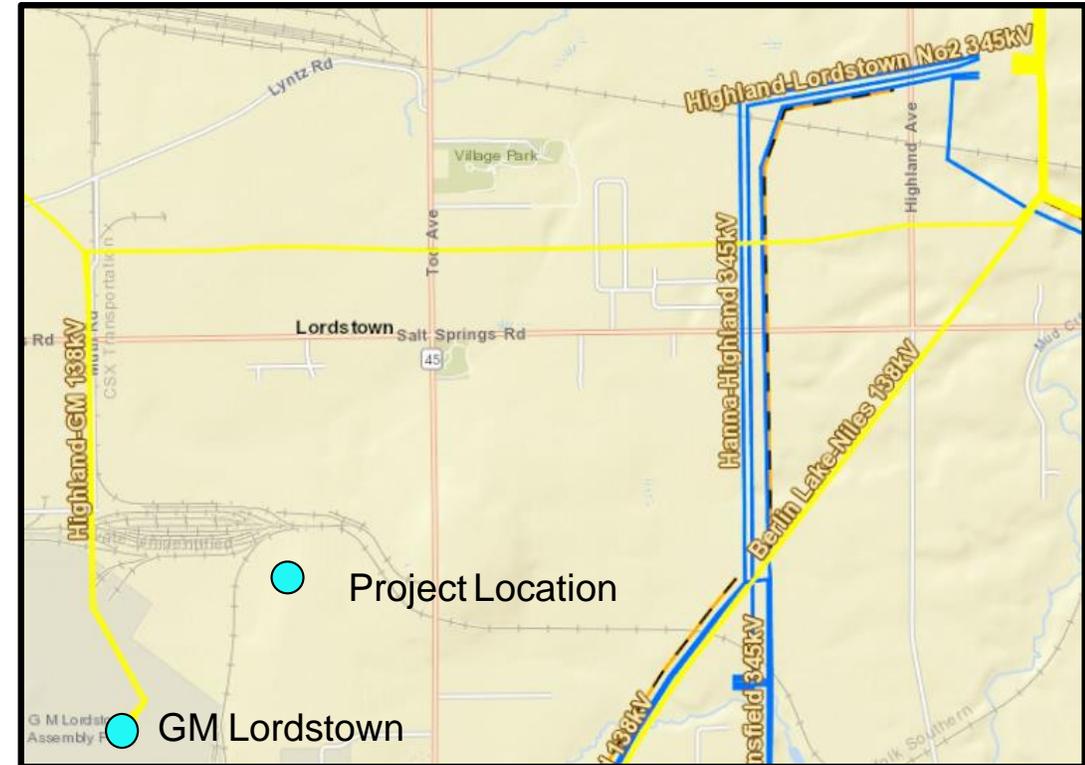
**Problem Statement:**  
New Customer Connection – A customer requested 138 kV transmission service for approximately 95 MVA of total load near the Highland-GM Lordstown 138 kV Line.

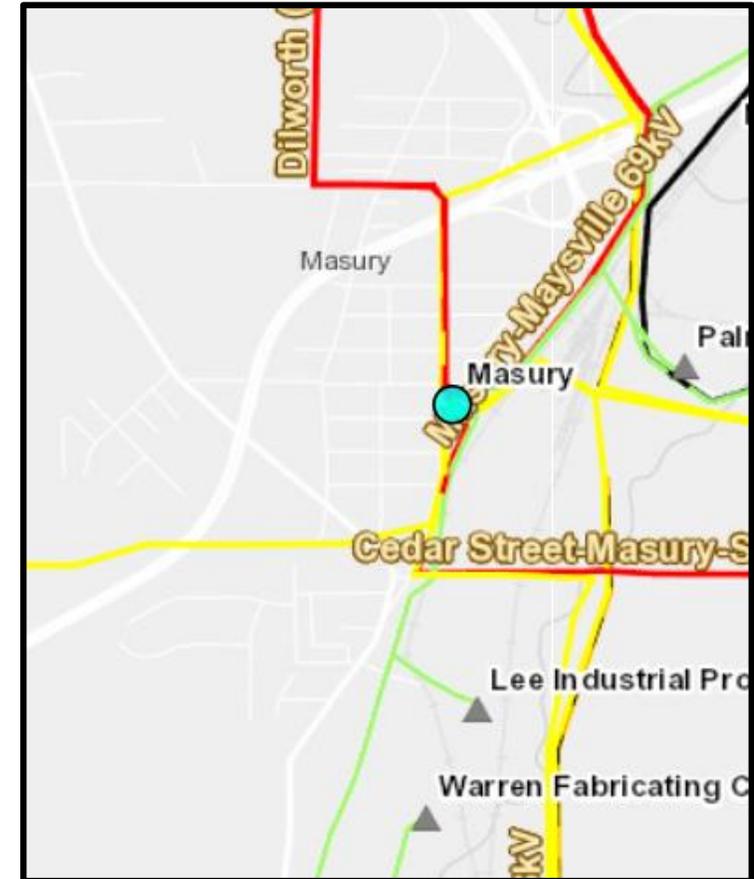
Masury 138 kV Substation

- System analysis shows that after a Masury 138 kV bus fault, a substantial amount of load is at risk (~42 MW)
- Masury 138 kV bus fault ATSI-P1-2-OEE-138-024 outages five 138 kV lines, two 138/69 kV transformers, and two 138-23 kV transformers
- There have been five pre-contingency switching events in the past year for the Masury 23 kV area
- Five (5) 138 kV OCB breakers (B2, B85, B101, B87, and B6) at Masury are showing end of life characteristics;
  - Deteriorated bushings
  - Deteriorated mechanism
  - Oil leaks
  - Age (>30 years) with increasing maintenance
  - Obsolescence of equipment and spare parts
- Masury 138 kV bus protection currently employs a bus blocking scheme which is not the FE standard protection scheme

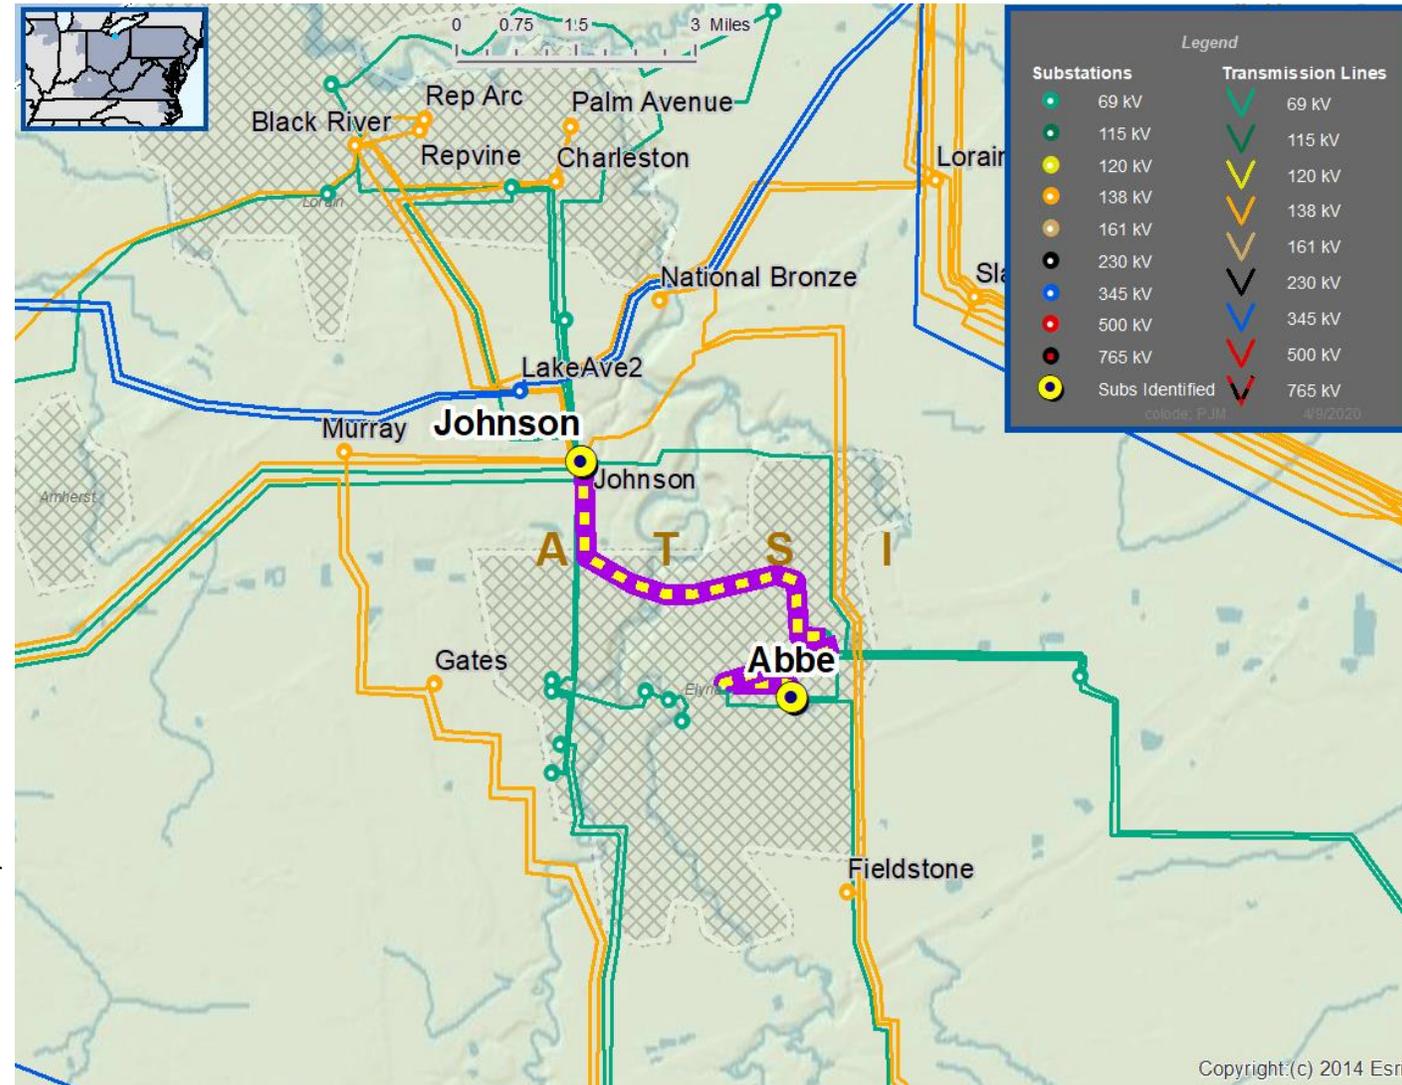
Abbe – Johnson #1 69 kV switch (A-47)

- Switch originally installed in 1982
- Corrosion on operating mechanism
- Existing KPF switch is obsolete and no longer supported by the manufacturer
- Undesirable design with vertical operating rod
- Transmission line ratings are limited by the existing switch rating

<b>ATSI-2020</b>	<b>Transmission Line / Substation Locations</b>	<b>Existing Line/Terminal Equipment MVA Rating (SN / SE)</b>	<b>Existing Conductor/Transformer MVA Rating (SN / SE)</b>	<b>Limiting Terminal Equipment</b>
-006	Abbe-Johnson #1 69 kV Line switch A-47	82 / 103	110/134	Switch A-47

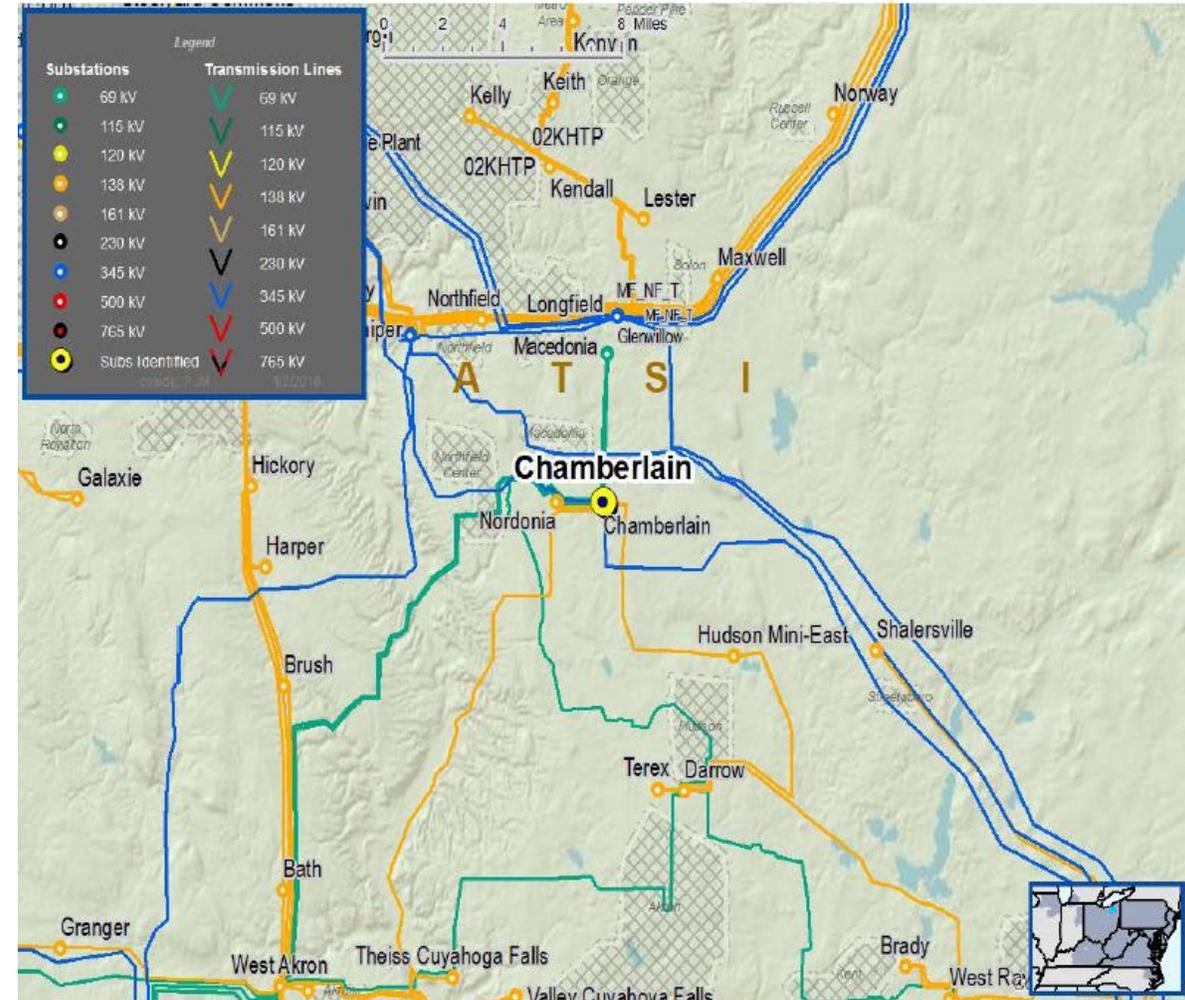
Chamberlin 138 kV Substation

- *Two (2) 138 kV Oil Circuit Breaker (OCB) breakers (B86 & B69) and MOAB Switch A-19 at Chamberlin are showing degrading performance, increasing maintenance, age (> 30 years), and obsolescence of equipment and spare parts.*

Chamberlin 138 kV Breaker and Switch Upgrades

- Replace two (2) 138 kV Oil Circuit Breaker (OCB) breakers ( ) B86 & B69 that are part of the protection scheme for the two 138 / 69 kV transformers at Chamberlin substation, upgrade the transformer #2 relay, and replace MOAB Switch A-19.

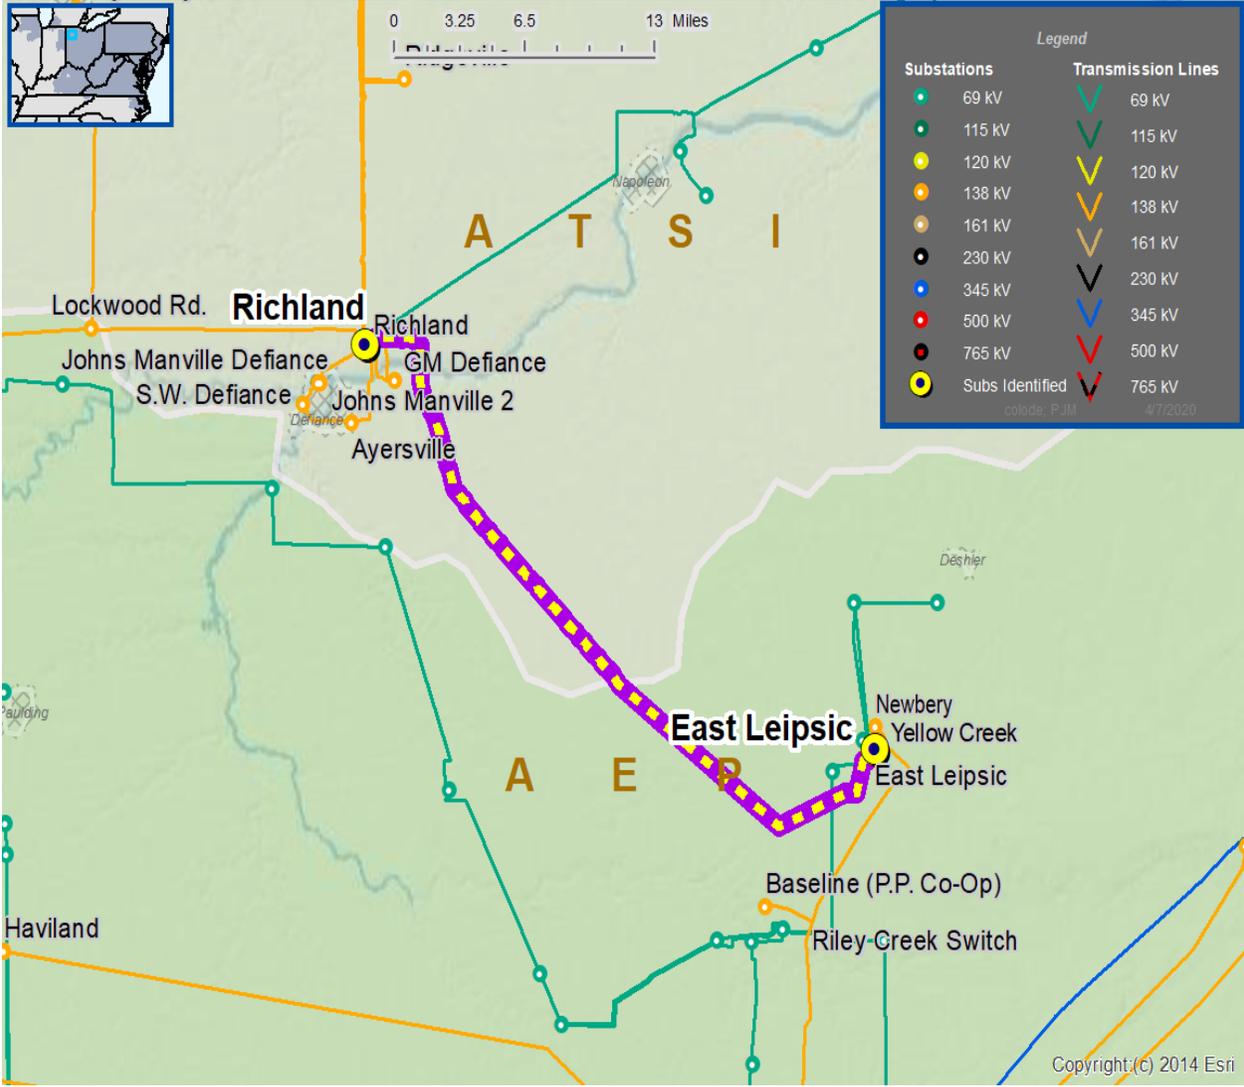
Richland-East Leipsic 138 kV (~15.8 miles) Transmission Line:

- The Richland-East Leipsic 138 kV Transmission Line was built in the 1960s. The average age of the structures on this line are 54 years old. FirstEnergy has historically experienced an average age of reject for wood poles to be 48.7 years.
- Line was surveyed in 2018 and showed a structure reject rate of 100% (126/126). The primary reasons for reject were structure age, woodpecker holes, pole top decay, and phase raised structures.
- There has been a growing trend in unscheduled interruptions on this line. There have been 11 total outages since 2011 for lightning, equipment failures, and other issues.
- There has been an increase in unplanned maintenance on this line. A recent aerial patrol found 90 active maintenance conditions requiring repair for wood pole rot, broken static wire and attachment hardware, and bent braces.

- Rebuild entire 15.8 mile of the ATSI owned Richland-East Leipsic 138 kV line.
- Replace existing conductor (636 kcmil ACSR) with 795 kcmil ACSR.
- Install OPGW along the entire line.

- Substation equipment for replacement includes: Breaker B13250, disconnect switches, line trap, CVT, tuner and COAX, substation conductor, relaying, and revenue metering.
