Sub Regional RTEP Committee: Western AEP Supplemental Projects

October 15, 2021

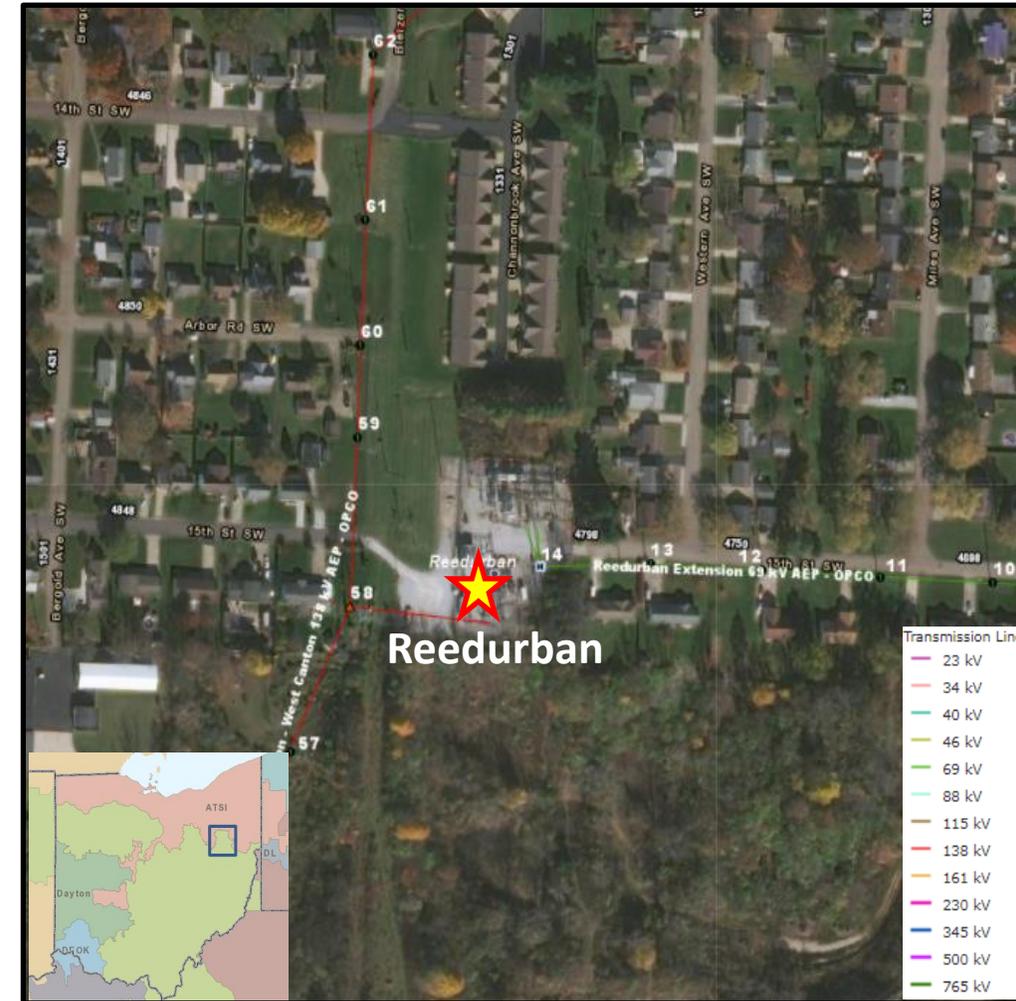
Need Number: AEP-2021-OH052**Process Stage:** Need Meeting 10/15/2021**Project Driver:** Equipment Material/Condition/Performance/Risk; Operational Flexibility & Efficiency**Specific Assumption Reference:** AEP Guidelines for Transmission Owner Identified Needs (AEP Assumptions Slides 13-14)**Problem Statement:****Reedurban Station:**

Circuit Breaker: R (69 kV)

- Breaker Age: 1979
- Fault Operations: 10
- This breaker is oil filled without oil containment; oil filled breakers have much more maintenance required due to oil handling that their modern, SF6 counterparts do not require.
- This model family has experienced major malfunctions associated with their OA-3 hydraulic mechanism, which includes low-pressure readings, hydraulic leaks, pump lockouts, and failure to shut off. These mechanism malfunctions have led to several failures to close and other types of misoperations across the AEP fleet.
- The manufacturer provides no support for this family of circuit breakers and spare parts are not available.

Relays: 8 of the 25 relays (21% of all station relays) are in need of replacement. All 8 of these are of the electromechanical type which have significant limitations with regards to spare part availability and fault data collection and retention. The 69kV circuit to Gambrinus used an obsolete pilot wire communications channel.

The control house has a number of concerns: poor ventilation, rusting roof, lead-based paint, and physical security issues. Portions of the perimeter are not built to current standards. All station cables are direct-buried without a cable trench, leading to increased probability of failure. The station service is an obsolete design (delta configuration, with corner ground, which is a safety concern).

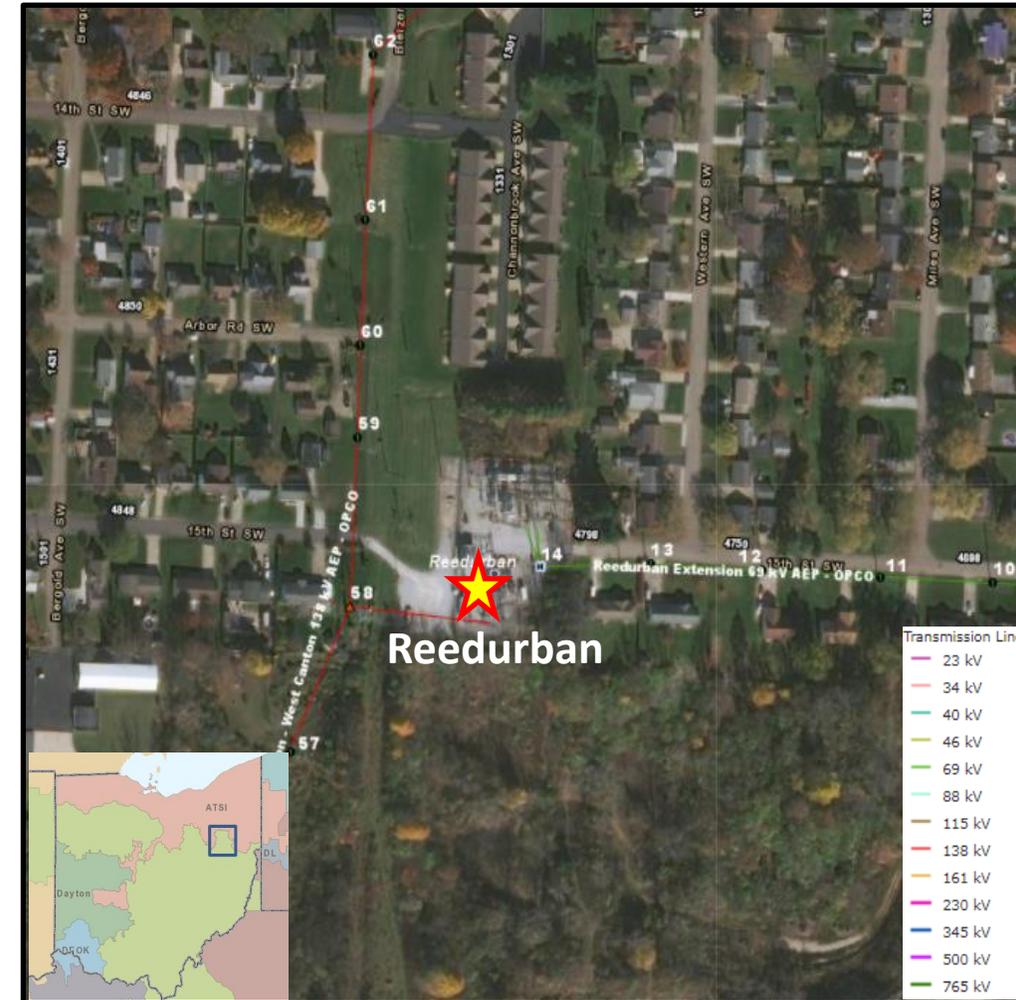
The Miles Avenue-Reedurban-South Canton 138kV circuit is a 3-terminal line, due to the 138-69kV transformer source at Reedurban, and the lack of 138kV line breakers at Reedurban (contains motor-operated switches today, requiring remote-end breaker operation). Three-terminal lines are more difficult to reliably protect and are a risk for overtripping and misoperations.

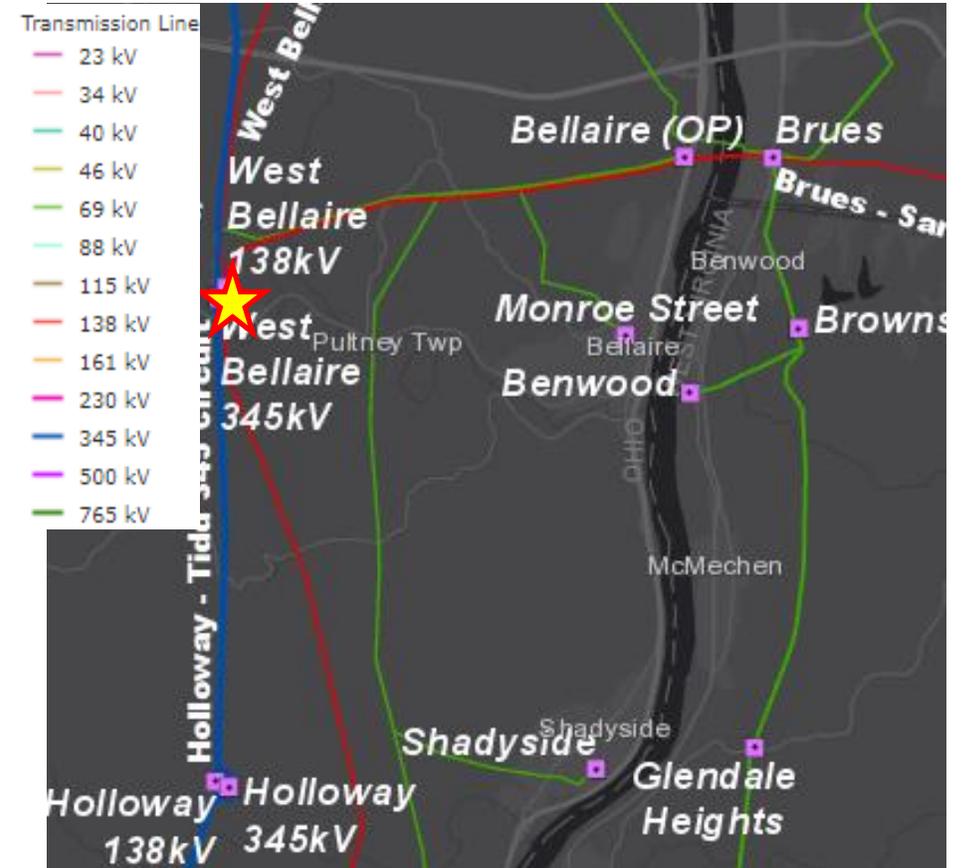
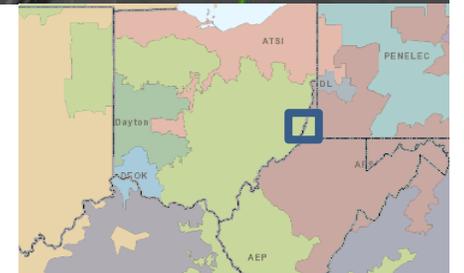
West Bellaire 138 – 69 kV Transformer #2:

Transformer #2 has failed due to a short circuit event verified by extremely high excitation currents and oil sampling results.

- Transformer Age: 1969, rewound in 1989
- Nameplate Rating: 115/128.8 MVA

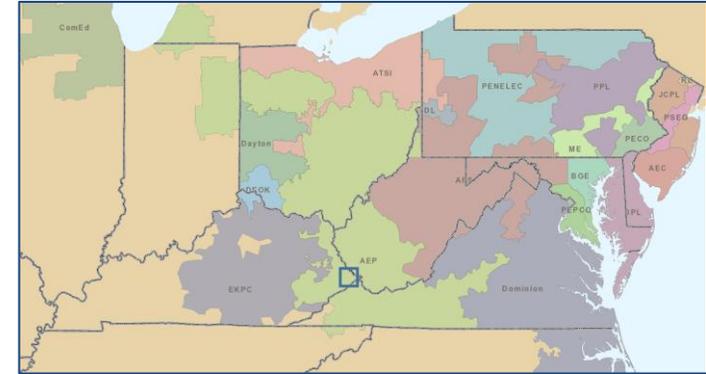
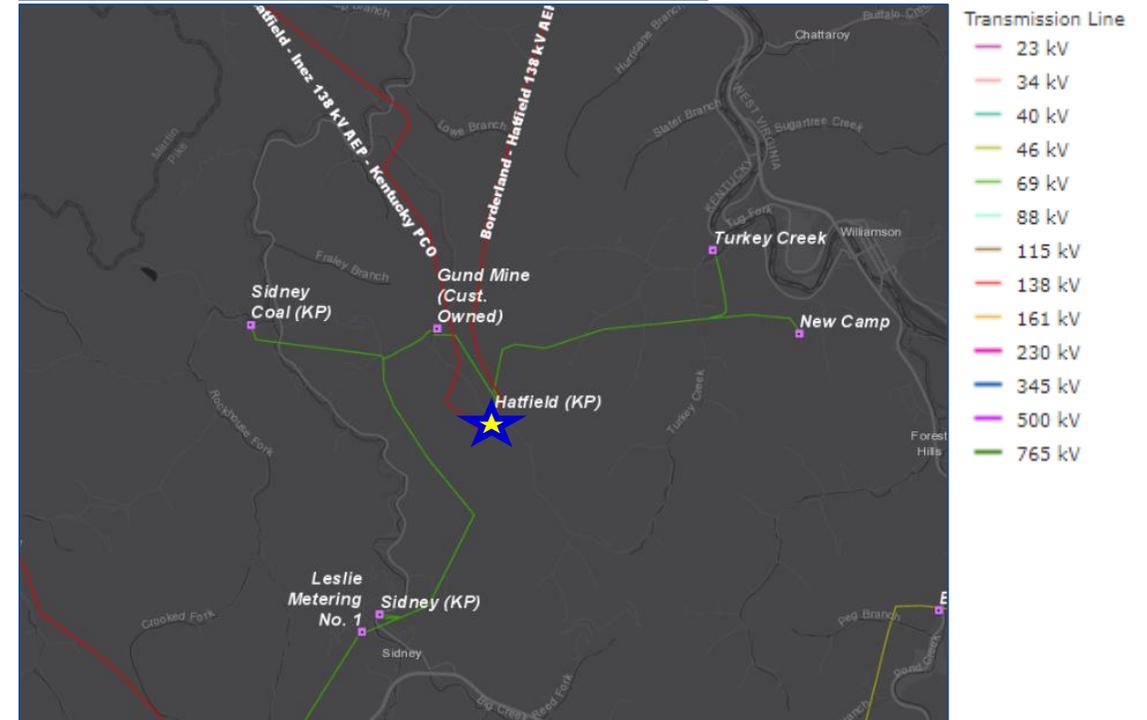
Hatfield Substation:

Transformer #1 (138/69/46kV):

- The high side MOAB/Ground Switch scheme on TR1 protection.
- TR-1 bank is tapped off the 138kV Bus without 138kV line breakers, creating a three terminal line with the 138 kV line exits.

Transformer #2 (46/7.2kV 111 MVA):

- Grounding Transformer for station service
- 1990 Vintage unit
- DGA indicates elevated levels of CO2 gas concentration
- Bushings are at a greater risk of failure due to capacitive layer deterioration and change in bushing power factor.
- High decomposition of the paper insulating materials.
- Wood tie foundations
- Oil containment is in need of repair or replacement
- GND TR-2 is a legacy transformer, from a previous station setup that has been preserved as a source of station service. The grounding bank and associated bus work increases the exposure for failure in order to provide station service.

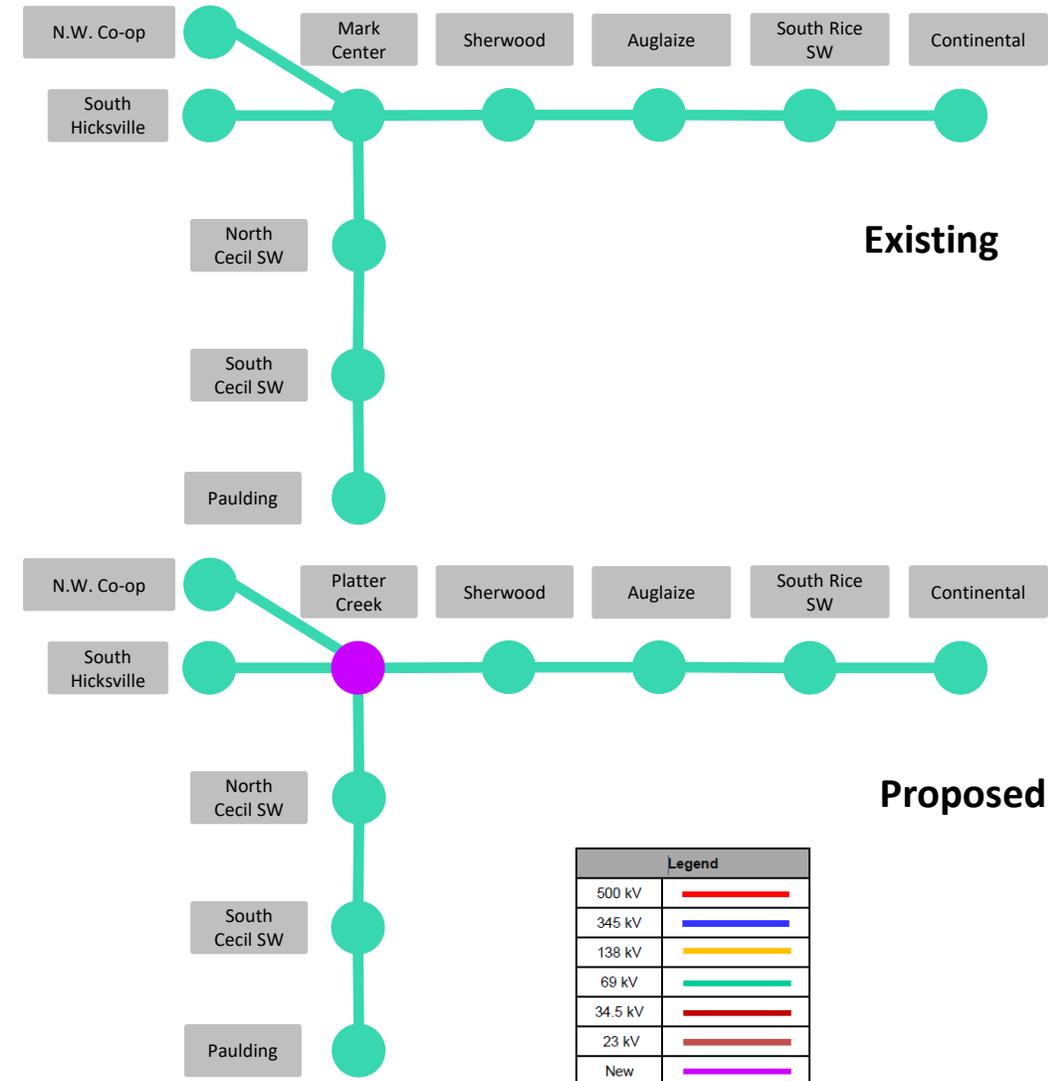
- Rebuild Mark Center station in the clear as Platter Creek station. Install 4 new 3000A, 40kA, 69 kV breakers at the new Platter Creek ring bus and add a DICM. Upgrade NW Coop 69 kV metering. **Estimated Cost \$6.37M**
- Retire existing Mark Center station. Relocate circuit switcher AA to Platter Creek. **Estimated Cost \$0.76M**
- Remote end work at South Hicksville station. **Estimated Cost \$0.57M**
- Relocate Mark Center – Continental to terminate at Platter Creek. **Estimated Cost \$0.37M**
- Relocate Mark Center – Paulding to terminate at Platter Creek. **Estimated Cost \$0.51M**
- Relocate Mark Center – South Hicksville to terminate at Platter Creek. **Estimated Cost \$0.40M**
- Relocate Mark Center- NW Co-op to terminate at Platter Creek. **Estimated Cost \$0.02M**

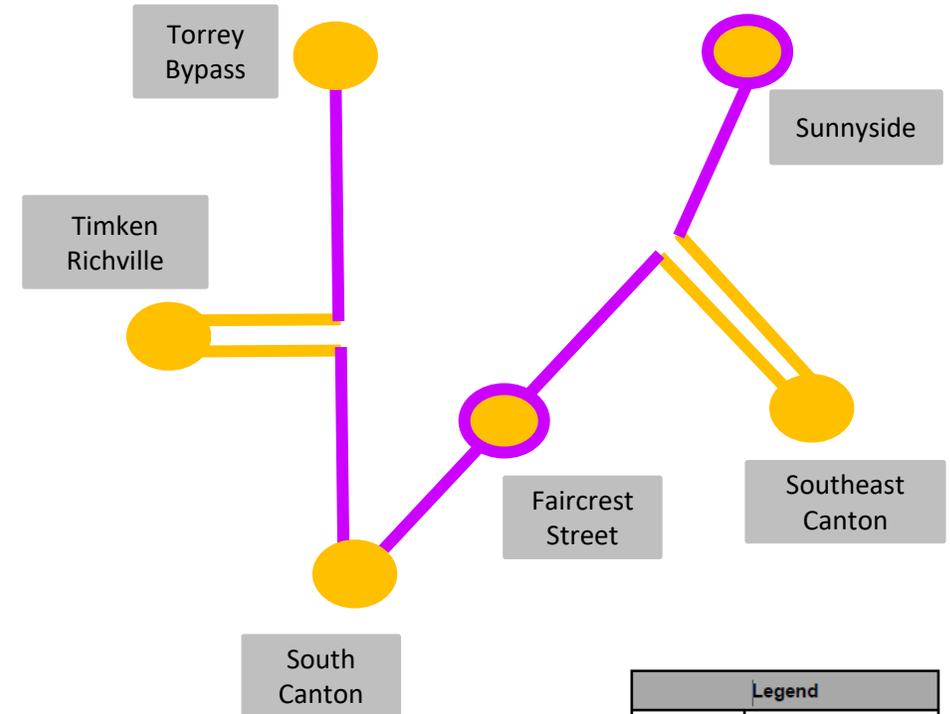
Rebuild the Philo-Torrey 138kV transmission line between South Canton and Torrey (3.5 miles). The circuits affected are South Canton-Timken Richville and Timken Richville-Torrey 138kV. **Estimated Cost: \$7.64M**

Rebuild the Philo-Canton 138kV transmission line between South Canton and Sunnyside (5.5 miles). The circuits affected are South Canton-Southeast Canton and Southeast Canton-Sunnyside 138kV. **Estimated Cost: \$14.22M**

Replace the 138kV switches at Faircrest Street station to accommodate the new line structures. **Estimated Cost: \$0.12 M**

At Sunnyside, upgrade the relays on the 138kV circuit to Southeast Canton. The control building needs expanded to accommodate the new relay panels. **Estimated Cost: \$0.73 M**

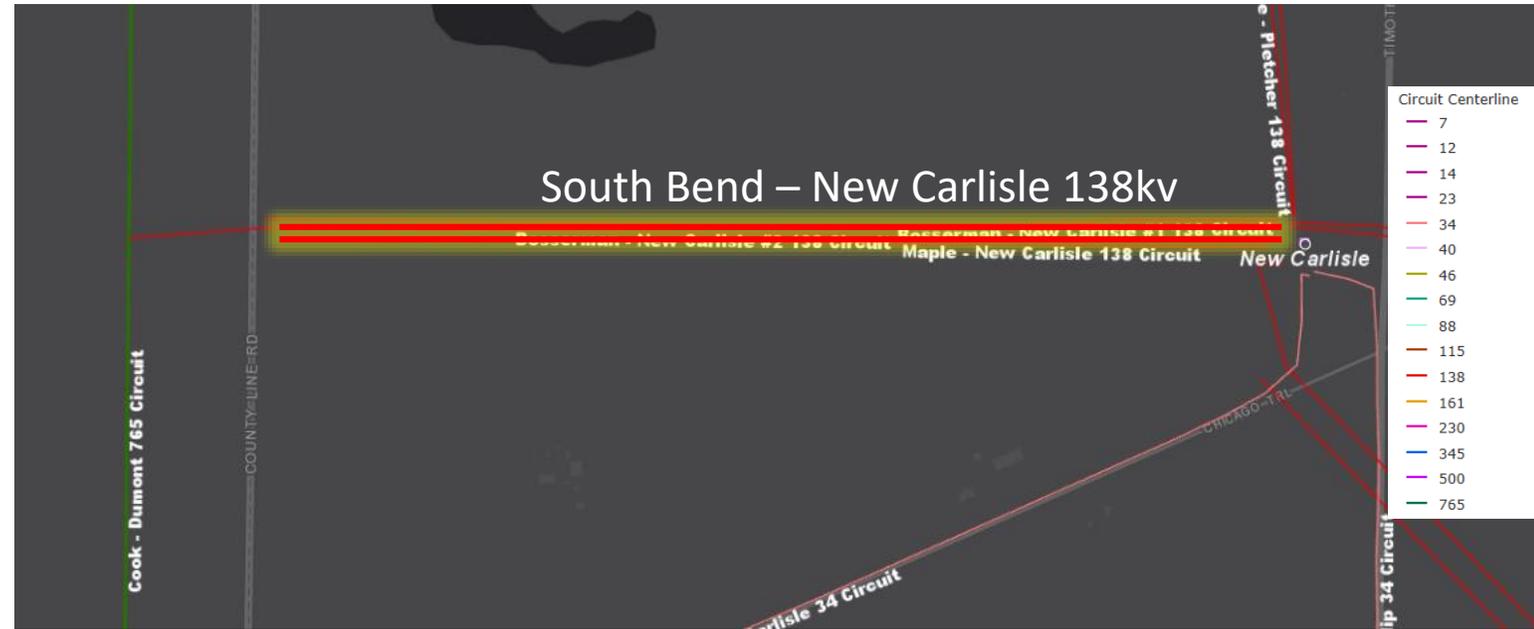
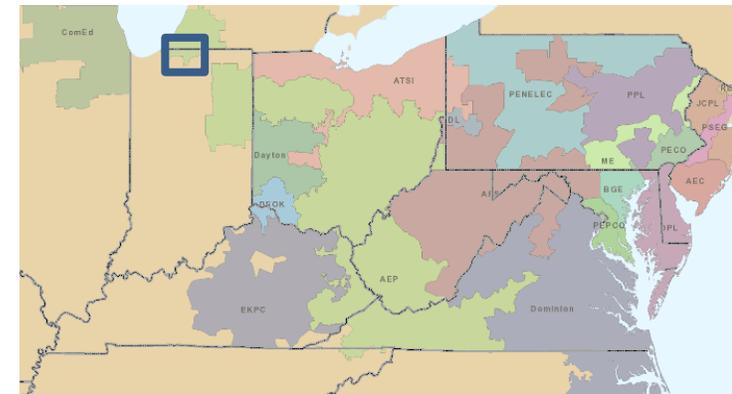
South Bend – New Carlisle 138kV line:

- 0.88 miles of double circuit 1930 steel lattice line
- Original 397 MCM ACSR and steel structures are still on the line
- There is one structure with open conditions (20% of line) relating to worn shield wire hardware
- Circuit 1 has had 3 momentary outages and 3 permanent outages since 2015.
- Circuit 2 had 1 permanent outage since 2015
- Circuit is a tie with NIPSCO

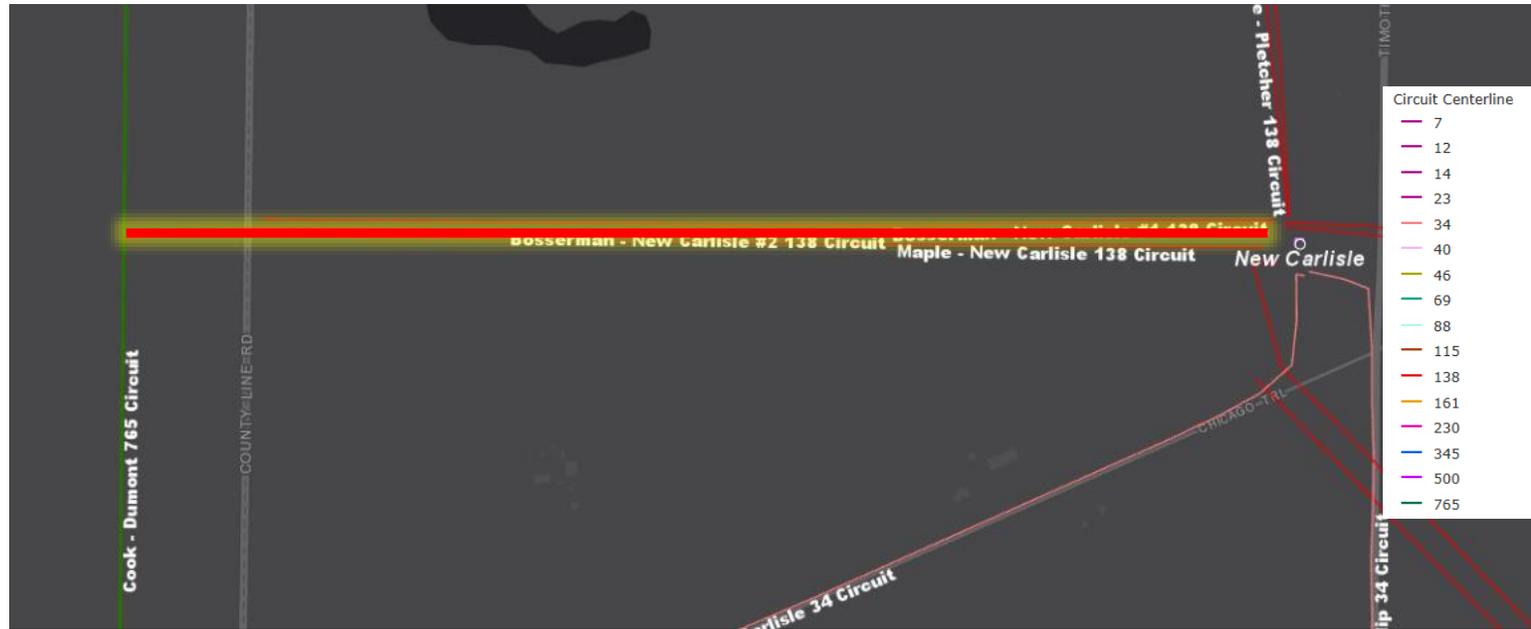
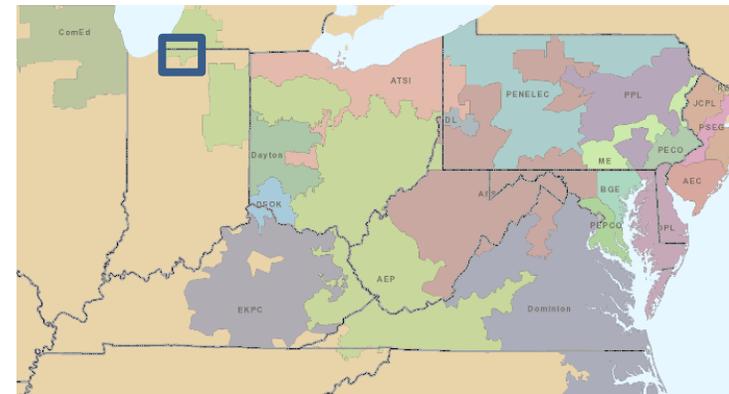
New Carlisle - Maple 138kV line:

- 0.86 miles of 1952 wood pole H frame line
- Utilizes original structures and 397 ACSR from 1952
- 5 structures have open conditions (63% of line) relating to pole rot, split or rot crossarms, broken ground lead wire, rusty guy wires, and cracked static bracket
- 2 momentary outages over the past 5 years
- Circuit is an interconnection with NIPSCO and MISO

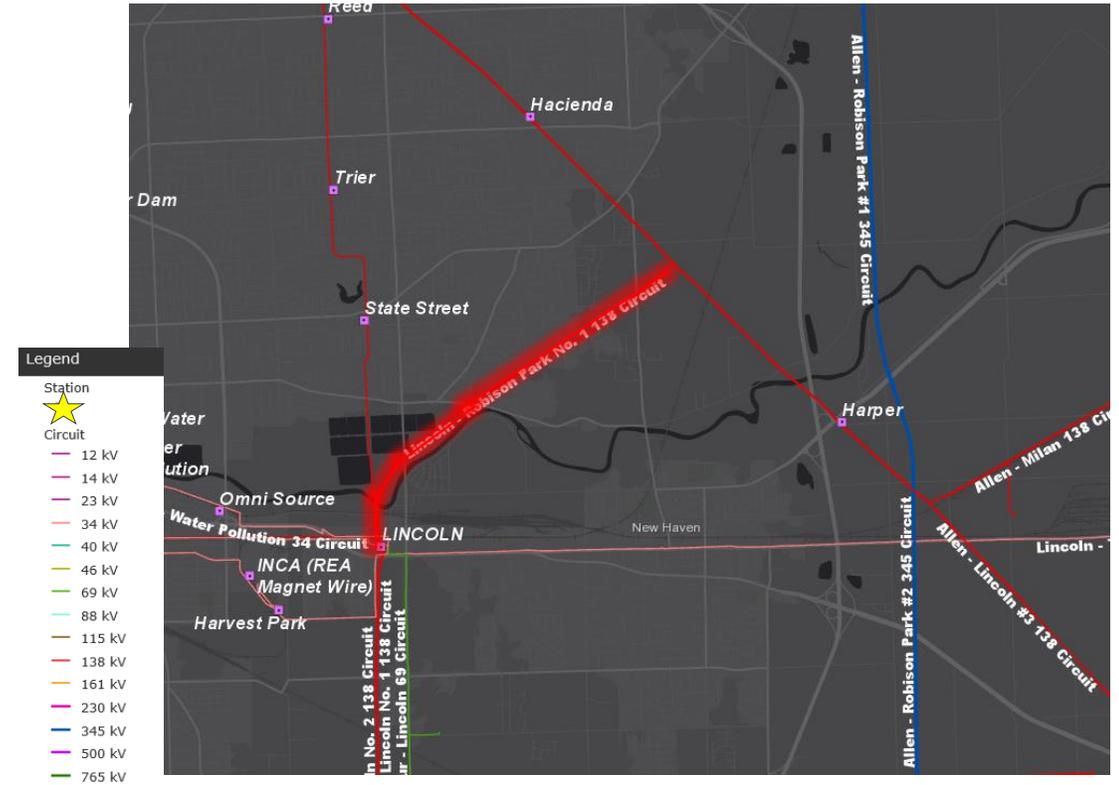
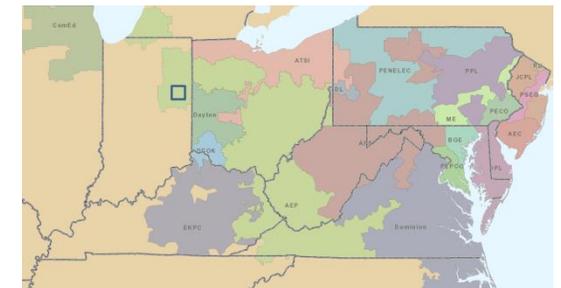
- **Lincoln Tap 138kV ~3.65 Miles**
 - Steel lattice double circuit 397 ACSR construction with all 20 structures original from 1947
 - 9 open hardware conditions on 7/20 structures
 - Insulator equipment and hooks with moderate wear
 - 50% of the towers had flashed insulator strings
 - Corrosion on insulator caps & pins

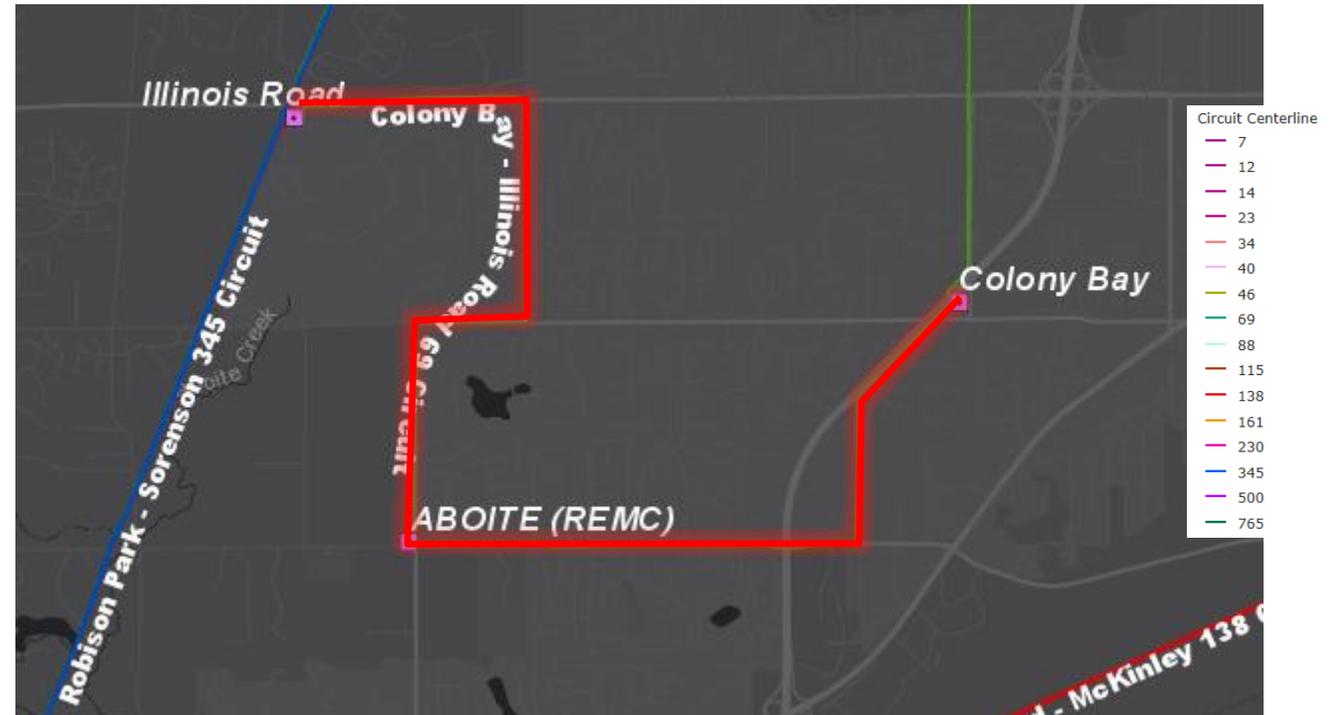
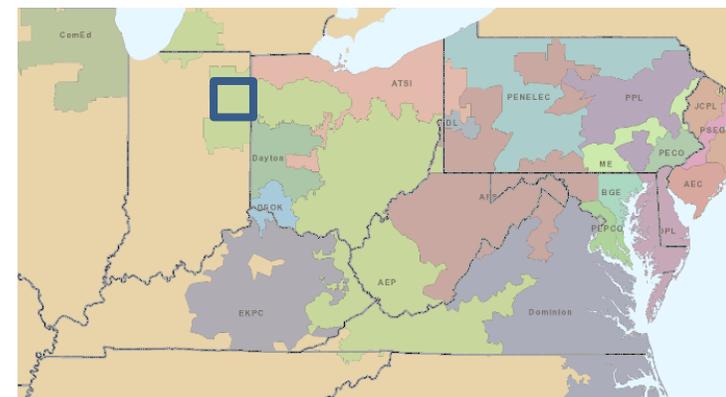
Colony Bay – Illinois Rd 69kV line (6.92 miles):

- 71 of the 189 poles are original 1969 wood poles.
- 6.33 miles of line is original 1969 556.5 AL conductor
- Since 2015 there have been 6 momentary outages
- Structures fail NESC Grade B, AEP Strength requirements and ASCE structural strength standards
- 14 of 36 structures assessed had issues such as ground line decay, insect/bird, shell damage
- 30% of structures on this line were identified as having beyond normal levels of decay.

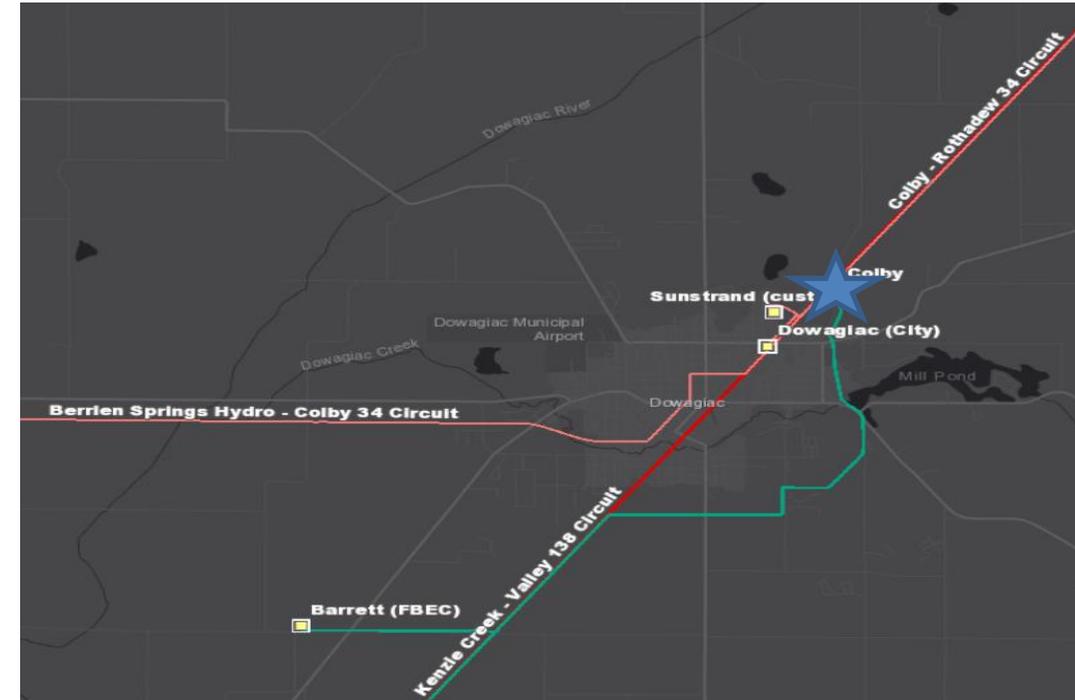
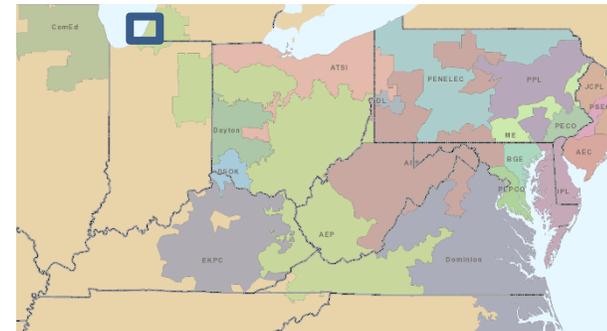
Colby Station -

- Breakers A, B, C, D, and E
 - 1963-1968 vintage oil breakers
 - CB Fault operations: CB A(38), C(67), D(86), E(12) – Recommended(10)
 - Breaker B control cabinet has documented corrosion concerns
 - Since 2017 breaker D's operation counter hasn't functioned
- Currently contains a 3-terminal line within the station.

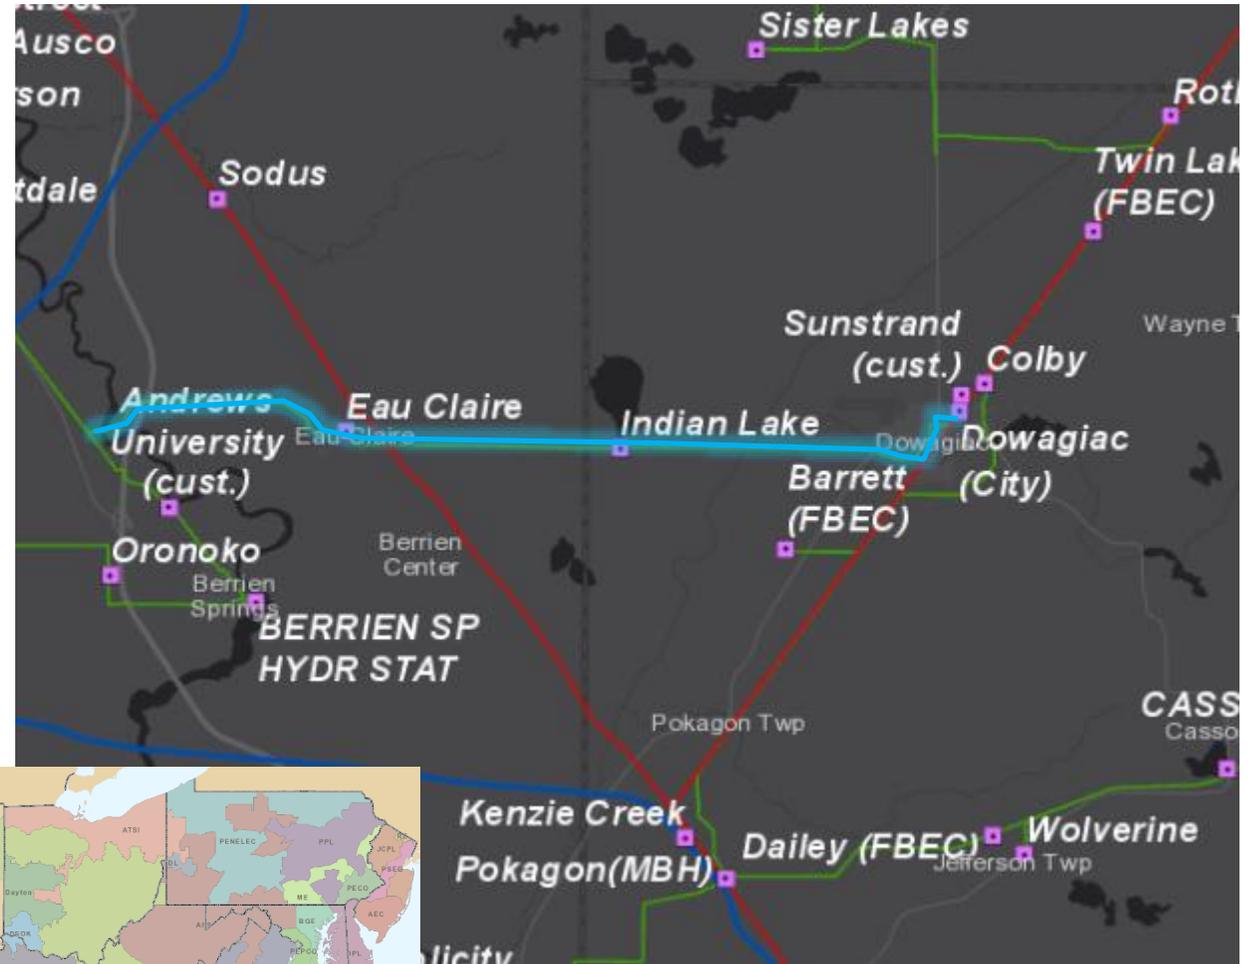
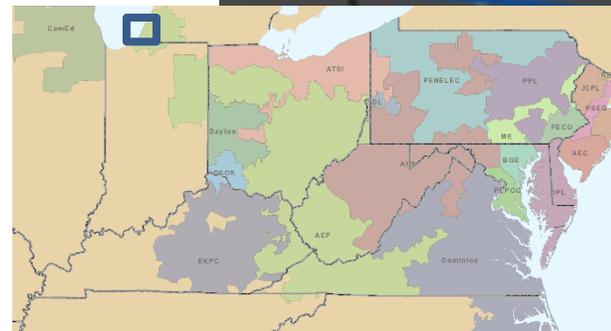
Berrien Springs-Colby 69kV line

- 15.72 miles of wood pole structures with horizontal insulators rebuilt in 1995
- 148 structures with at least one open condition, 31% of the structures on the line
 - Open conditions include insect or woodpecker damage, broken or stolen ground wire conditions, and broken or burnt insulators. **The damage caused by the insects and woodpecker activity have decimated poles in this area.**
- Outages: 2 permanent since 2015
- CMI: 297,132

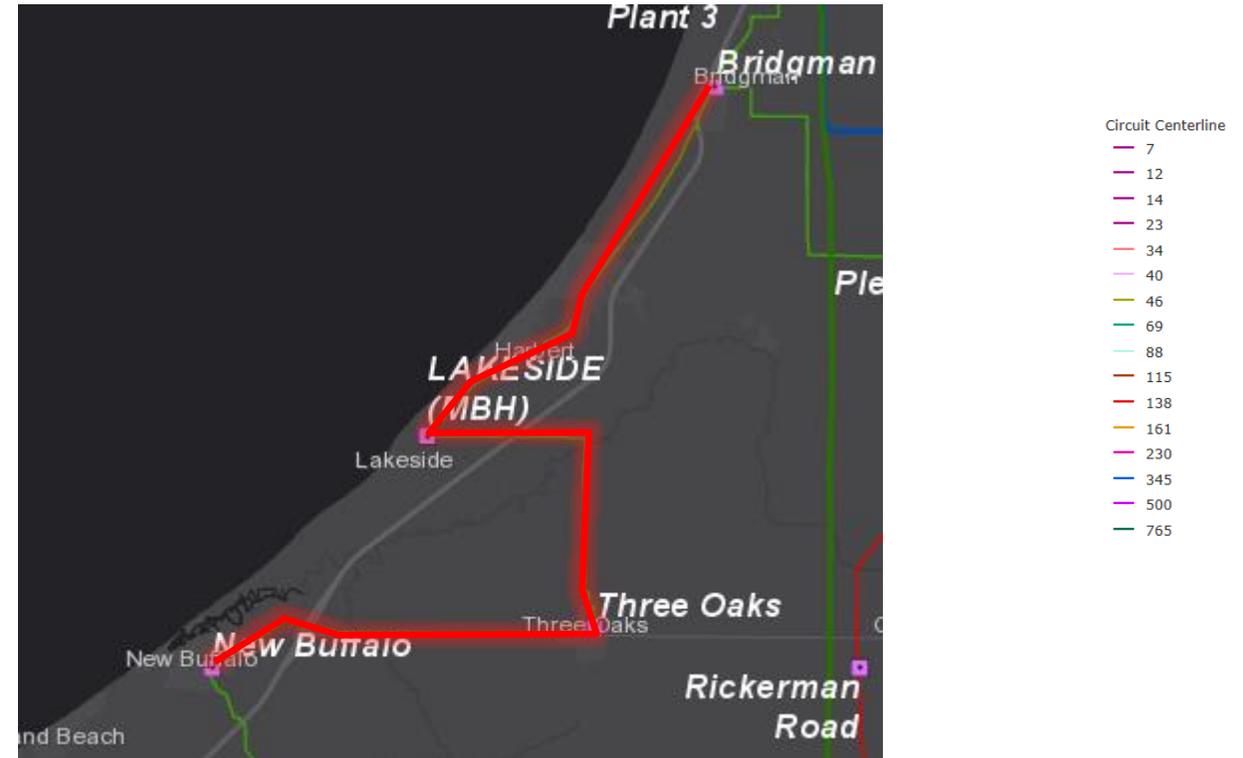
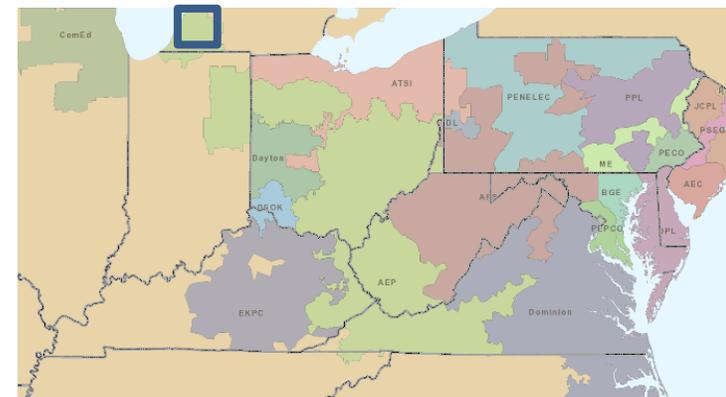
New Buffalo – Bridgman 69kV line:

- 22.1 miles of mostly 1964-68 wood pole
- Conductor is 336.4 ACSR and 4/0 ACSR
- Since 2015 there have been 4 momentary and 6 permanent outages on the Three Oaks – Bridgman circuit.
- Since 2015 there have been 8 momentary and 2 permanent outages on the Three Oaks – Bosserman circuit.
- 4,488,189 CMI from 2015-2020 on the Bosserman – Three Oaks circuit
- Structures fail NESC Grade B, and AEP Strength requirements with portions failing ASCE structural strength standards
- 23 of 53 structures assessed had wood decay such as rot, heavy checking or woodpecker damage.
- All inspected poles show moderate to heavy shell decay
