# Sub Regional RTEP Committee: Western AEP Supplemental Projects

November 19, 2021

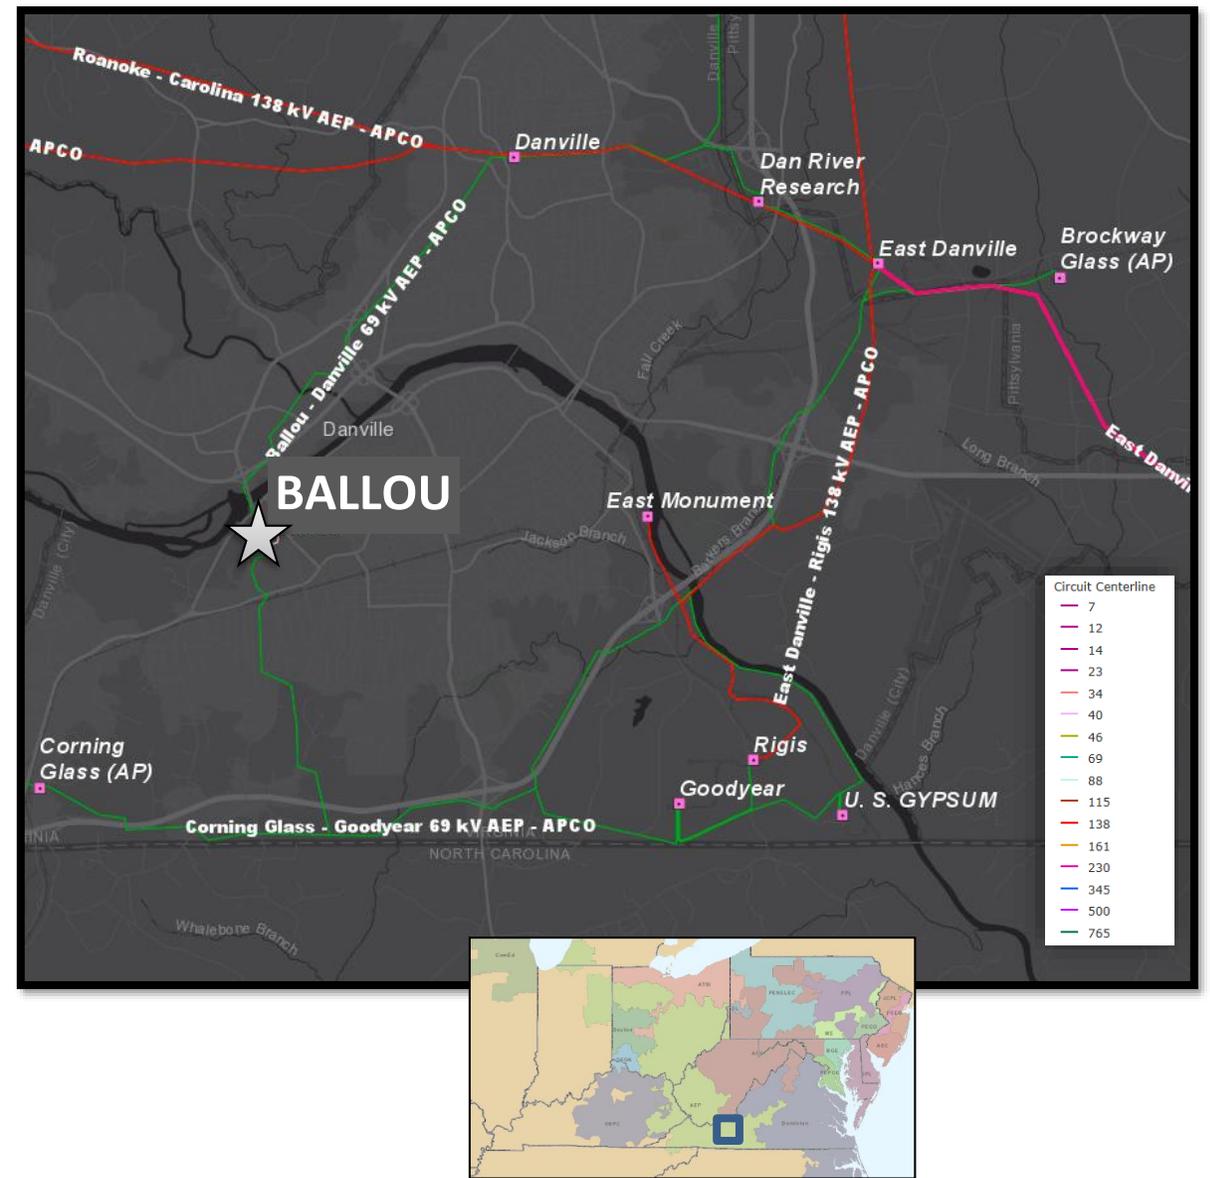
- The City of Danville requested a new 69 kV delivery point located at Ballou Station in Danville, VA to provide up to 25 MW of peak load (with an average load of 7-10 MW).

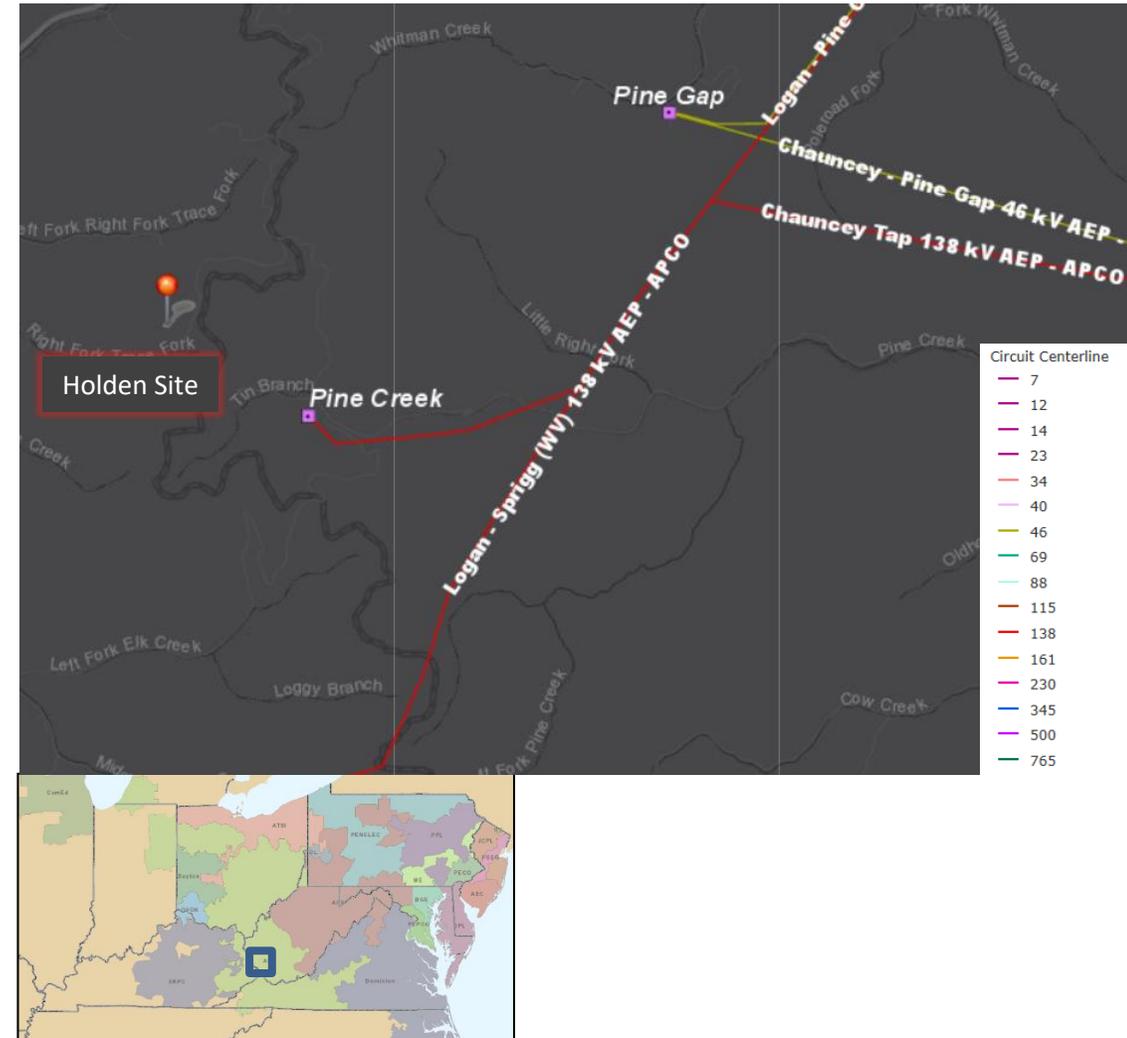
- AEP Distribution has requested new transmission service to a new distribution station, Holden, supporting the Buck Harless Industrial Park site in Whitman, WV.

- This station is the result of West Virginia House Bill 144. The intent of the program is to support the development of Business Ready Sites in WV.
- Initial load at the Holden Site will transfer from the existing Pine Creek station site. Pine Creek Station is constructed using wood poles in an arrangement that is not expandable. There are also site constraints at Pine Creek preventing station expansion onto adjacent property. The site constraints prevent the industrial park site from being served by the existing Pine Creek station location. Adding new circuits for the industrial park would require replacement of the distribution structures and expansion of the station which is not feasible in the current location.

- At Pine Creek, 138 kV Circuit Breaker XT1 is an oil breaker that are difficult to maintain due to the required oil handling. There is an increased potential for oil spills during routine maintenance and failures with these types of breakers. There are 7 remaining AHE-54-138-5000 circuit breakers on the AEP system, including the 1 at this station. Spare parts are increasingly more difficult to obtain because the manufacturer no longer supports this model type.

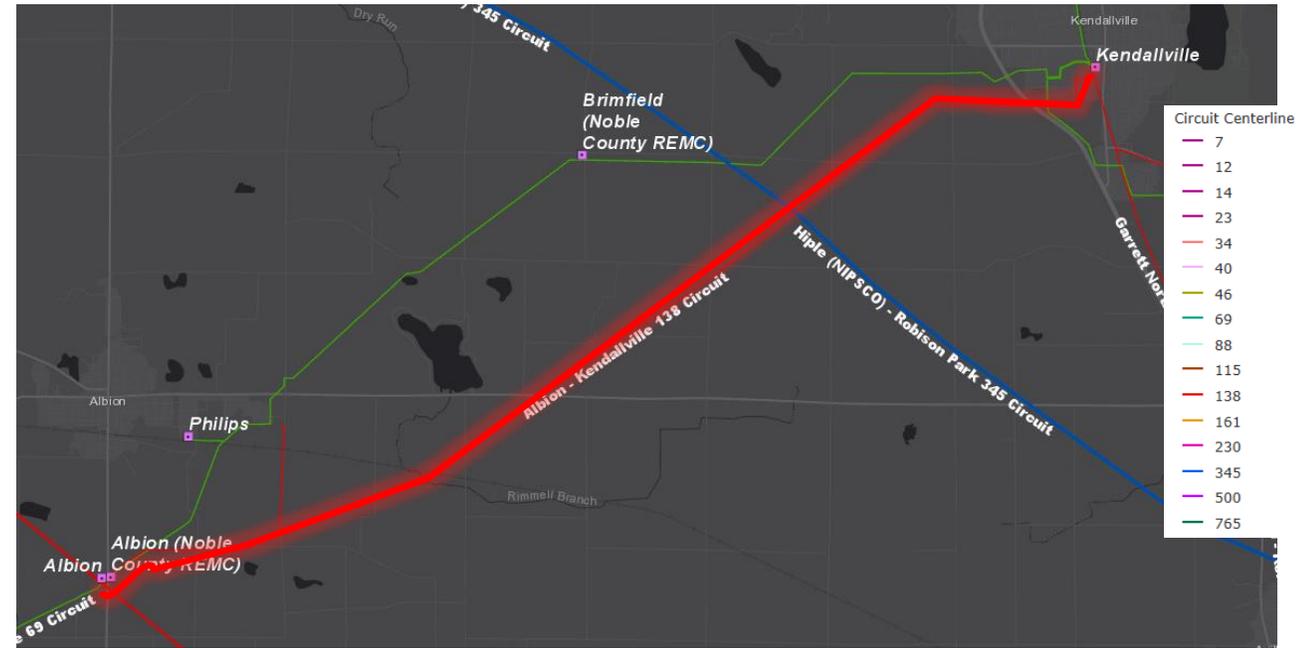
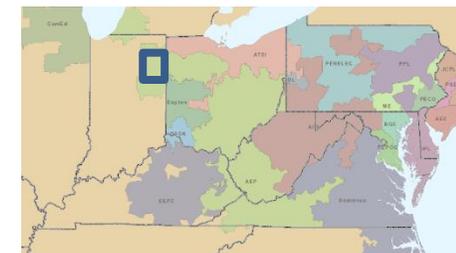
### Albion – Kendallville 138kV line (9.75 miles):

- 1972 wood H frame construction
- Since 2015 there have been 2 momentary outages to this line
- The structures on this line fail to meet NESC Grade B, AEP structural strength standards, grounding standards and shield angle requirements.
- 10 structures were investigated at the ground and 44 structures were assessed by drone. The following conditions were noted.
  - Nearly all structures had moderate to heavy insect or woodpecker damage, and light to moderate shell decay. A few also had decay pockets at ground line.
  - All H Frames have light to moderate decay
  - ~14% had flashed insulators
  - Light to moderate corrosion on hardware
- Currently 23 (25% of line) structures have at least one open condition
  - 28 total conditions include rotting, cracked, burnt, leaning or woodpecker affected structures; broken conductor, shield wire and ground lead wire

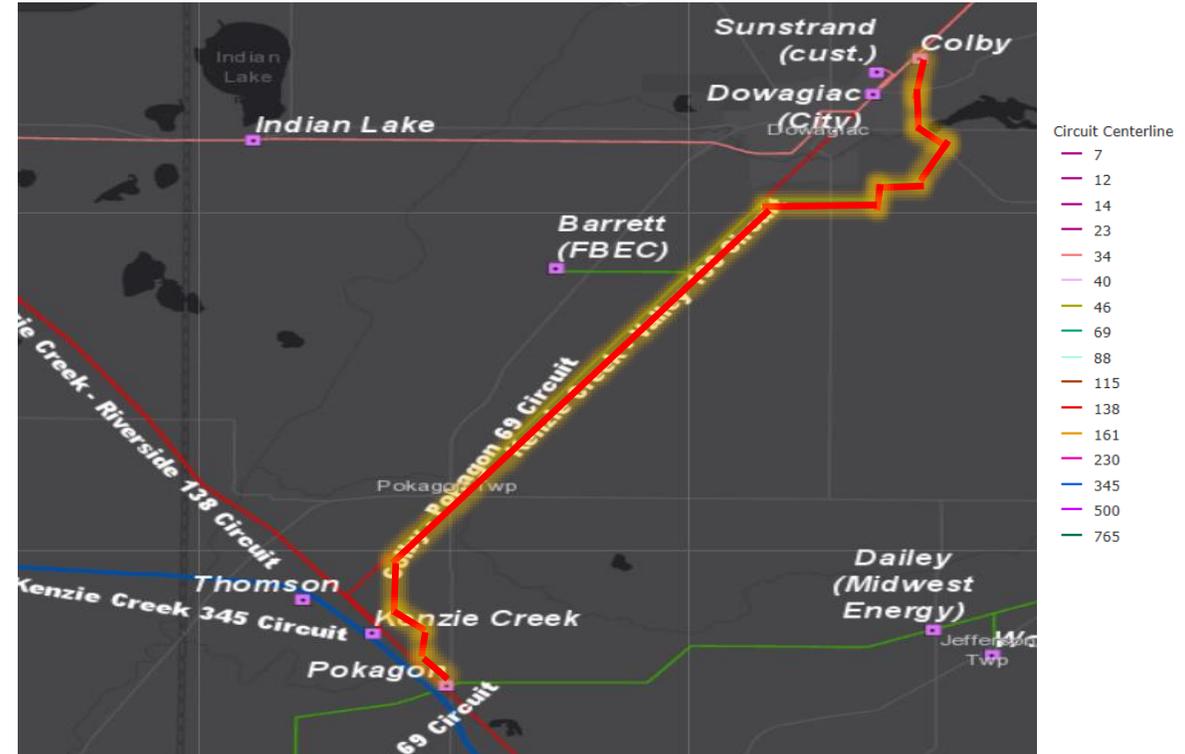
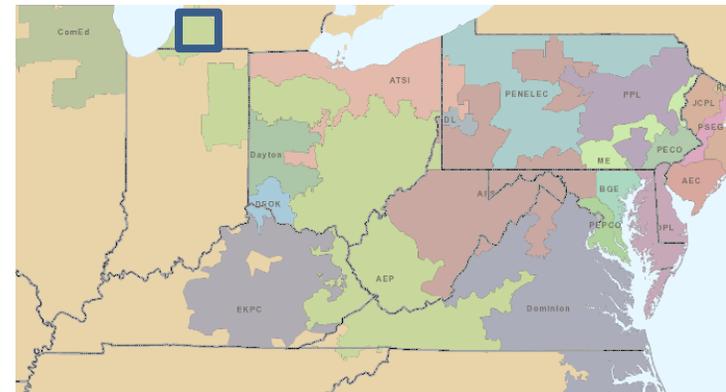
**Colby – Pokagon 69kV (11.22 miles):**

- 179 of the 183 poles are original 1967 wood poles.
- Original 1967 336 ACSR 18/1 Merlin conductor
- Since 2015 there have been 5 momentary outages
- Structures fail NESC Grade B, AEP Strength requirements, ASCE structural strength standards, and grounding methods utilize butt wraps on every other structure
- Out of the 58 assessed structures
  - 50% have moderate to significant insect and bird damage on the shell
  - About 38% of the assessed structures have heart rot decay at the pole base
- There are 80 structures with at least one open condition (not including forestry), which relate to 44% of the structures on the line
- There are a total of 90 open conditions on this line, not including forestry

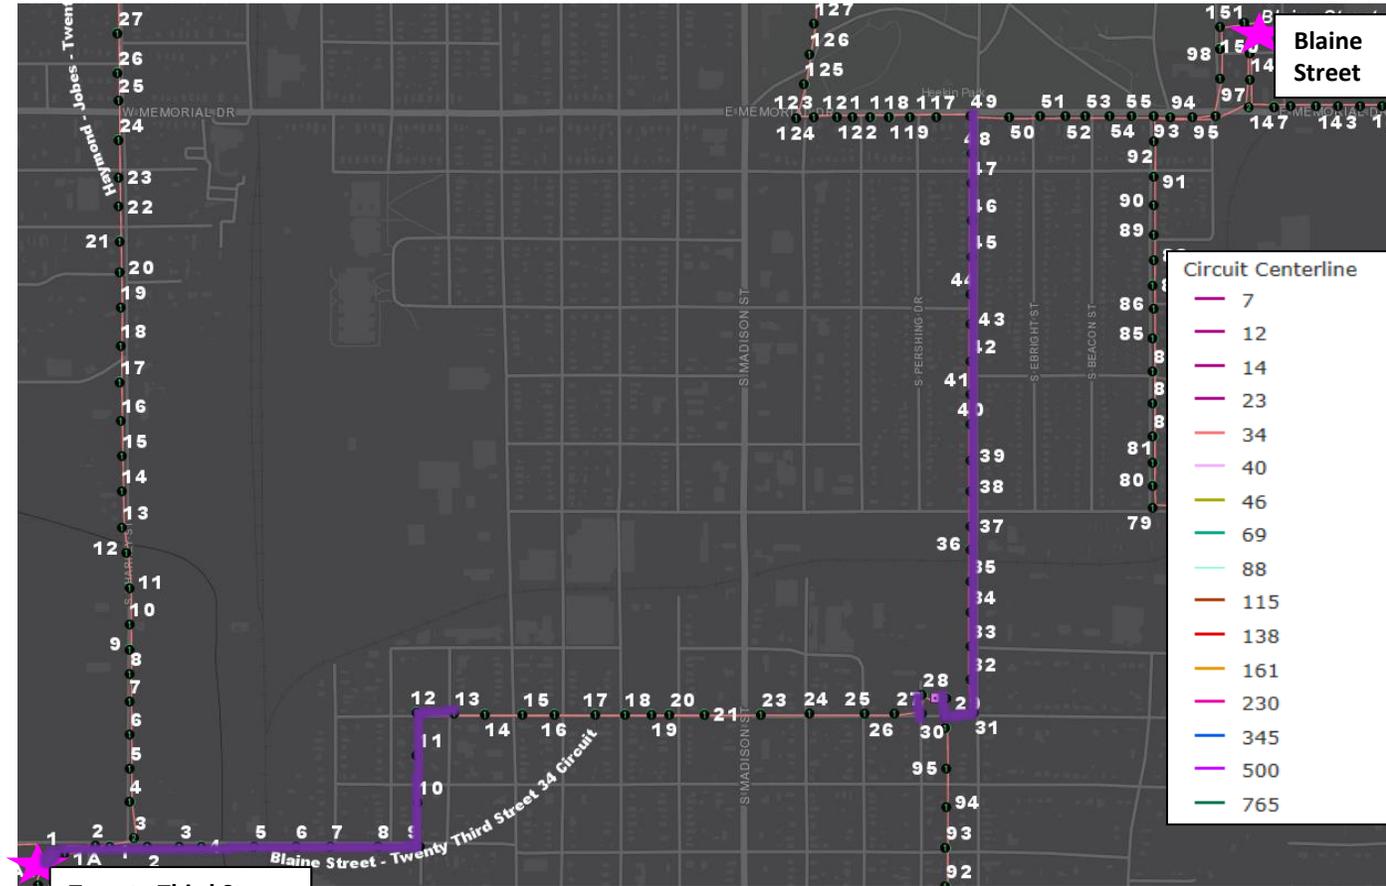
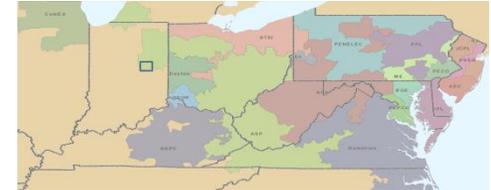
**Twenty Third Street – Blaine Street 34.5 kV (Vintage 1976)**

- Length of Line: 1.20 miles
- Total structure count: 54 with 42 dating back to original installation.
- Line Construction Type:
  - Wood pole structure with cross arm construction.

- Porcelain vertical post insulators
- Conductor Type:
  - 556,500 CM ALUM/1350 19 Dahlia (0.68 mi)
  - 795,000 CM ALUM/1350 (0.52 mi)
- Condition Summary

- Number of open conditions: 5 structure open conditions with 1 structure related open conditions.
    - Open conditions include broken pole, shielding grounding improperly installed and missing ground lead wires.

- Based on the ground crew and aerial drone assessment of 30 structures:
    - Approximately 67% of the poles assessed have moderate to heavy shell damage, insect damage or woodpecker damage

- Approximately 50% of the poles assessed have heart rot
  - The grounding method utilizes butt wraps on every other structure, providing reduced lightning protection for the line.

- Structures fail NESC Grade B, AEP structural strength requirements, and ASCE structural strength requirements.

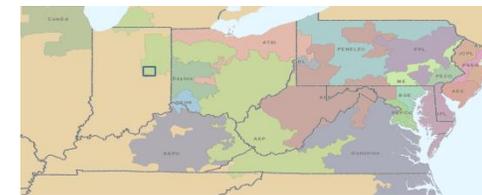
**Twenty Third Street 138/34.5 kV transformer #1:**

- Install date: 1965
- Dielectric strength breakdown due to elevated moisture levels from gasket leaks or breakdown in oil or paper/pressboard insulation. This impairs the unit's ability to withstand electrical faults.
- Aging insulating paper material becoming brittle allowing for increased susceptibility of short circuit faults causing failure of the main tank.
- Bushings are at risk of failure due to changes of bushing dielectric data. Failure of the bushings may cause a failure or loss of service of the transformer.

**Twenty Third Street 138/34.5 kV transformer #2:**

- Install date: 1970
- Dielectric strength breakdown due to elevated moisture levels from gasket leaks or breakdown in oil or paper/pressboard insulation. This impairs the unit's ability to withstand electrical faults.
- Aging insulating paper material become brittle and recent trends on Ethane and Methane indicating overheating temperatures within the tank impair the unit's ability to withstand future short circuit fault events.
- All bushings showed major changes in power factor from original values. Bushings are at risk of failure due to changes of bushing dielectric data. Failure of the bushings may cause a failure or loss of service of the transformer.

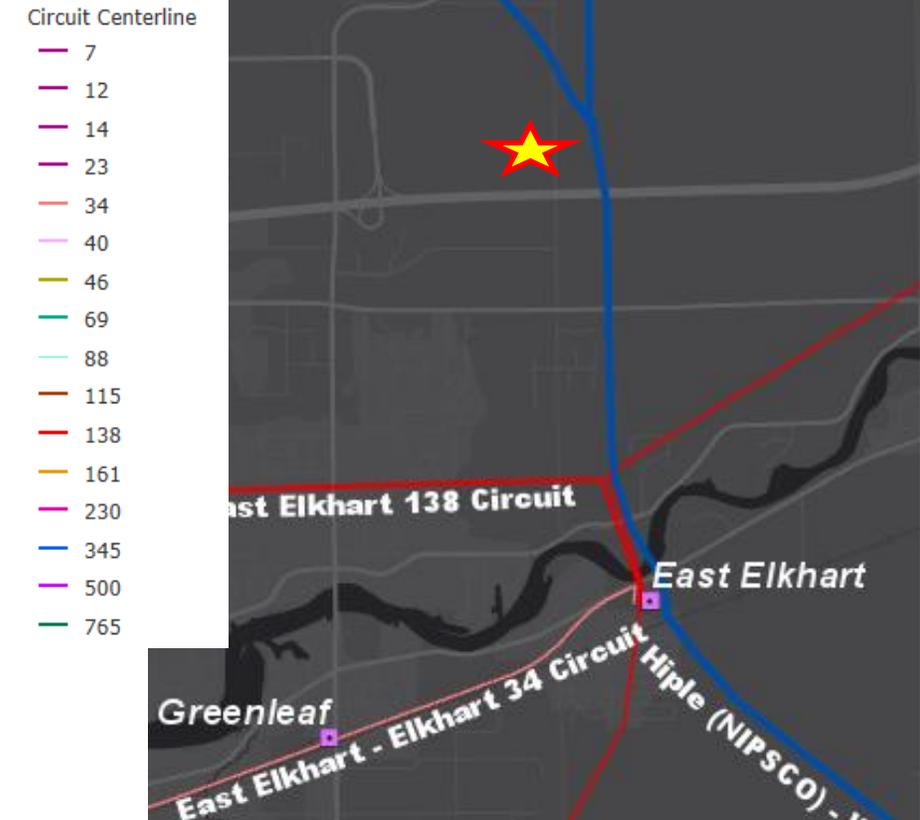
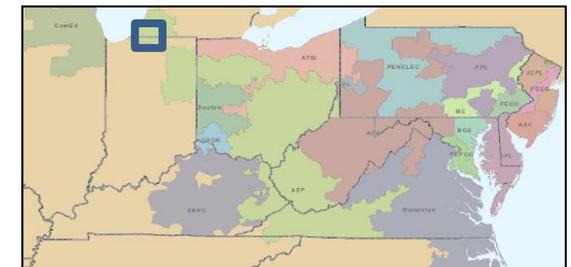
Retail customer has requested new transmission service in Elkhart, Indiana by January 2023. Anticipated load is approximately 8.5 MW.

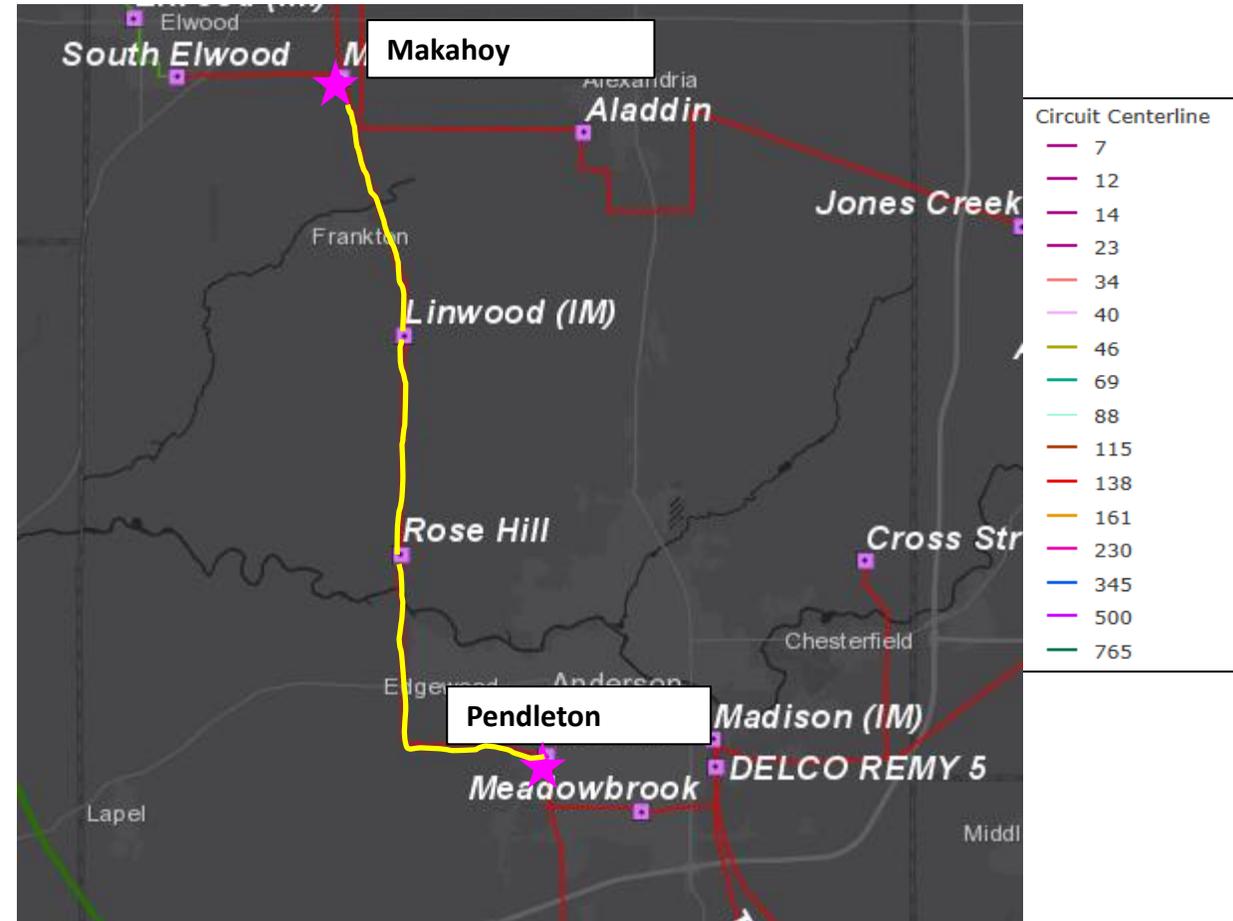
**Pendleton - Makahoy 138 kV (Vintage 1954)**

- Length of Line: 14.93 miles
- Total structure count: 106 with 92 dating back to original installation.
- Line Construction Type: Predominantly wood poles

- Wood cross arm
  - Horizontal insulators: Porcelain
  - Grounding method utilizes butt wraps on every other structure, providing reduced lightning protection for the line.

- Conductor Type: 556,500 CM ACSR 26/7 Dove
- Condition Summary
  - Number of open conditions: 21 structure open conditions with 8 structure related open conditions.

- Open conditions include cross arm or pole with rot top, shield wire broken strands, broken ground lead wire and burnt or broken insulators.
    - Based on the aerial drone and ground crew assessment done on 56 structures, the following was noted.

- The cross arms have moderate to advanced wood decay.
      - 40% of structures assessed at ground line have heart rot decay.
      - Structure hardware with moderate corrosion.

- Structures fail NESC Grade B, AEP structural strength requirements, and ASCE structural strength requirements

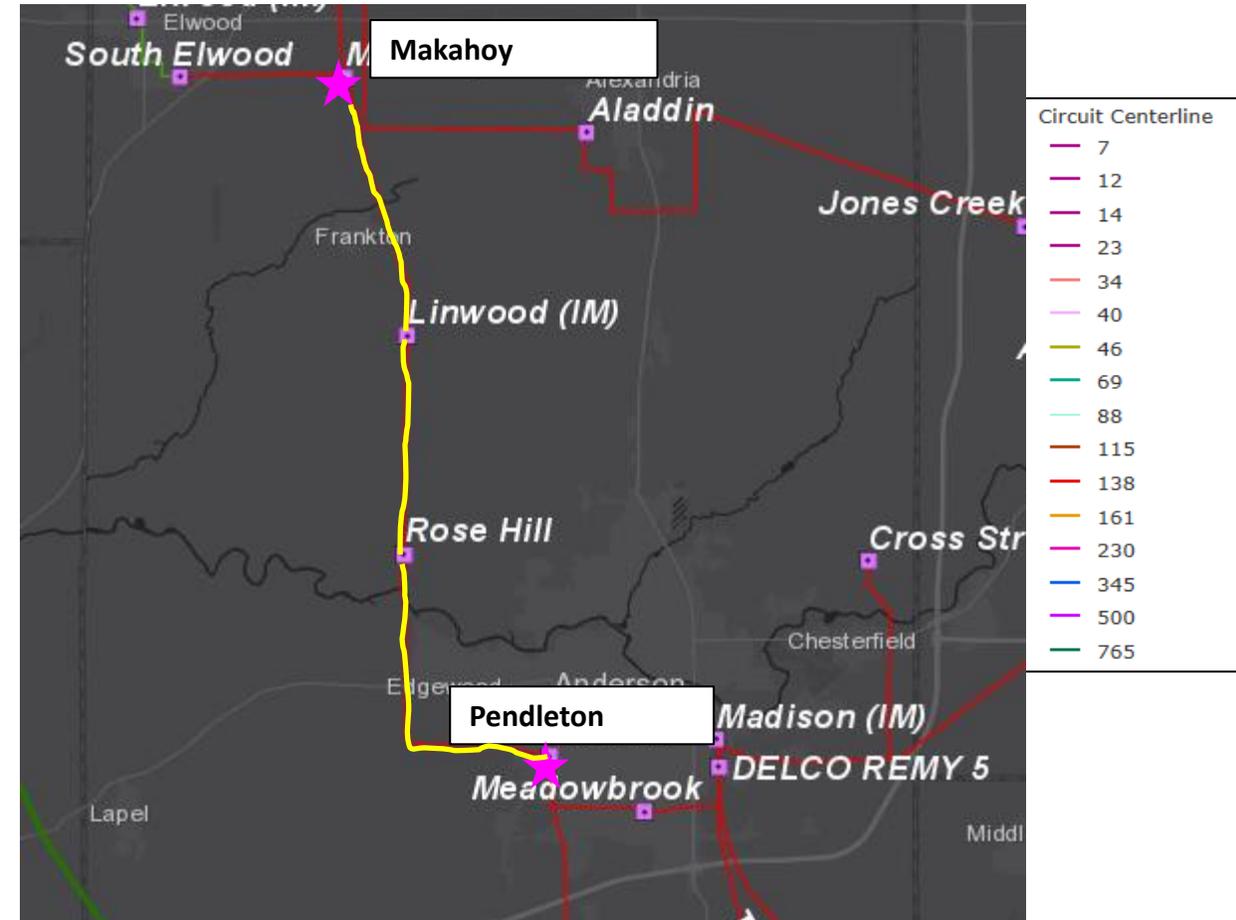
**Pendleton 138/34.5 kV transformer #2**

- Install date: 1967
- Oil concerns:
  - Dielectric strength breakdown: The elevated moisture levels and decreased interfacial tension indicate the dielectric strength of the insulation system are in poor condition, which impairs the unit's ability to withstand electrical faults.
  - No oil containment
  - Oil / Gasket leaks

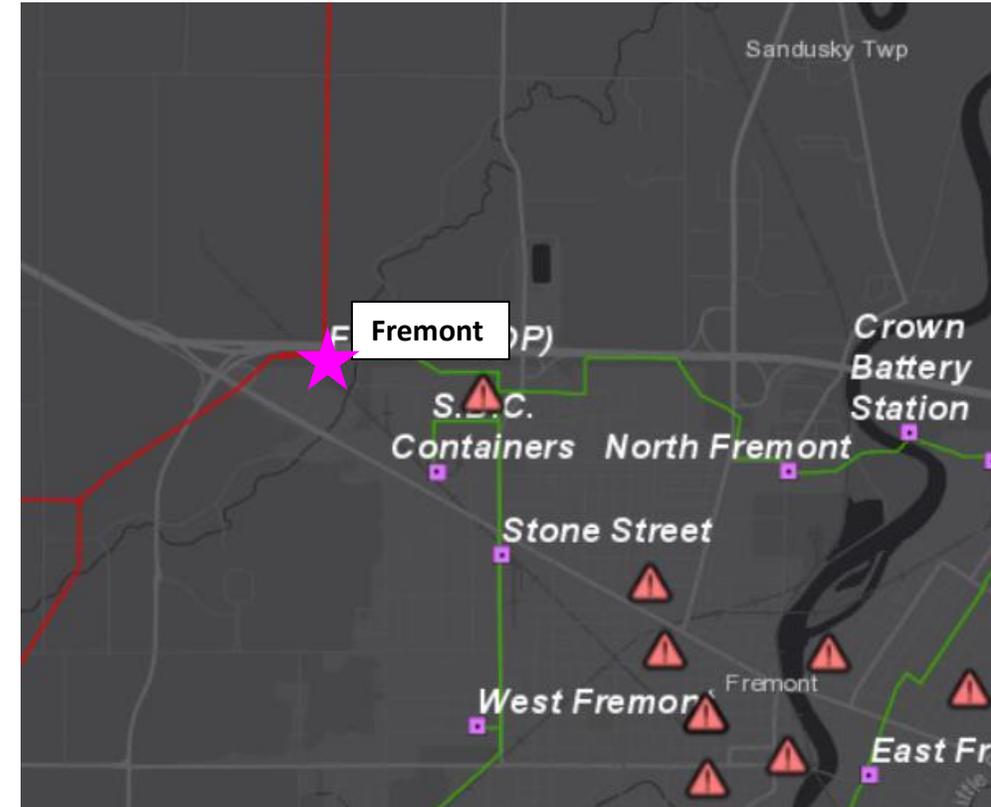
Circuit Breaker: C

- Breaker Age:
  - 1988
- Interrupting Medium: (Oil)
- Fault Operations:
  - Number of Fault Operations: 43
  - Manufacturer recommended Number of Operations: 10
- Additional Breaker Information:
  - These breakers are oil filled without oil containment; oil filled breakers have much more maintenance required due to oil handling than their modern, SF6
  - The manufacturer provides no support for this family of circuit breakers and spare parts are increasingly more difficult to obtain. This model family has experienced major malfunctions associated with their hydraulic mechanism, including low-pressure readings, hydraulic leaks, pump lockouts, and failure to shut off. These mechanism malfunctions have led to several failures to close and other types of mis-operations across the AEP system.

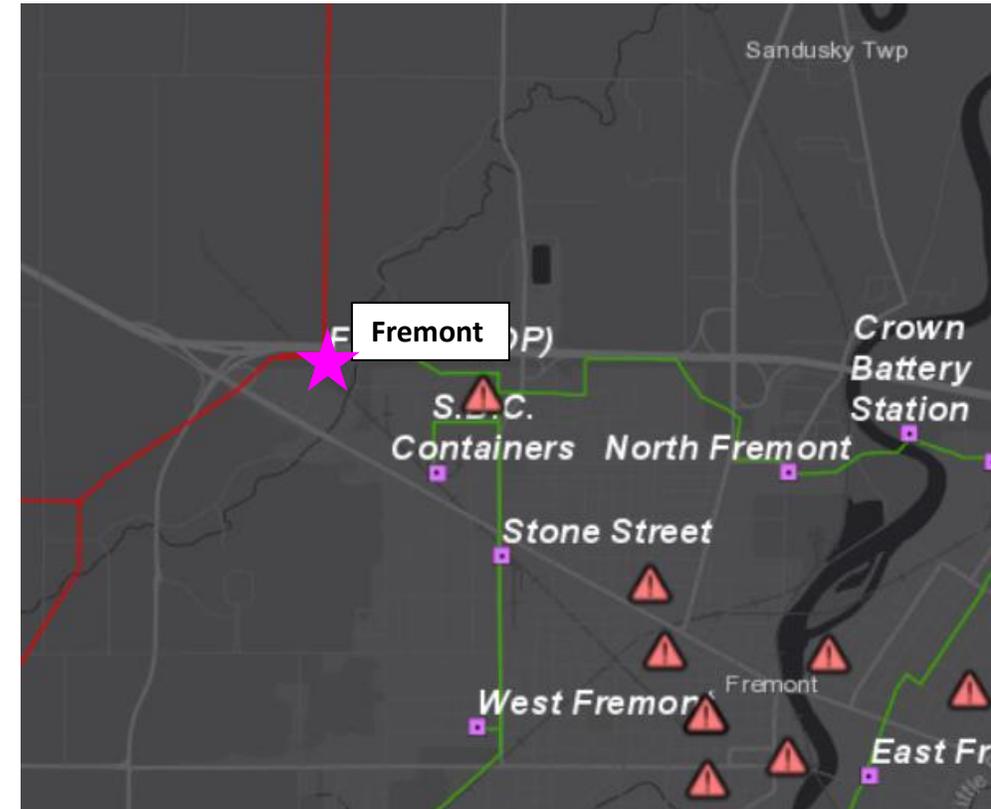
### Relays:

- 52 of the 60 relays (87% of all station relays) are in need of replacement. 42 of these are of the electromechanical type and 1 of the static type which have significant limitations with regards to spare part availability and fault data collection and retention. In addition, these relays lack of vendor support. There are 8 microprocessor based relays commissioned between 2004 and 2011 and one DPU unit with firmware that is no longer supported.

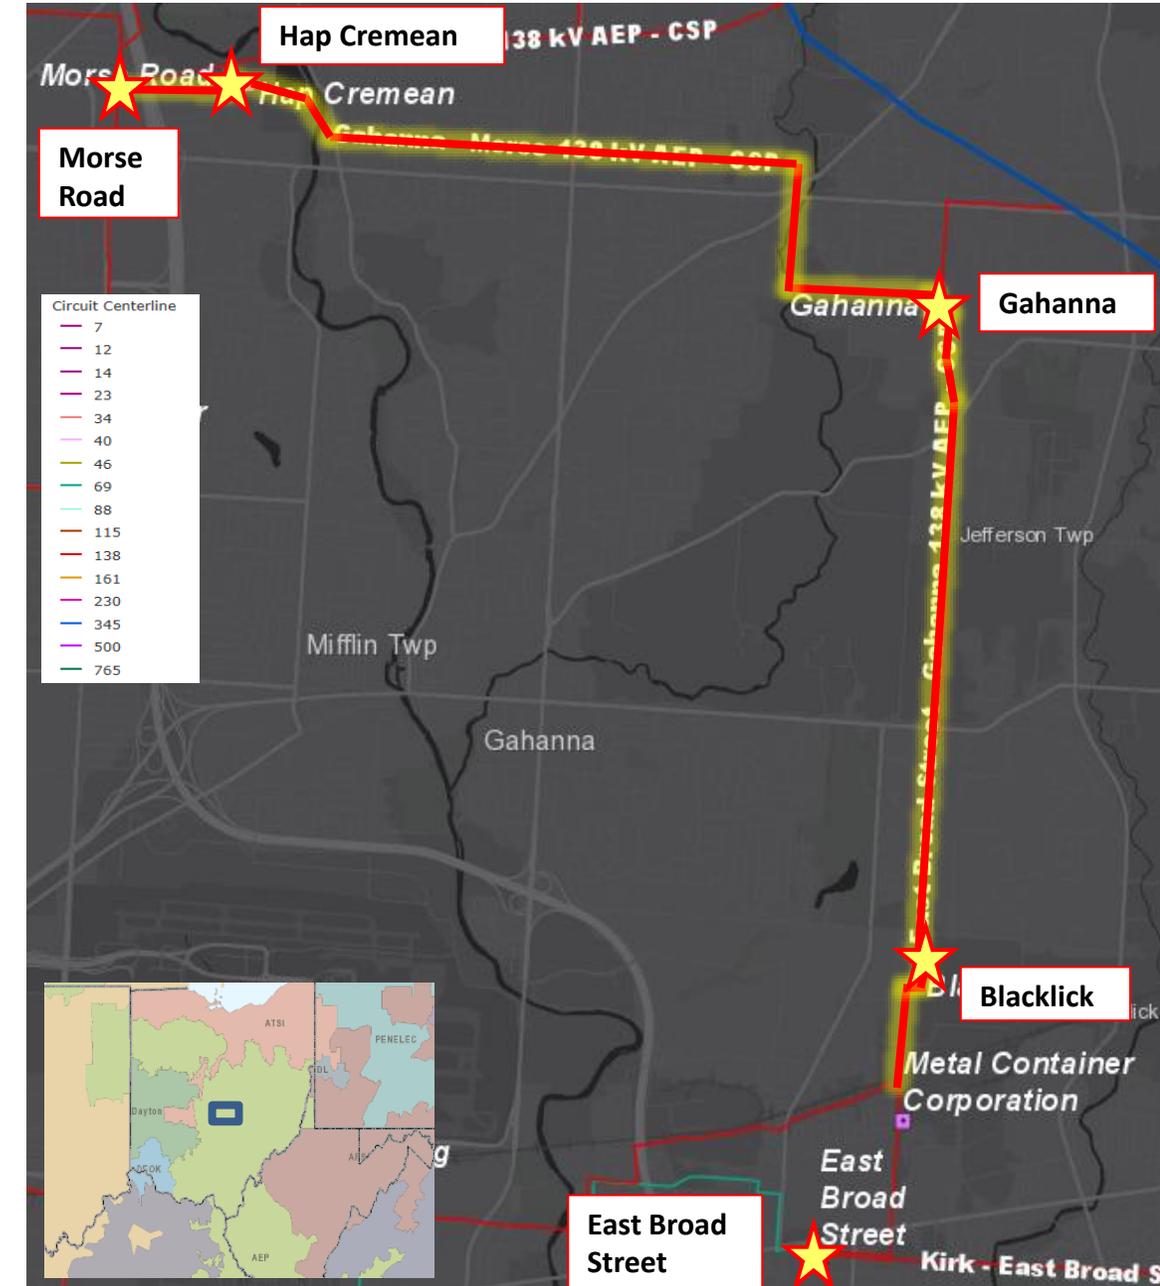
Gahanna-Hap Cremean (4.39 miles) & Hap Cremean-Morse Road ( 0.65 miles) 138 kV Single Circuit Line:

- The circuit conductor is 336 kCM ACSR 30/7 (1956)
- The structures are wood poles with vertical insulators (1950s).
- Currently, 36 structures have at least one open condition (36 out of 49), consisting of bowed crossarms, rot heart, rot top, rot pocket, woodpecker holes, insect damage and damaged poles
- The structures on the line do not meet the 2017 NESC Grade B loading criteria, AEP structural strength requirements, and the current ASCE structural strength requirements.
- The insulators on the line do not meet current AEP standards for CIFO and minimum leakage distance requirements.
- The grounding is inadequate for current AEP Standards. The shield angle on a typical tangent structure is inadequate for AEP current shield angle requirements.

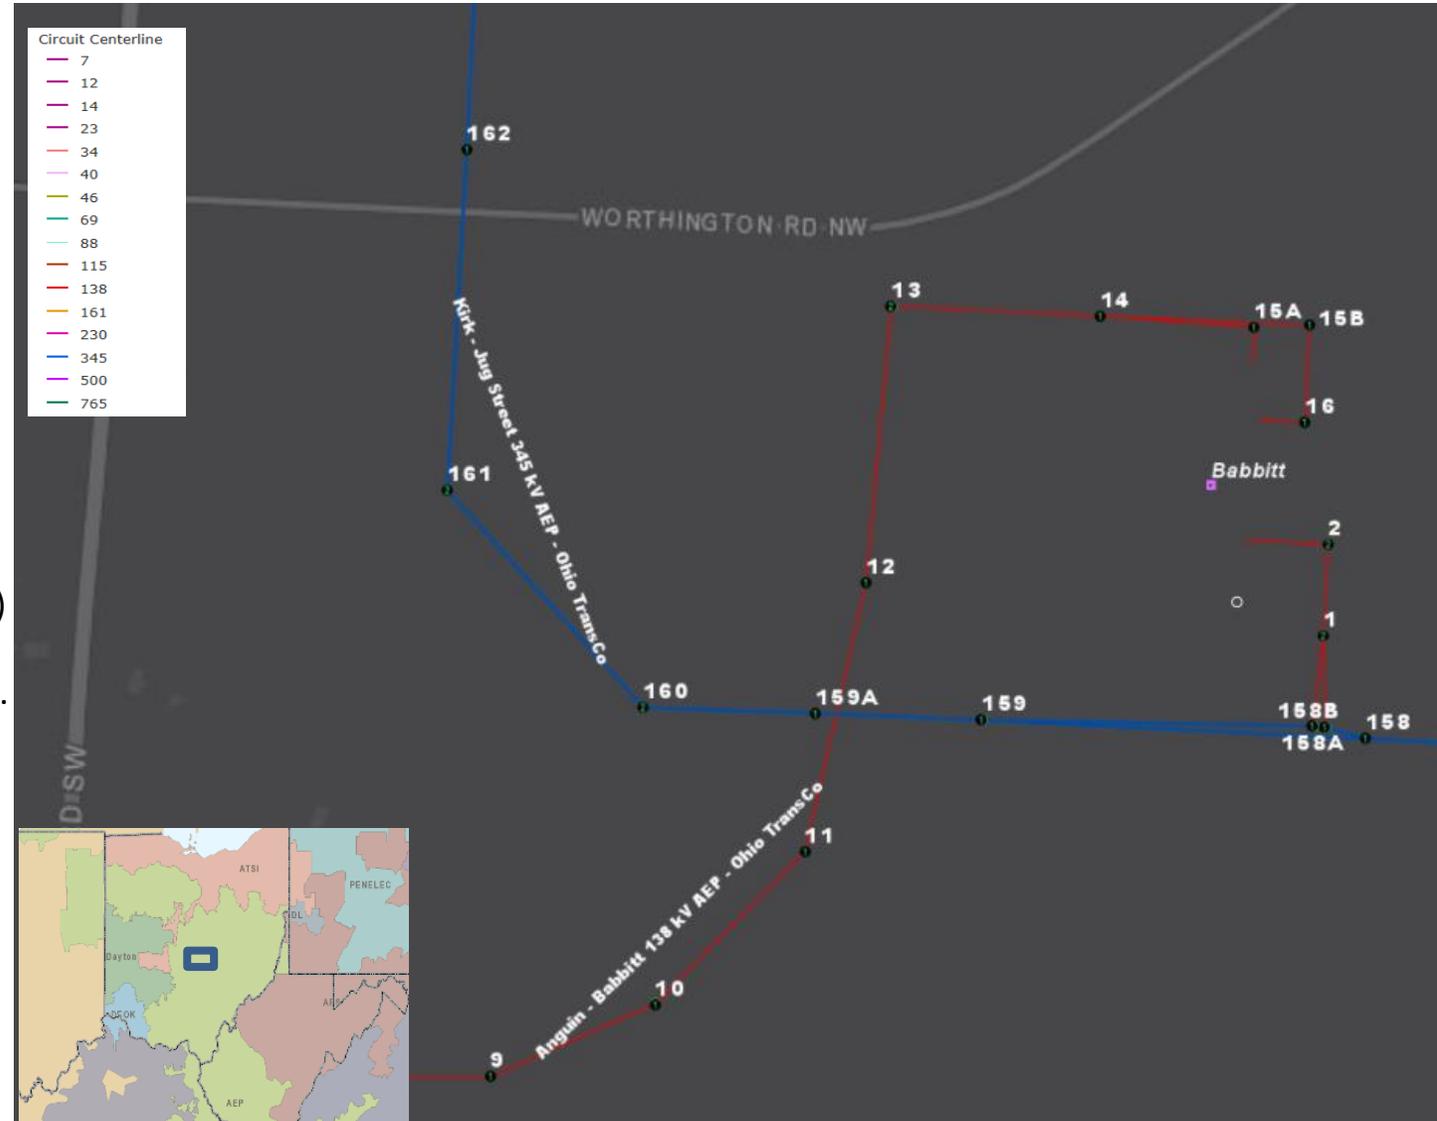
- AEP Ohio has requested a new 138 kV delivery point from Babbitt 138 kV station.
- Additional capacity is needed on the Distribution system (~ 50 MVA) to shift load from existing area circuits. Continued load growth and limited tie capability is an issue in the surrounding New Albany area.
- **Model:** 2026 RTEP

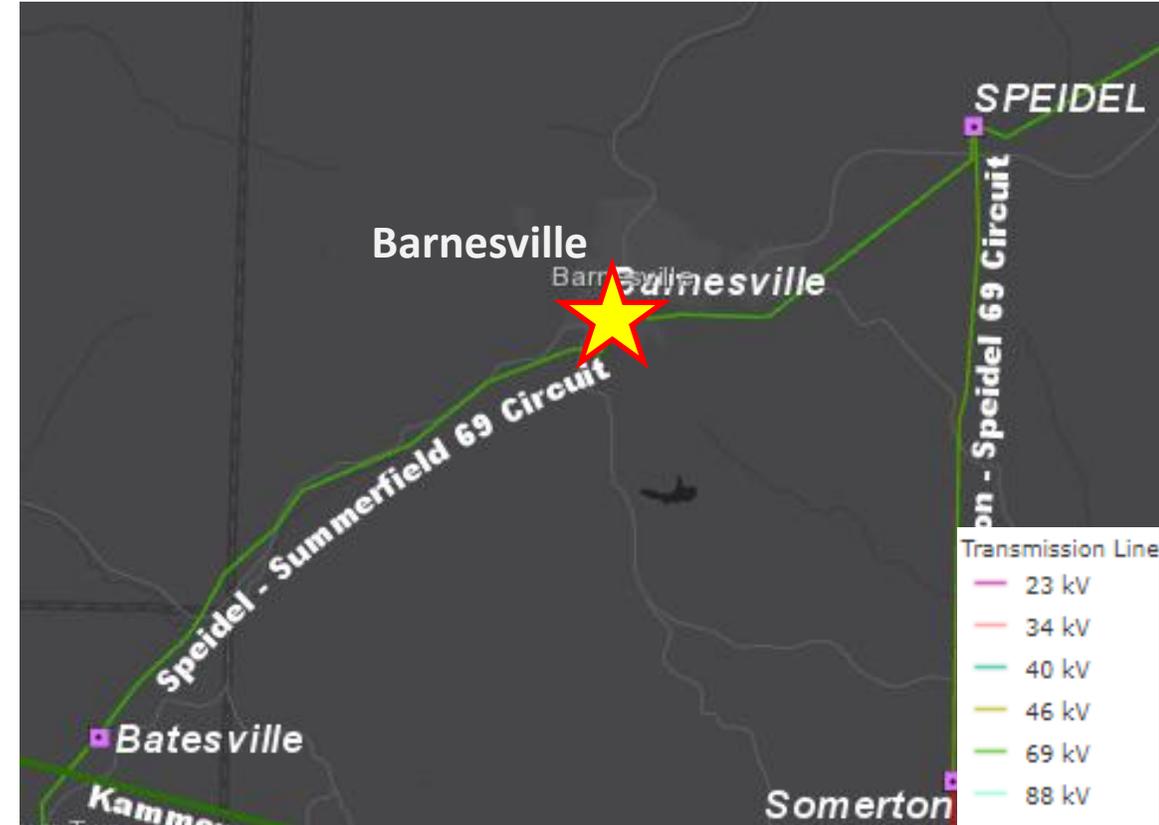
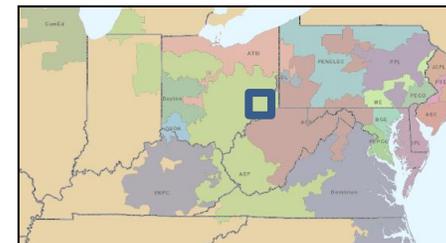
AEP Ohio has requested a new load delivery point due to capacity loading limits at the Barnesville 69/12kV substation. The station is limited by its power transformer and secondary cables. The transformer was manufactured in 1968, has poor oil quality, and has bushing issues reported.

The station is served radially via a 0.4-mile 69kV tap. This T-line tap dates back to 1942, with original #1 copper conductor, and currently has 2 open conditions. Other projects in the area have proposed to rebuild the remainder of the 69 kV line in the area.

Barnesville has an obsolete MOAB/ground-switch for the transformer protection system. This requires remote-end breaker clearing many miles away, and drops another tapped AEP Ohio distribution station in the process (Batesville).

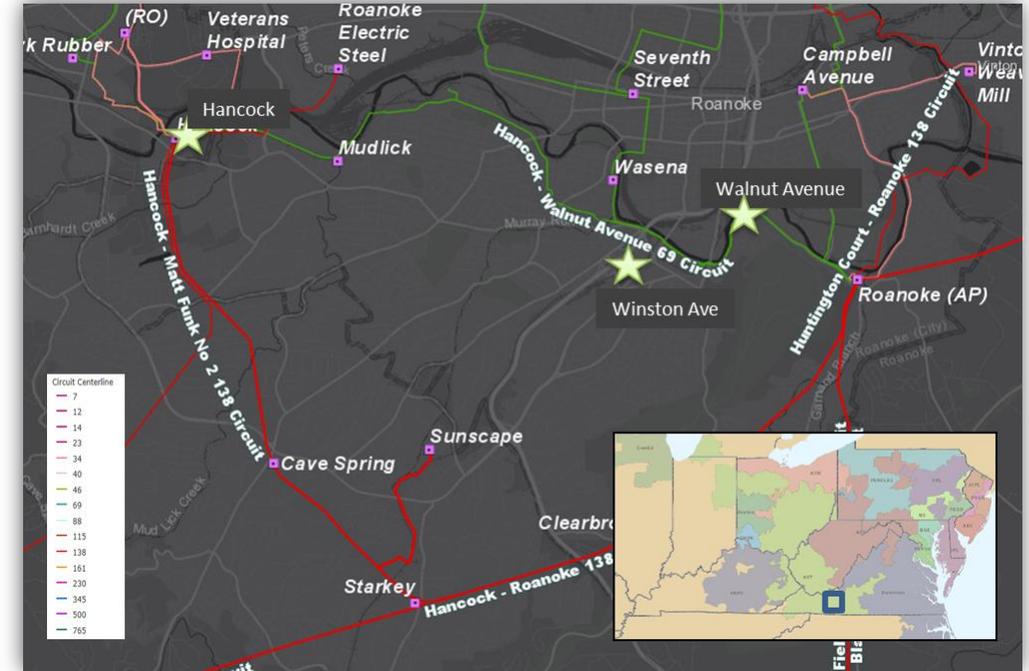
- Distribution requested a new station (Winston Avenue) located just south of the Hancock-Walnut Avenue 69 kV circuit to serve load currently fed from Walnut Avenue Station, which is located in the flood way of the Roanoke River as determined by FEMA and the Army Corps of Engineers. There have been several instances in the last three years where prolonged periods of rain have resulted in water levels that reached the bottom of the breaker control cabinets in the station.

- Medical related load continues to grow in the area served by Walnut Avenue Station. The main feed for Roanoke Memorial Hospital (RMH) is the Walnut Avenue/South Roanoke 12 kV feeder. RMH has plans to construct a new 15 story (2 MVA) expansion at nearby Crystal Springs along with a renovation/relocation of their existing Cancer Center by April 2024. The load on the South Roanoke 12 kV feeder is projected to reach 8.9 MVA, or 69% of its 12.9 MVA capability by summer 2024. This load is primarily RMH and while the concern is not necessarily related to a projected overload, it is about having Roanoke’s largest hospital served by a main feed in the Roanoke River Floodway and its alternate feed (Wasena/Wiley 12kV) in the Roanoke River Floodplain.

- The Walnut Avenue/Maher Ave 12 kV feeder has seen and will continue to see medical related growth. Recent additions have been the Virginia Tech School of Medicine, Carilion Biomedical center for which the first of three planned expansions was announced for 6/2020. The load on the Maher Avenue 12 kV feeder is projected to reach 9.1 MVA, or 80% of its 11.4 MVA capability by summer 2024. While the concern is not necessarily related to a projected overload, cold load pickup is a concern following an outage when trying to restore power on a 12 kV feeder when its load exceeds 9.0 MVA.

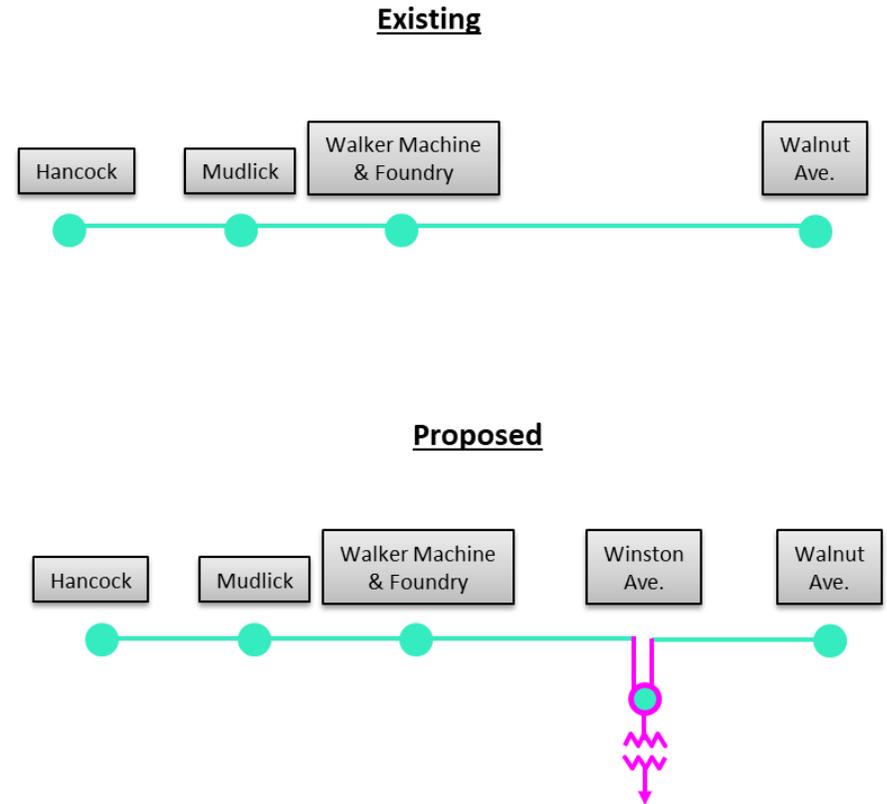
This project will be completed in 2 phases to transfer load away from Walnut Ave. which is located in a flood way while continuing to provide reliable service to sensitive customers currently served and future growth.

- Extend a 0.37 mile double circuit 69 kV line to the new station location by tapping the existing Hancock-Walnut Ave 69 kV Circuit using 556 ACSR 26/7 overhead conductor. **Estimated Cost: \$2.8M**
- Establish new 69 kV station (Winston Avenue) in a straight bus configuration with 2-69 kV circuit breakers, 69/12 kV, 25 MVA transformer with high-side circuit switcher and three 12 kV feeder breakers. **Estimated Cost: \$0 (Station cost is Distribution)**
- Update relay settings at Walnut Ave and Hancock stations. **Estimated Cost: \$0.03M**

- At Winston Ave install a second 69/12 kV, 25 MVA transformer with high-side circuit switcher and 12 kV feeders. **Estimated Cost: \$0 (Station cost is Distribution)**
- At Roanoke install a second 138/12 kV Distribution transformer with high-side circuit switcher and 12 kV feeders. **Estimated Cost: \$2 M**
- Retire Distribution from Walnut Ave. Station. **Estimated Cost: \$0 (Station cost is Distribution)**

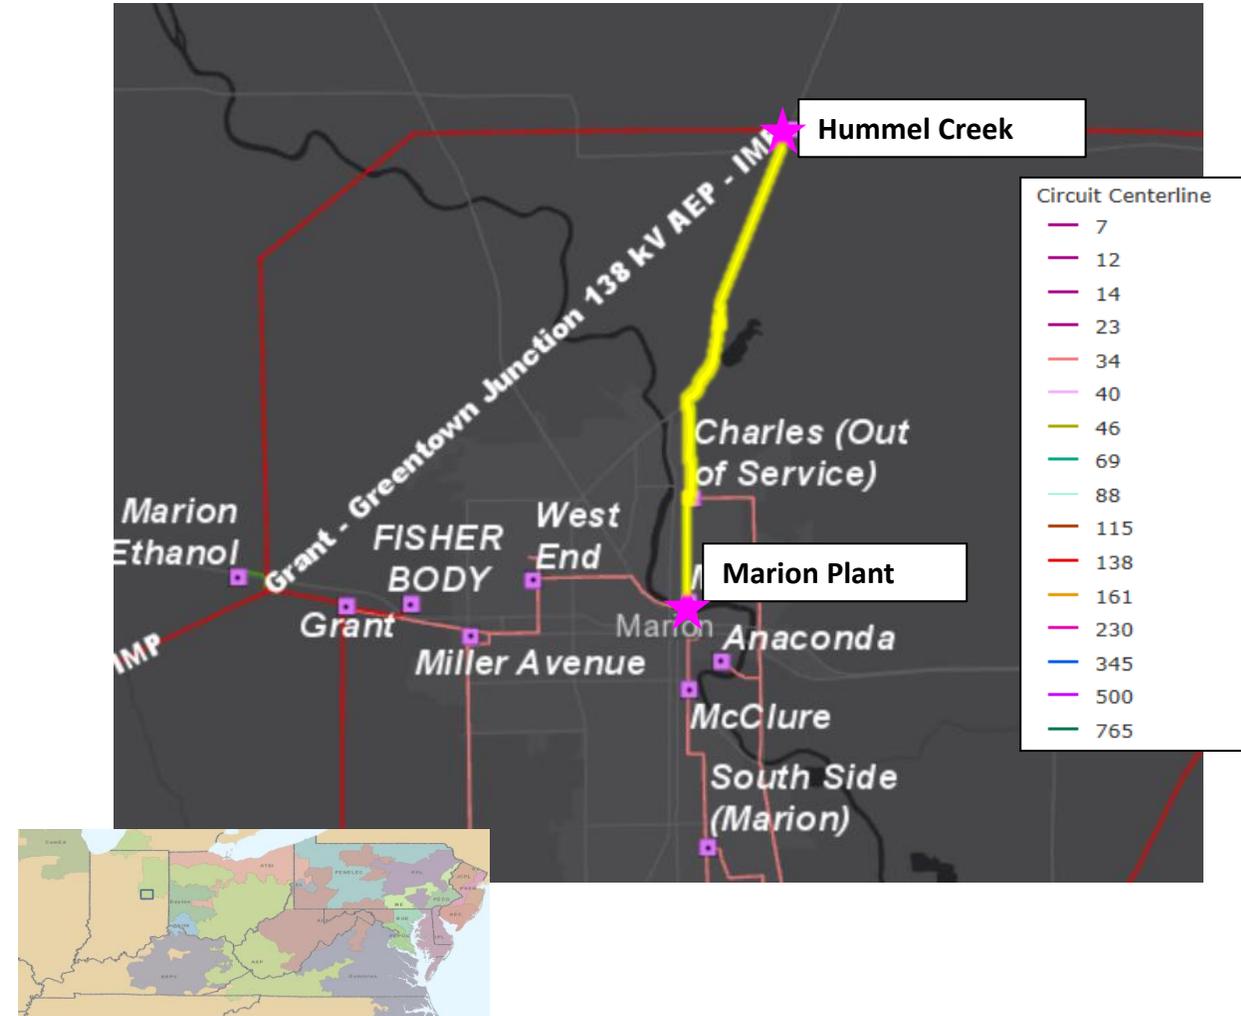
- Porcelain insulators
- Conductor Type: 556,500 CM ALUM/1350 19 Dahlia
- Condition Summary
  - Number of open conditions: 19 structure open conditions
    - Open conditions include knee/vee brace, shielding/grounding open conditions related to the ground lead wire with missing or stolen, hardware, broken insulators.

- Based on the ground crew assessment most poles and arms assessed are in poor condition with a overall condition of the line moving towards increased maintenance cycles and less reliability.

- Structures fail NESC Grade B, AEP Strength requirements, and ASCE structural strength standards
  - The grounding method utilizes butt wraps on every other structure, providing reduced lightning protection for the line.

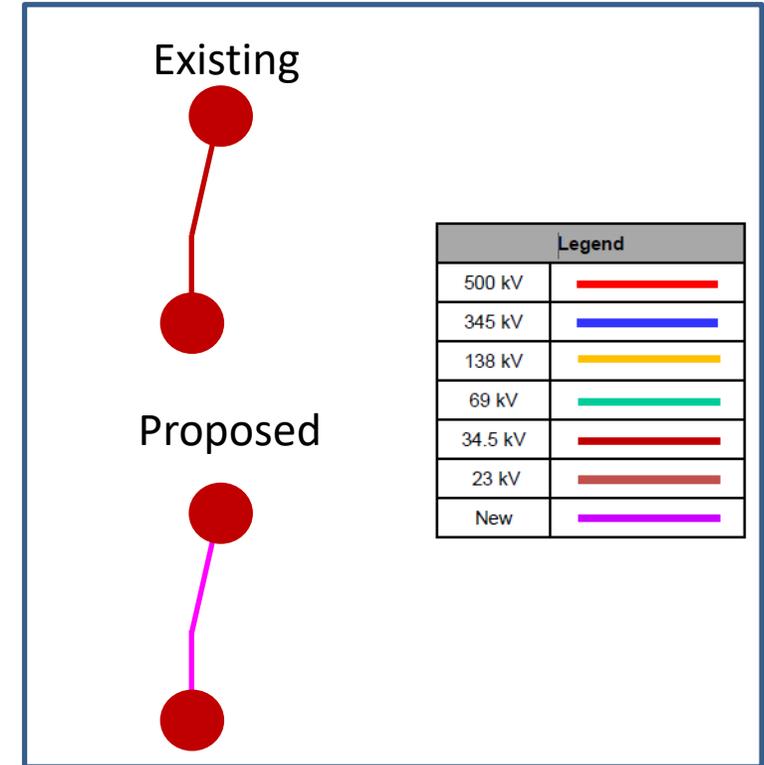
Retire and remove the Hummel Creek – Marion Plant 69 kV line (~4.48 miles). This would consequently require the rebuild of ~1.46 miles of the Grant – Marion Plant 69 kV line and the replacement of the Grant 138/69/34.5 kV transformer due to thermal violations for various N-1 outages around Deer Creek.

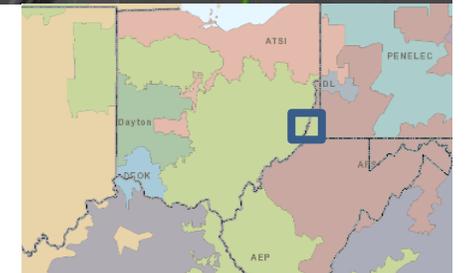
Transformer #2 has failed due to a short circuit event verified by extremely high excitation currents and oil sampling results.

- Transformer Age: 1969, rewound in 1989
- Nameplate Rating: 115/128.8 MVA

**Proposed Solution:** Replace the failed 138-69 kV transformer with a spare transformer (130 MVA nameplate, 2016 vintage). Cost includes removal costs, transport, and installation of the transformer. **Estimated Cost: \$0.5M**
