Sub Regional RTEP Committee: Western AEP Supplemental Projects

Need Number: AEP-2021-AP037

Holston – Sullivan Gardens 138 KV (installed in 1927)

Need Number: AEP-2020-AP041

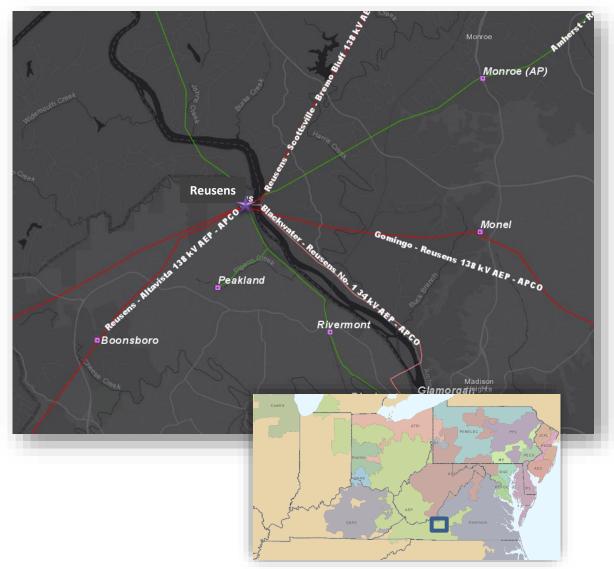
AEP Transmission Zone M-3 Process Lynchburg, VA Area

AEP Distribution is requesting a new 138/12 kV transformer at Reusens station to transfer load from Peakland and Boonsboro stations due to the following concerns:
