# Sub Regional RTEP Committee: Western AEP Supplemental Projects

February 18, 2022

# AEP Transmission Zone M-3 Process Johnson County, Kentucky

**Need Number:** AEP-2022-AP004

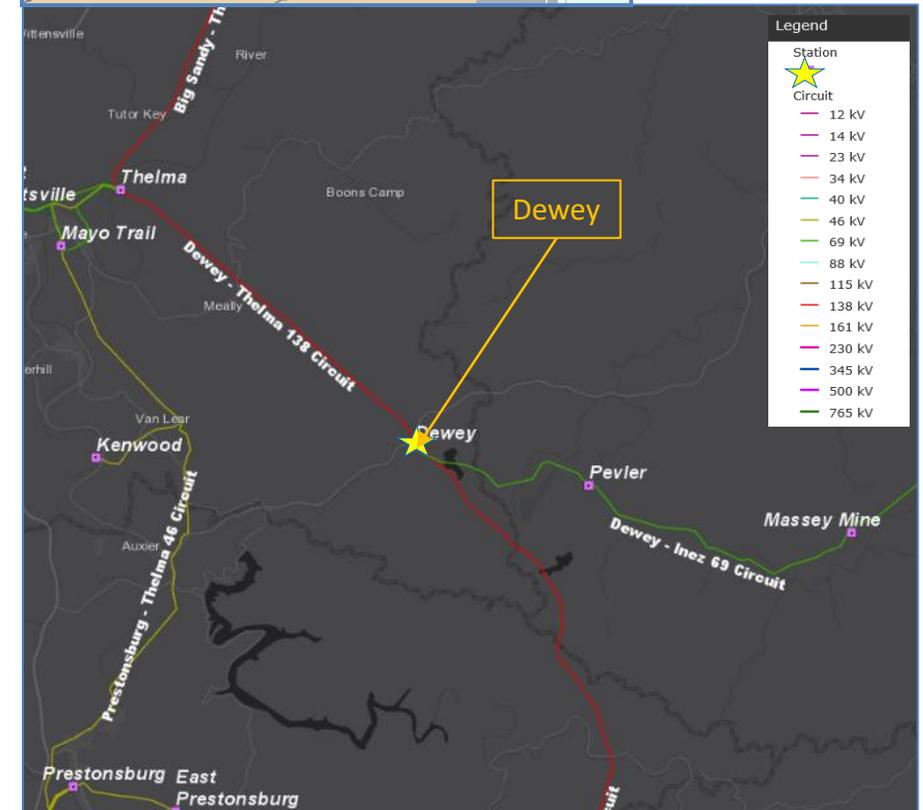
Dewey substation Needs:

- 138kV Circuit Breaker B:
  - 1992 Vintage, number of fault ops: 55
  - The 138kV transmission owned circuit breaker, CB-B, is a 145-PA-40-20B type, SF6 filled breaker. As of May 11, 2020, there have been 437 recorded malfunctions of this 145-PA model family on the AEP System. The most common issues are related to loss of SF6 gas and mis-operations. The expected life of the bushing gaskets and door inspection port seals is 25 years; this unit has reached this age. Seals that are no longer adequate cause SF6 leaks to become more frequent. SF6 leaks impact the environment. The manufacturer provides no support for this family of circuit breakers and spare parts are not available.

- Relaying
  - Currently, 21 of the 34 relays (62% of all station relays) are in need of replacement. 21 of these are of the electromechanical type which have significant limitations with regards to spare part availability and fault data collection and retention.

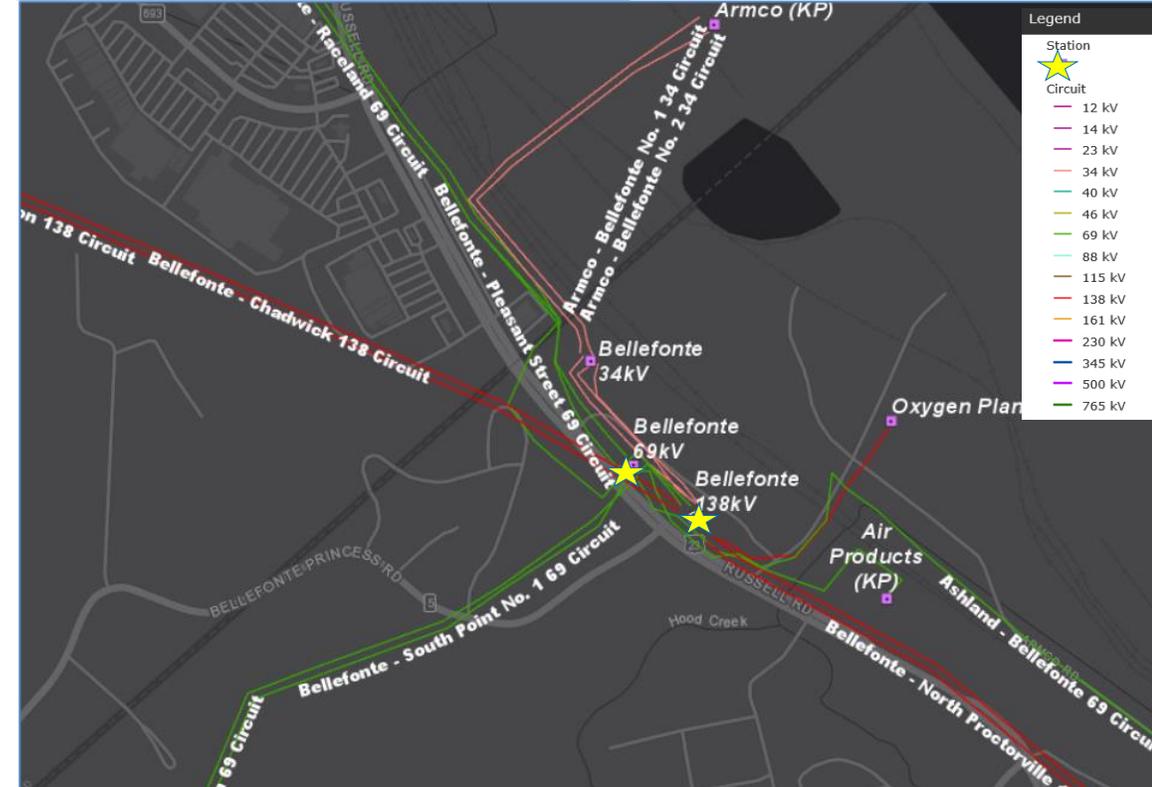
Bellefonte 138kV Yard:

- 138/34kV 45MVA Bank #1:
  - 1950s Vintage, originally manufactured in 1951,
  - The dielectric strength of the overall insulation system (oil and paper) is in poor condition, which impairs the unit's ability to withstand electrical faults.

- Active Oil leaks.
- 138/69-34kV 196 MVA Bank #2:
  - 1970s Vintage, originally manufactured in 1970,
  - Low side bushings have Capacitive layer deterioration.

- This unit has severe nitrogen leaks. There are racks installed with manifolds in order to keep the nitrogen pressure on this transformer. This unit also has active oil leaks. One third of the fans on this unit have failed.

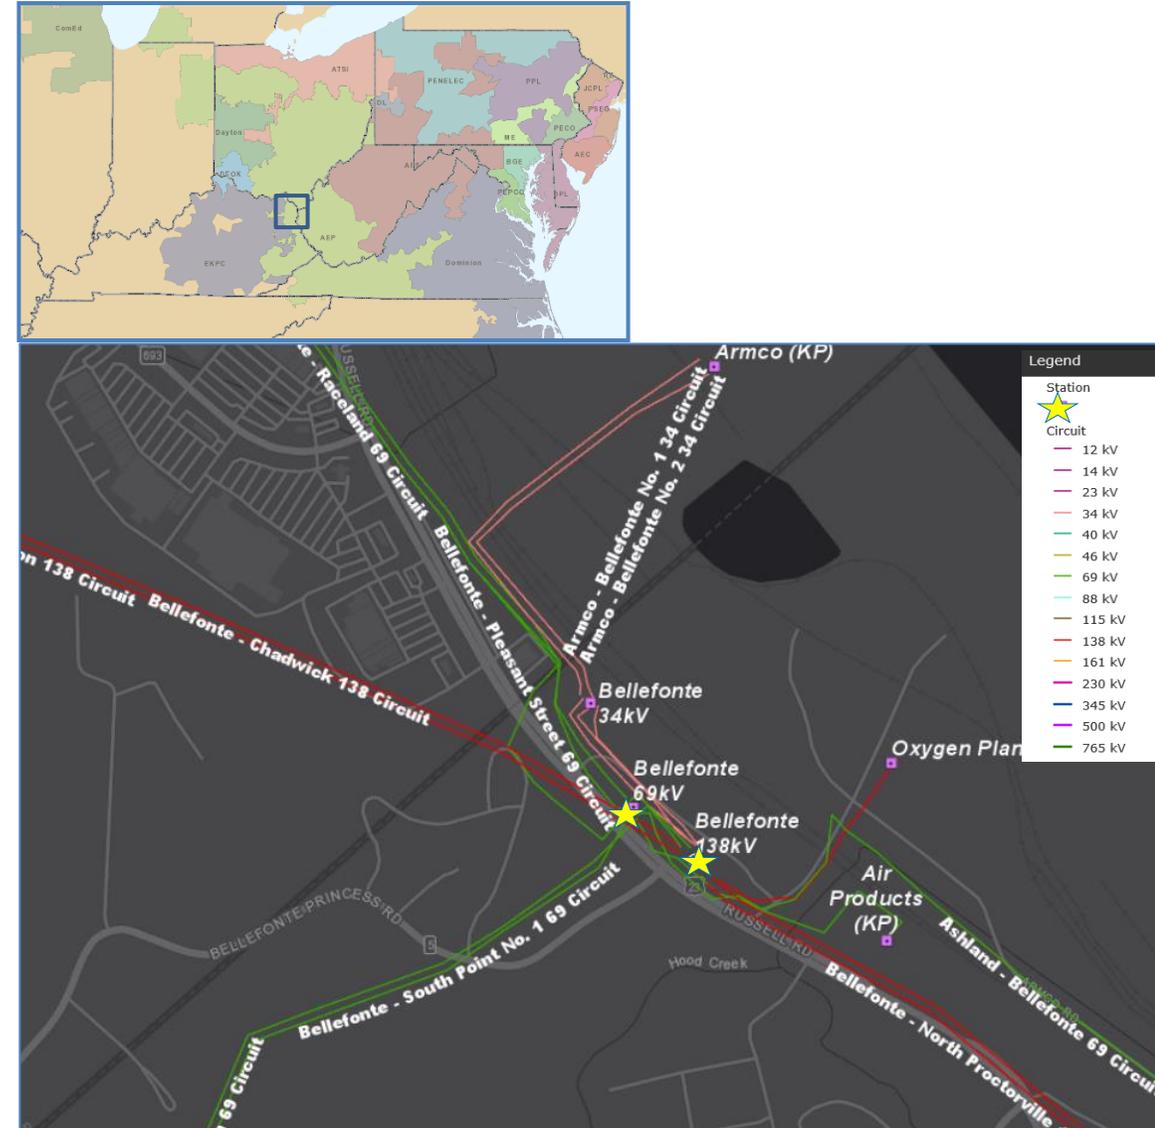
## Bellefonte 69kV Yard:

- Bus Tie Breaker H: 1960s vintage, Manufactured in 1965, Type: Oil , Fault Ops: 3,
- Circuit Breaker T: 1960s vintage, Manufactured in 1967, Type: Oil , Fault Ops: 1,
- There is no vendor support for this family of circuit breakers and spare parts are increasingly more difficult to obtain.
- This model family has experienced major malfunctions associated with their OA-3 hydraulic mechanism, which includes low-pressure readings, hydraulic leaks, pump lockouts, and failure to shut off. These mechanism malfunctions have led to several failures to close and other types of mis-operations across the AEP fleet.

69kV circuit switcher KK is a Mark V type , without gas monitor. The neutral shift device is heavily corroded.

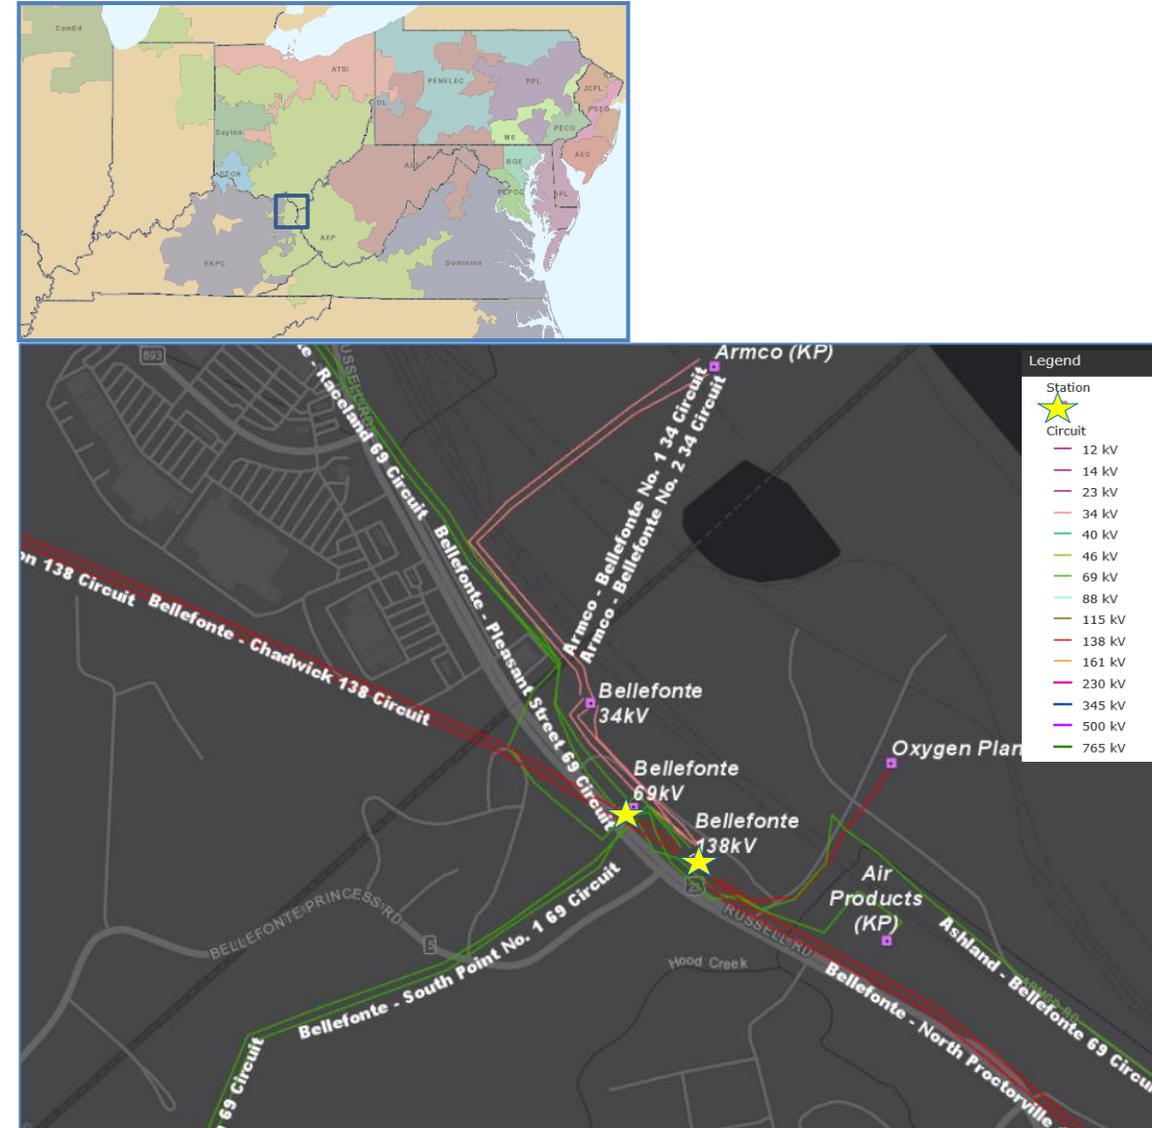
## Bellefonte 34kV Yard:

- Relaying:
  - 34 of the 34 relays at the station are in need of replacement
  - All 34 relays are electromechanical type which have significant limitations with regards to fault data collection and retention.

- The existing RTU installed at Bellefonte 34.5kV Metering Station is a legacy TLG DOS unit which has high failure and malfunction rates, lacks telecom infrastructure compatibility, lacks software compatibility, lacks vendor support, lacks spare parts availability, lacks vendor supplied training, lacks an active warranty, and has poor RTU resource utilization. This particular unit has experienced 5 recorded malfunction over its in-service life including loss of communication and being down.

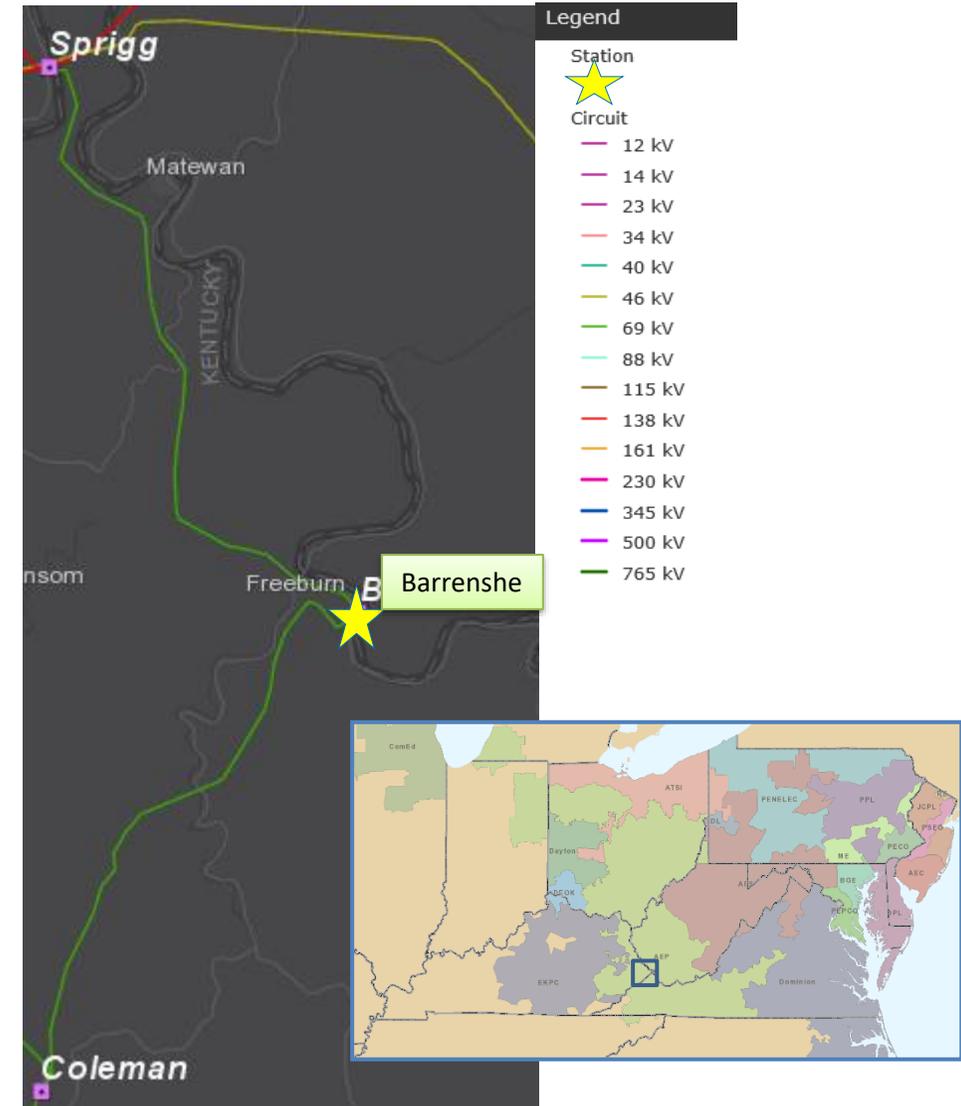
- All 15 relays at Barrenshe station are in need of replacement. There are 11 electromechanical relays which have significant limitations with regards to fault data collection and retention. These relays lack vendor support and have little to no access to spare parts. Also, the remaining 4 microprocessor relays were commissioned from 2006-2007 and are at the end of their useful life.

- The station bay was constructed using wood poles that were installed in 1953. The poles are very rotten and there is concern that any type of stress on the poles could cause the station to fail completely. The poles closest to the transformer are leaning and have twisted the bus.

- In 1977, flood waters were over 3/4 up the control cabinet. There has been repeated wash out in the rear of the station causing the fence post foundations to wash away. The station lies in the 100 year flood plain between mountainous terrain and highway 194 making expansion at the existing site extremely difficult.

- 69 kV MOAB W is 1973 vintage and needs replaced due to wear and lack of available parts.

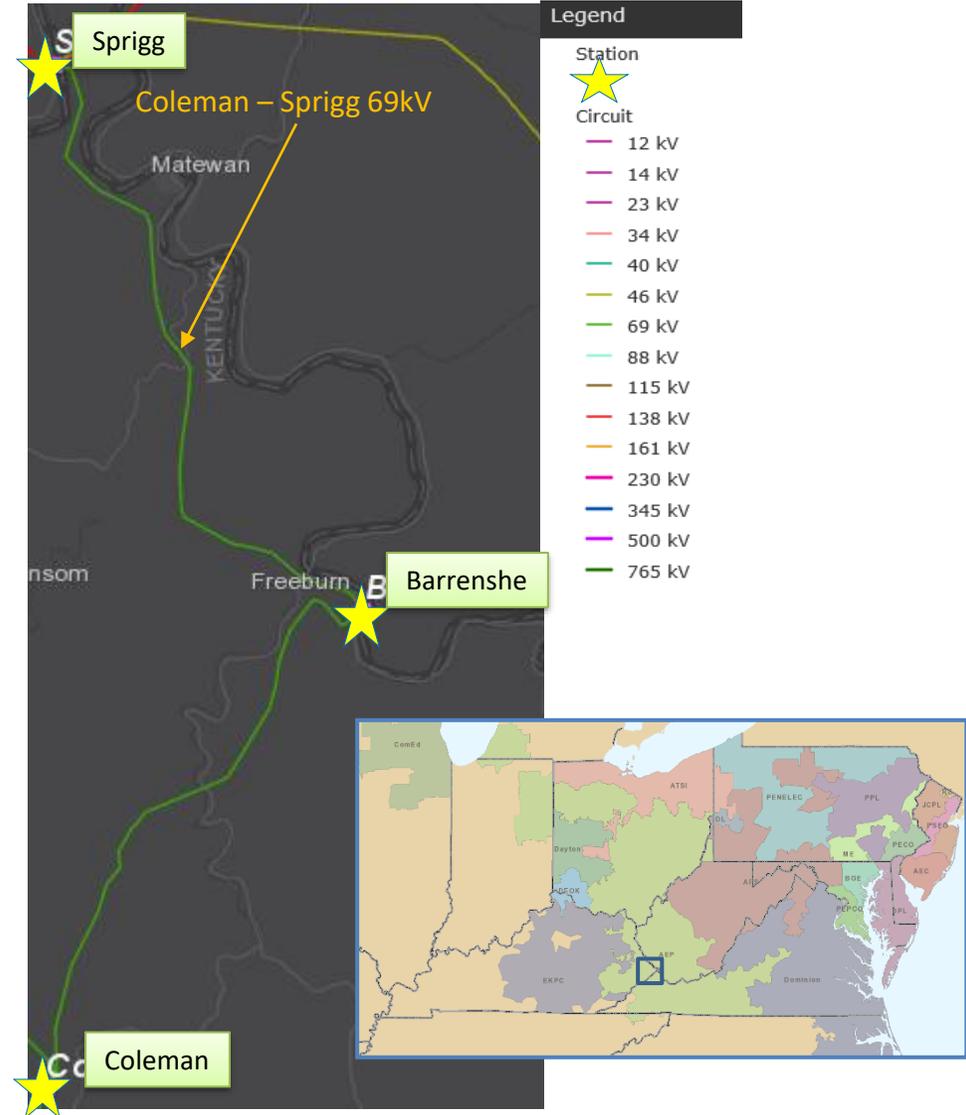
Line Conditions:

- The 10 permanent outages caused 2.6M minutes of interruption for distribution customers
- The line structures fail to meet 2017 NESC Grade B loading criteria, current AEP structural strength requirements, and the current ASCE structural strength requirements.

- Currently, there are 44 structures with at least one open condition, which relates to 43% of the structures on the circuit specifically affecting the crossarm, knee/ vee brace, or pole including rot, damaged, insect damage, and bowed conditions.

- 39 of 101 (39%) structures are 1920s vintage
- 53 of 101 (52%) are 1970s vintage. The Barrenshe – Coleman segment was rebuilt in the early 1970s. On the Sprigg – Barrenshe segment, 17 structures were also rebuilt in the 1970s. These 1970s structures are also showing signs of pole cracking, weathering, rot, and woodpecker damage. The crossarms and braces show signs of mold as well as signs of rot, cracking, splitting, bowing, and weathering.

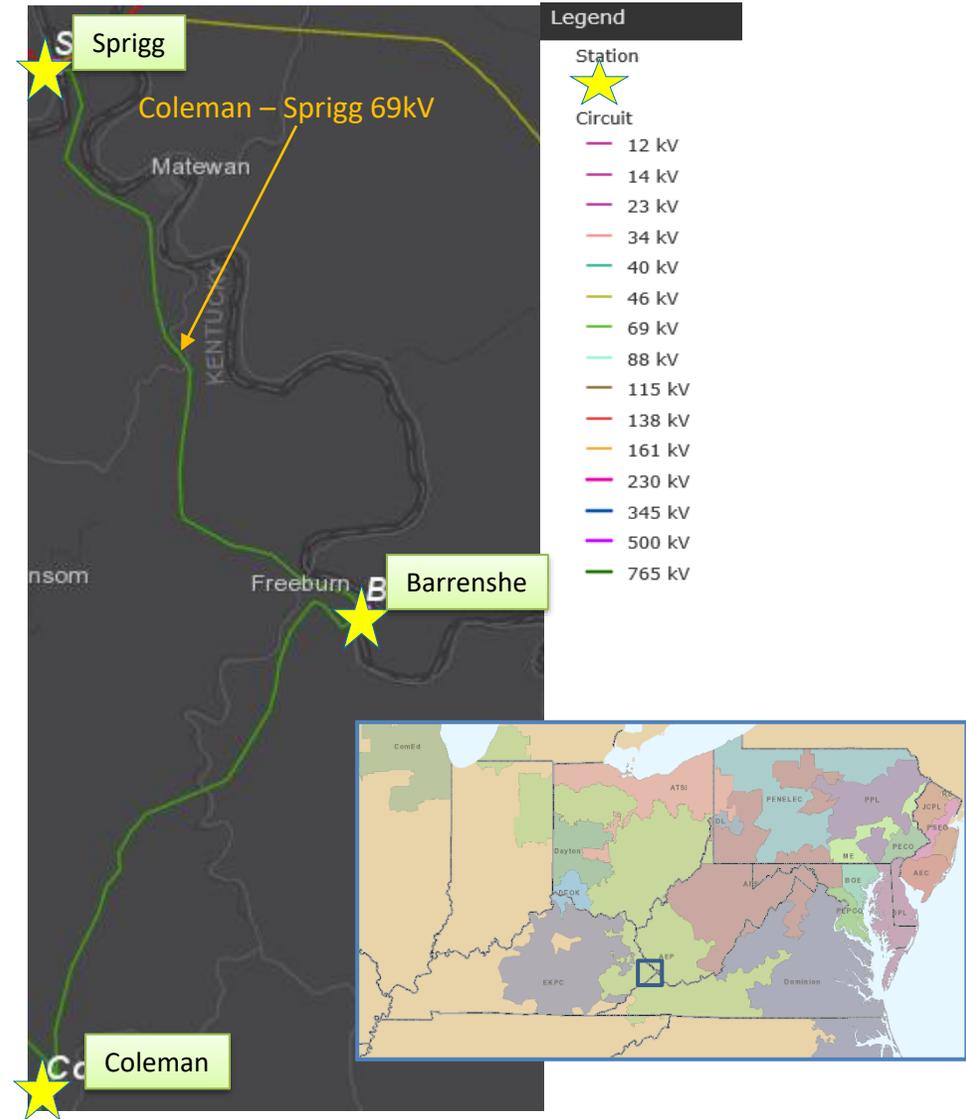
Line Conditions Con't:

- The 4-bell porcelain insulators on the line do not meet current AEP standards for CIFO and minimum leakage distance requirements.
- There is no shielding present on the Sprigg – Barrenshe segment, which is inadequate for AEP's current shielding requirements and leads to poor lightning performance for the circuit.

- The butt wrap grounding is inadequate per current AEP Standards and causes poor lightning performance. The current grounding system, poor shielding angle, and the electrical strength of the insulators do not meet current AEP and industry accepted criteria, making the line susceptible momentary and permanent outages, affecting customer reliability.

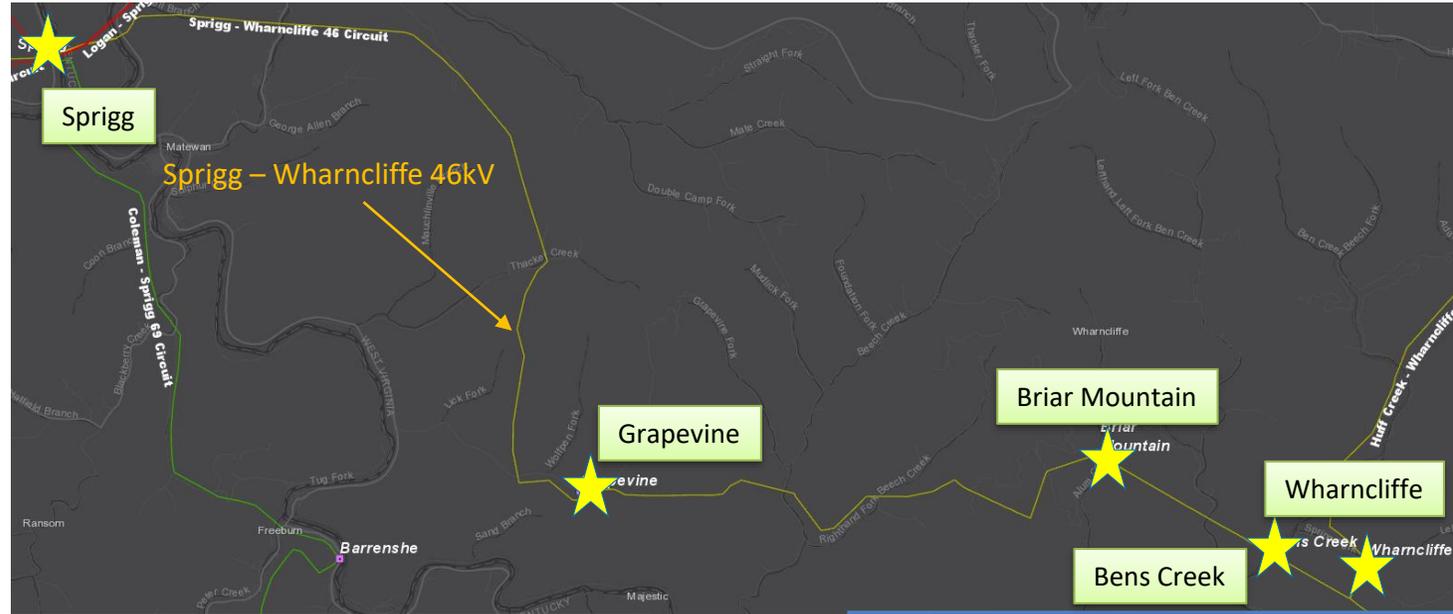
Line Conditions:

- The 10 permanent outages caused 481k minutes of interruption for distribution customers
- The line structures fail to meet 2017 NESC Grade B loading criteria, current AEP structural strength requirements, and the current ASCE structural strength requirements.

- Currently, there are 39 structures with at least one open condition, which relates to 33% of the structures on the circuit specifically affecting the crossarm, knee/ vee brace, or pole including rot, damaged, insect damage, woodpecker holes, and bowed conditions.

- 32 of the 120 structures are 1930s vintage or older accounting for 27% of the structures. Another 33 of the 120 structures are split almost evenly between 1940s, 50s, and 60s vintage, accounting for 28% of the structures. An additional 22 of 120 structures are spread between the 1970s and 90s (18%). The described structures, including 11% more are all wood structures, with only 16% of the line made up of steel structures.

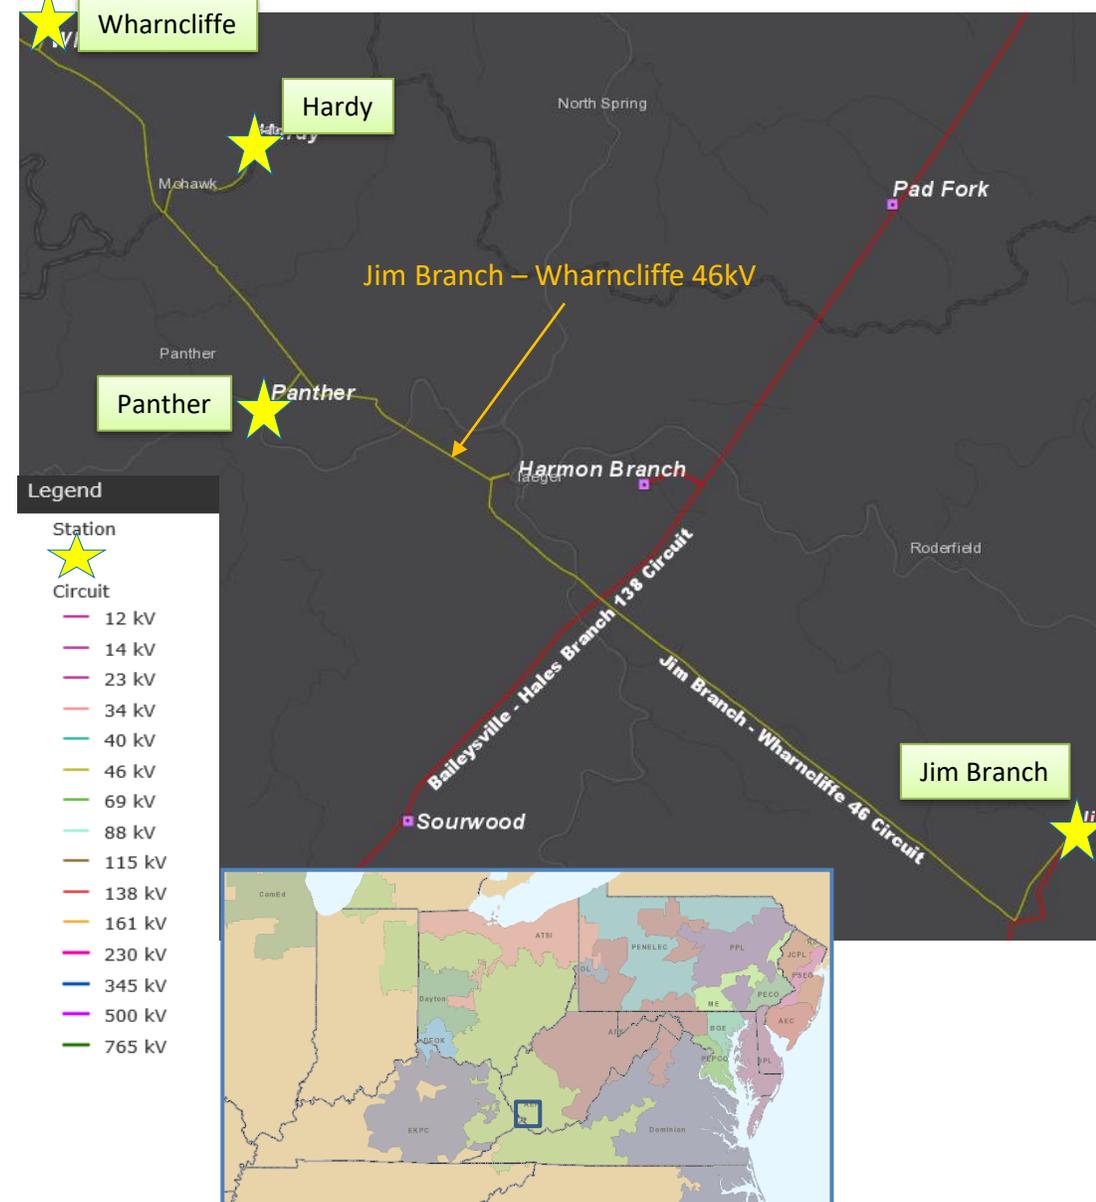
Line Conditions:

- The momentary outages were attributed to lightning (24), wind (3), relay mis-operation (1), unknown (1), and distribution (1) causes. The permanent outages attributed to vegetation contacts from outside the AEP ROW (12), lightning (4), pole failure (1), failed insulator (1), ice/snow (1), and relay mis-operation (1) causes. The large number of lightning caused outages is due to 65% of the circuit lacking shield wire.

- The permanent outages caused 2.62M minutes of interruption for 11,744 customers at Panther and Hardy substations.
- The line structures fail to meet 2017 NESC Grade B loading criteria, current AEP structural strength requirements, and the current ASCE structural strength requirements.

- 134 of the 162 structures are 1930s vintage or older accounting for 83% of the structures. These structures have conditions like top rot, Woodpecker damage, split top, heart rot, base rot, bowing, and corroded hardware.

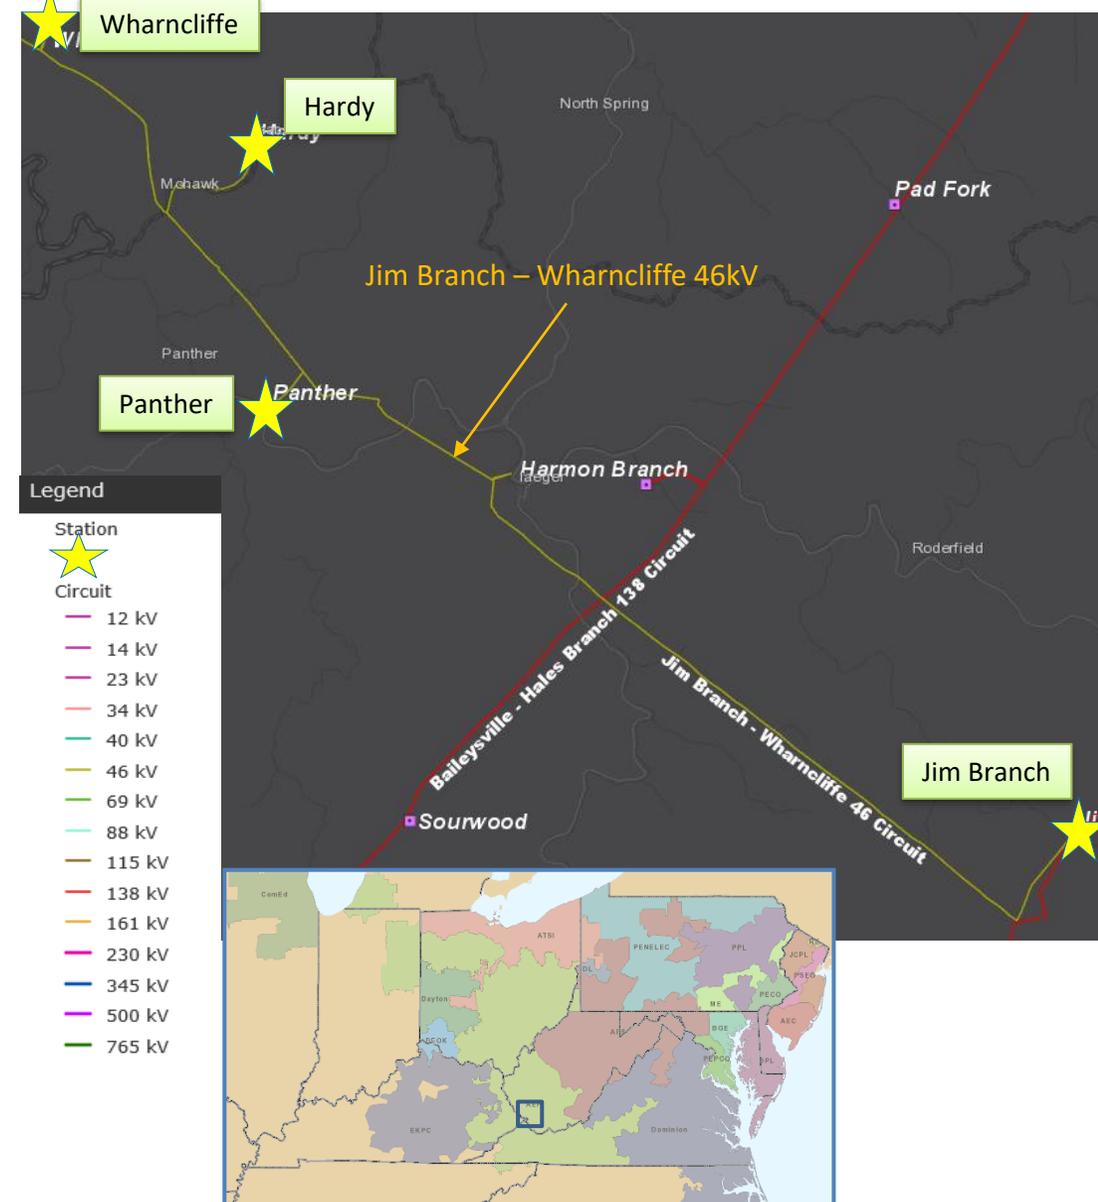
Line Conditions Con't:

- The majority of the line has no static wire, making it inadequate for AEP current shielding angle requirements.
- The butt wrap grounding and typical shield angle is inadequate per current AEP Standards and can cause poor lightning performance. The current grounding system, poor shielding angle, and the electrical strength of the insulators do not meet current AEP and industry accepted criteria, making the line susceptible momentary and permanent outages, affecting customer reliability.

- The inadequate grounding limits the available path to ground during any type of line fault, increasing the intensity the conductor and related hardware have to withstand during the fault. The reduced electrical strength of the insulators could lead to electrical damage to structures and hardware during a fault if the insulator were to fail from elevated electrical stresses.

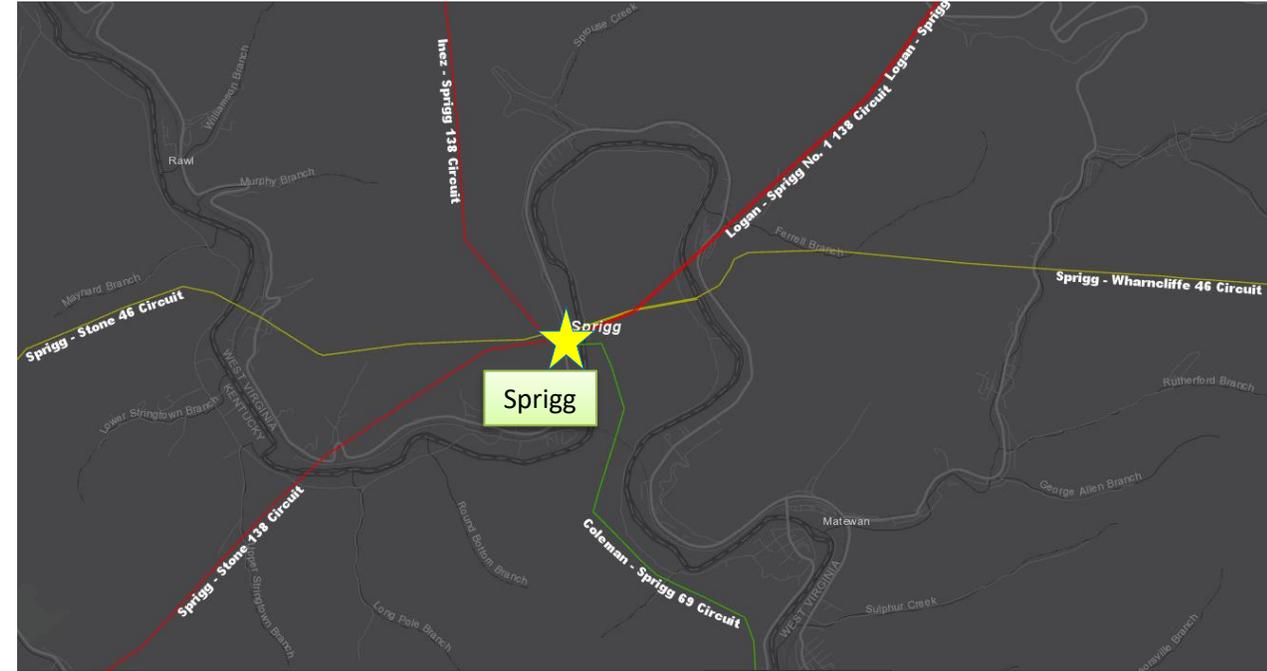
- 1971 Vintage Transformer
- The presence of Ethane, along with the indication of overheating faults, indicates decomposition of the paper insulation that impairs the unit's ability to withstand future short circuit or through fault events.
- The dielectric is driven by the upward trend in insulation power factor, which indicates an increase in particles within the oil.
- The transformer has elevated moisture levels that are a result of gasket leaks or breakdown in oil or paper/pressboard insulation.

- 1972 Vintage Transformer
- The elevated levels of Acetylene indicate increased decomposition of the paper insulating materials. The dielectric is driven by the upward trend in insulation power factor, which indicates an increase in particles within the oil.
- The transformer has elevated moisture levels that are a result of gasket leaks or breakdown in oil or paper/pressboard insulation.

- There are 82 electromechanical and 3 static relays which have significant limitations with regards to fault data collection and retention. These relays lack vendor support and have little to no access to spare parts.

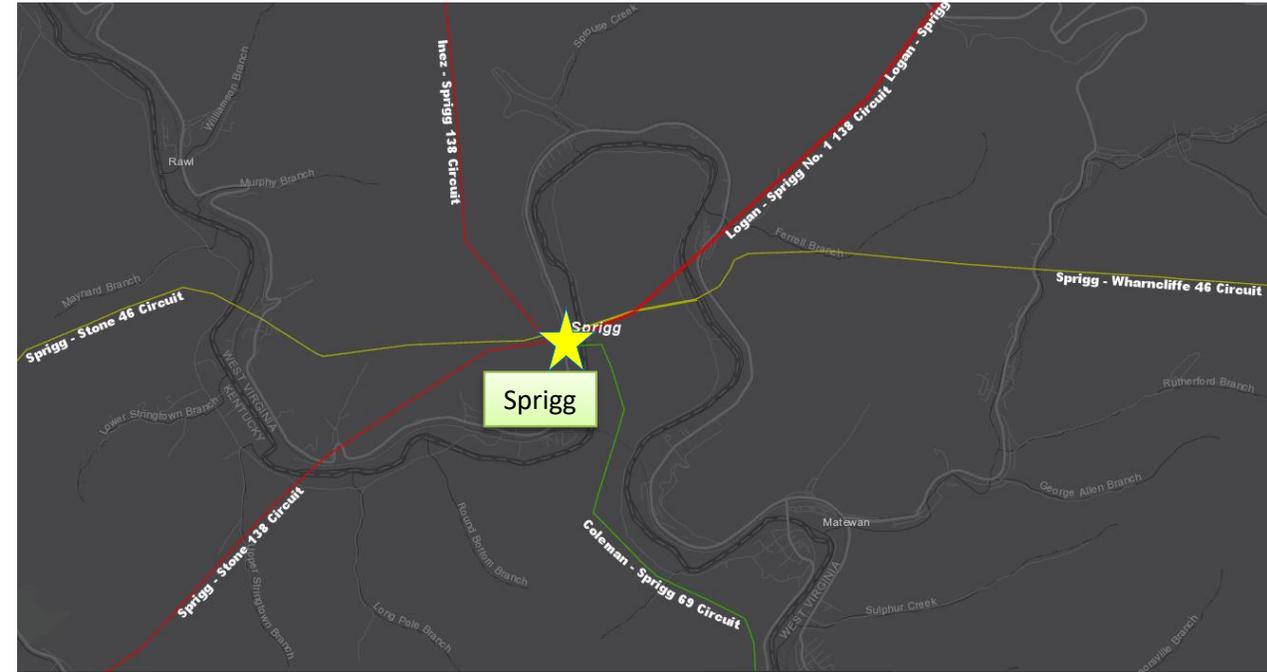
- A, B, C, and D are 1987 vintage and S is 1990 vintage SF6 filled circuit breakers.
- The manufacturer provides no support for these types of breakers and there are no spare parts available for these breakers.
- Circuit Breaker A, B, C, & D, have each exceeded the manufacturer’s recommended number of fault operations. Circuit Breaker S has experienced 6 low gas level malfunctions since December 2013. The age of the seals are causing the SF6 leaks to happen more frequently.

- Circuit breaker H is 1960 vintage and N and T are 1972 vintage with all being oil filled without containment. The manufacturer provides no support for this fleet of circuit breakers and spare parts are not available. The breakers have oil contamination from aging gaskets allowing moisture and other particles to ingress.
- Circuit Breaker H, N and T have each exceeded the manufacturer’s recommended number of fault operations.

- The Station and Control House has experienced many floods in the past (1957, 1963, 1977 and 2002).
- Foundations are crumbling in the 46kV yard and the 138kV yard.

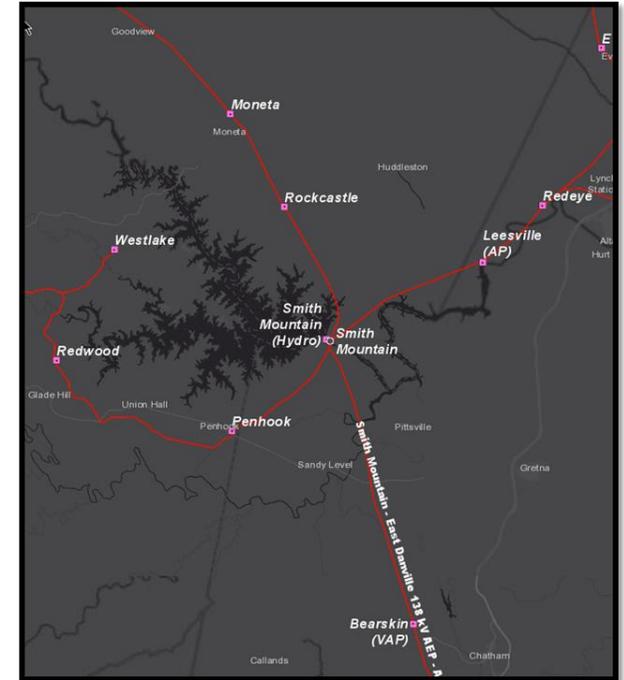
- **138 kV Circuit Breakers (A, A1, A2, B, B1, B2, C, C1, C2, and D2)**
  - Smith Mountain Station has ten 138 kV transmission owned circuit breakers (A, A1, A2, B, B1, B2, C, C1, C2, and D2) which are HVB145 type, SF6 filled breakers. These breakers are of 1990's or 2000's vintage. Most of these circuit breakers (A, A2, B, B2, C, C1, C2, and D2) have exceeded the manufacturer's recommended number of fault operations.

- The HVB145 model family has the propensity to mechanically pump close instead of locking open as it awaits an electrical close command from the relaying. This presents a high mis-operation risk on the system. The mechanisms have been a significant source of trouble during recent cold weather events. Also, this model family has a high occurrence of SF6 gas leaks.

- **Operational flexibility**
  - Currently, hydro generators #1 and #5 are connected directly to the 138 kV Bus #2 via a motor operated air-break switch (MOAB). Today, 138 kV breakers A2, B2, C2 and D2 are required to operate until the MOAB is able to sectionalize the fault. Every time Generation needs to be isolated by the 138kV MOAB X2, 138 kV Bus #2 must have a momentary outage to allow the MOAB to be opened.

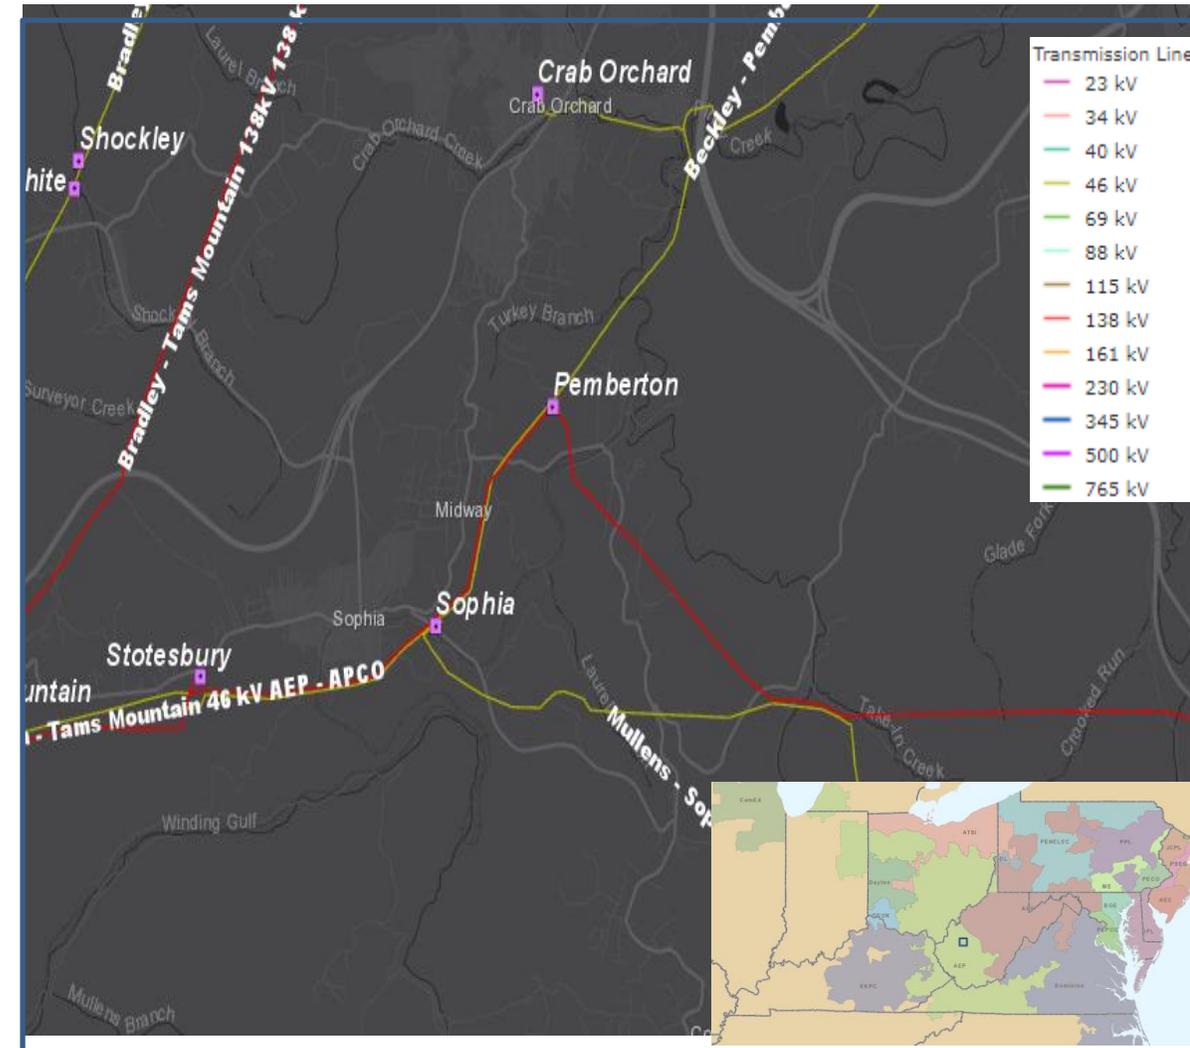
- These breakers have exceeded the manufacturer’s recommended number of fault operations
  - The manufacturer does not provide support for this type of breaker and spare parts are not available.

- Cooling controls, cooling fans and internal wiring are obsolete and in need of replacement
  - No secondary oil containment installed on the unit
- 11 of the 25 relays at the station are in need of replacement

- 4 relays are electromechanical type which have significant limitations with regards to fault data collection and retention.
  - 7 microprocessor relays with legacy firmware

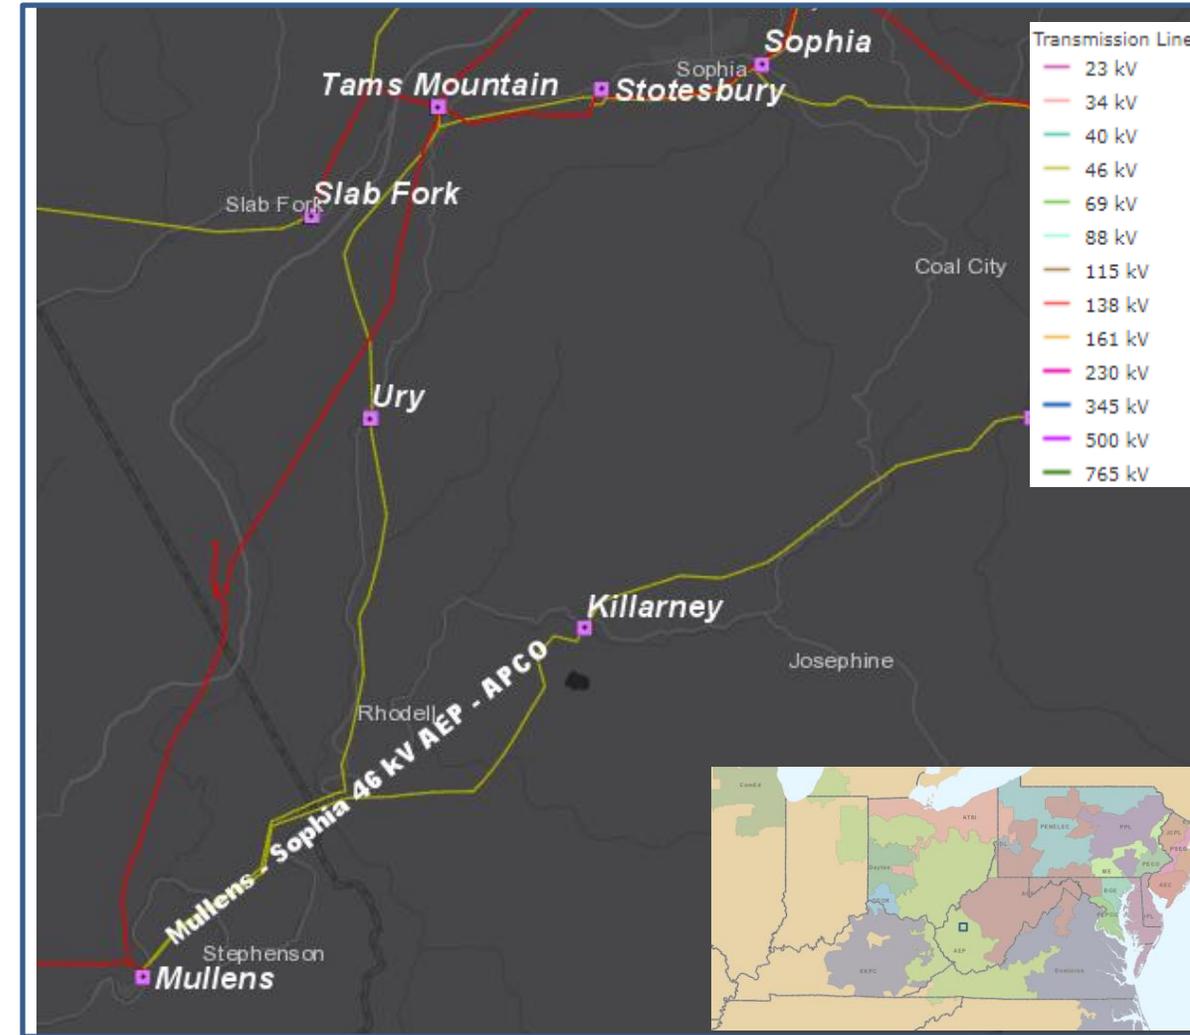
Sophia Station

- 46kV circuit breakers B, C and D are FK type oil filled breaker, without oil containment.
  - 1965 vintage
  - Oil filled breakers need more maintenance due to the oil handling required
  - These breakers have exceeded the manufacturer’s recommended number of fault operations
  - The manufacturer does not provide support for this type of breaker and spare parts are not available.
  - Oil spills can result in significant mitigation costs.
- 23 of the 33 relays at the station are in need of replacement
  - 16 relays are electromechanical type which have significant limitations with regards to fault data collection and retention.
  - 7 microprocessor relays with unsupported firmware.

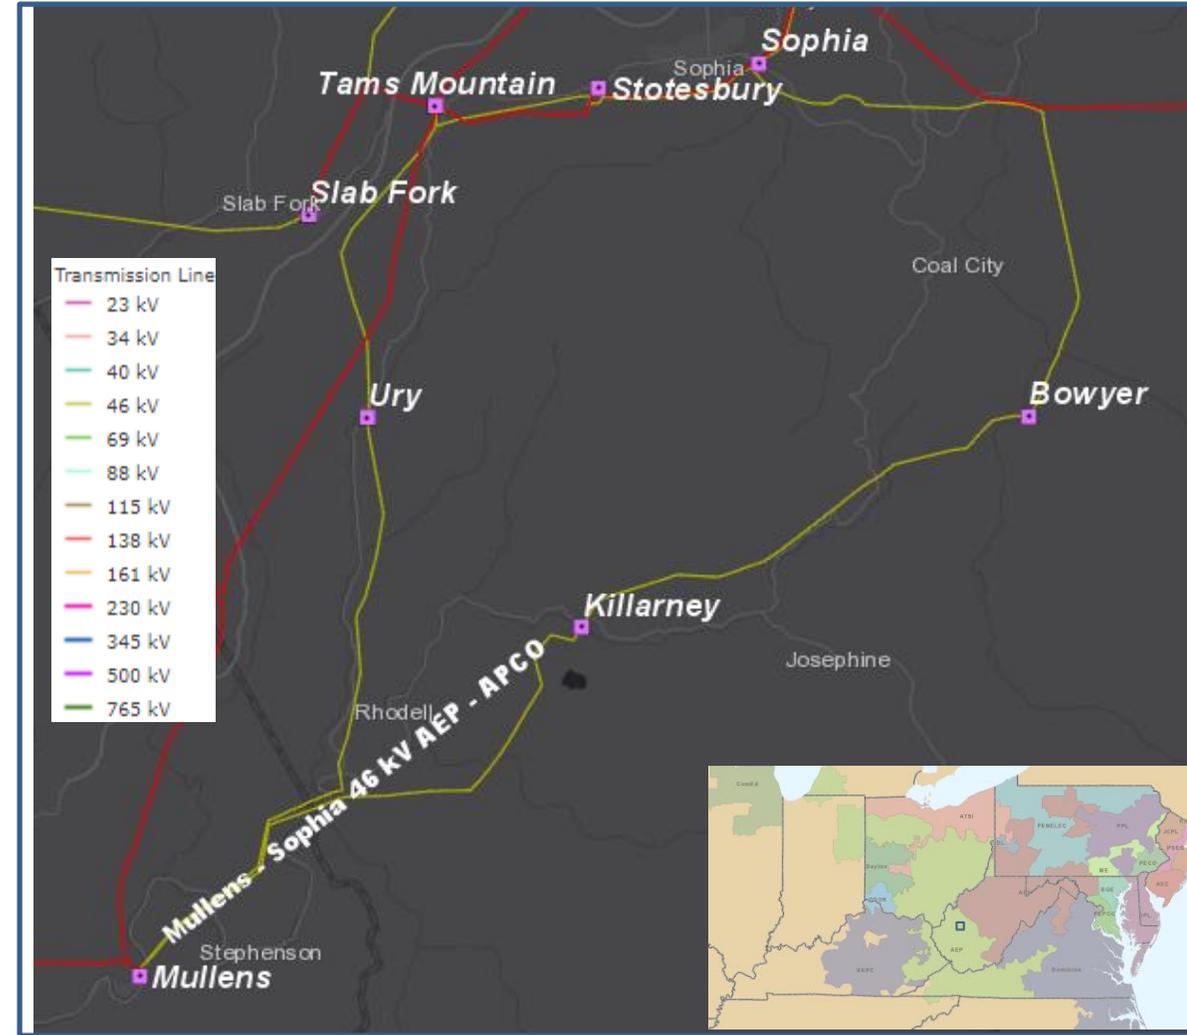
- **Broken Insulators:** Broken, cracked and otherwise damaged insulators lead to premature flashover causing permanent outages. When the insulator assembly breaks, the wire falls to the ground potentially damaging other conductors, and presents an increased public safety concern.

- **Conductor:** Aluminum Conductor Steel Reinforced (ACSR) conductor consists of aluminum strands wrapped around a core of galvanized steel strands. The steel provides the structural strength. Like other steel elements, the strands of the core have also lost the galvanized coating and steel section. The degraded state results in significant loss of tensile strength and potential risk to the public if the conductor was to fail and fall to the ground. Conductor damage is usually not visible in a field inspection. Specific conductor samples, from the belly of the sag (lowest point) and/or inside the clamps at the insulators, have confirmed significant corrosion. During the restoration or construction activities, conductors often break at adjacent locations due to handling, introducing a potential safety risk and increase public safety concern.

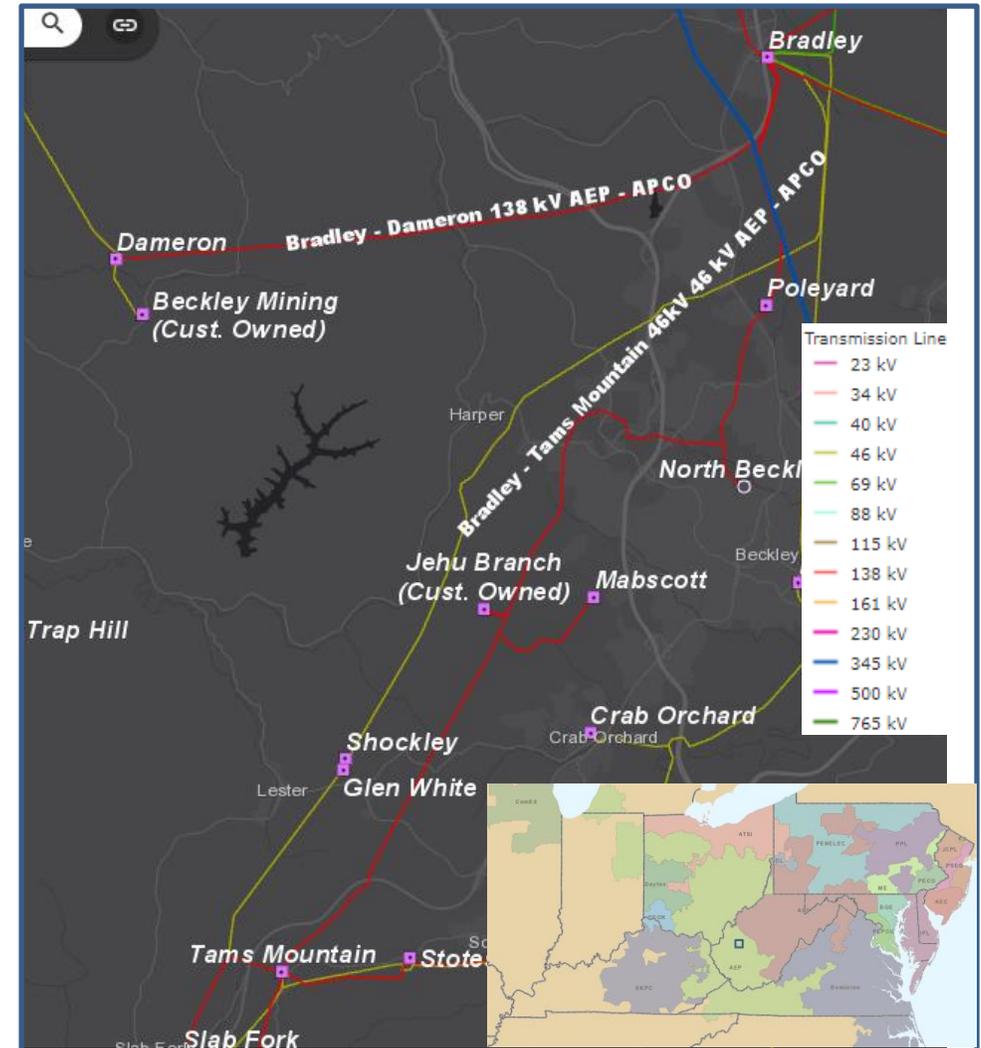
Bradley – Tams Mountain 46 kV (~15 miles)

- Originally constructed in 1920
- Consists primarily of wood pole structures of 1920 (42%), 1950s (13%) and 2002 (20%) vintages
- Conductor consists primarily of 1920 #2 Copper, 336 ACSR, 4/0 ACSR, and 3/0 ACSR
- Since 2015, there have been 13 momentary and 13 permanent outages on the Bradley – Tams Mountain 46 kV circuit.
  - Momentary outages due to lightning, wind, ice/snow, distribution and wind
  - Permanent outages due to vegetation fall-in outside AEP ROW, lightning, ice/snow, non-AEP tree removal, splice failure and vandalism
  - Outages resulted in a total of 980k CMI
- Currently there are 30 structures (19% of the line) with at least one open condition
  - 64 Open conditions affecting poles, crossarms, knee braces, woodpecker holes, insect damage, rot
  - 4 hardware conditions related to broken insulators
