# Sub Regional RTEP Committee: Western AEP Supplemental Projects

February 18, 2022

# AEP Transmission Zone M-3 Process Johnson County, Kentucky

**Need Number:** AEP-2022-AP004

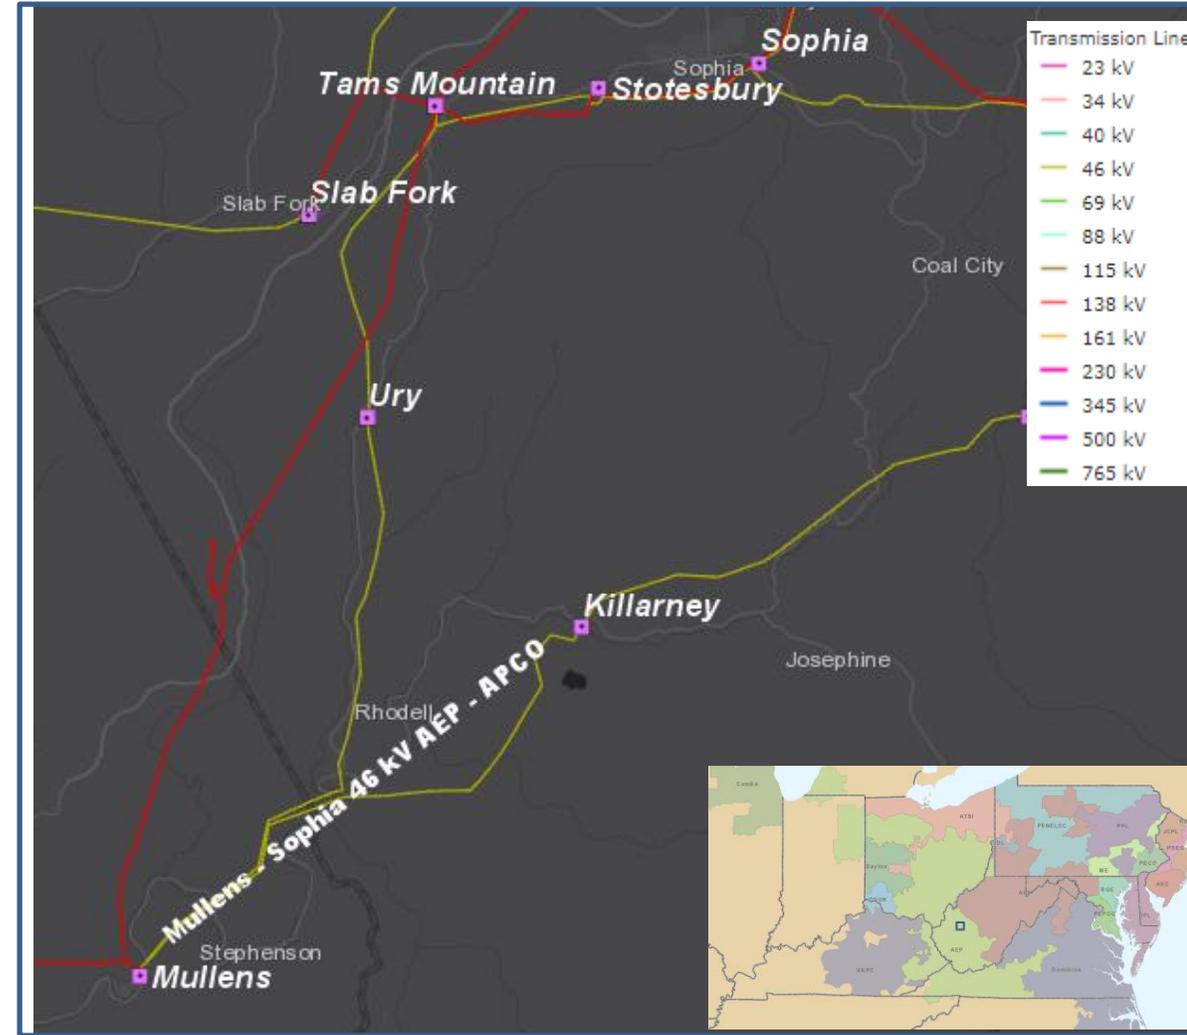
- Originally constructed in 1915
- Consists of 1915 vintage wood (65%) and steel lattice structures (33%)
- Conductor consists of 1915 vintage copper conductor and 556 ACSR
- Since 2014, there have been 2 momentary and 1 permanent outages on the Sophia – Tams Mountain 46 kV circuit.
  - Momentary outages due to ice/snow
  - Permanent outage due to lightning
- Currently there are 6 structures (15% of the line) with at least one open structural condition
  - 6 structural open conditions affecting pole, knee/vee brace and crossarms including corroded, broke, split and rot top

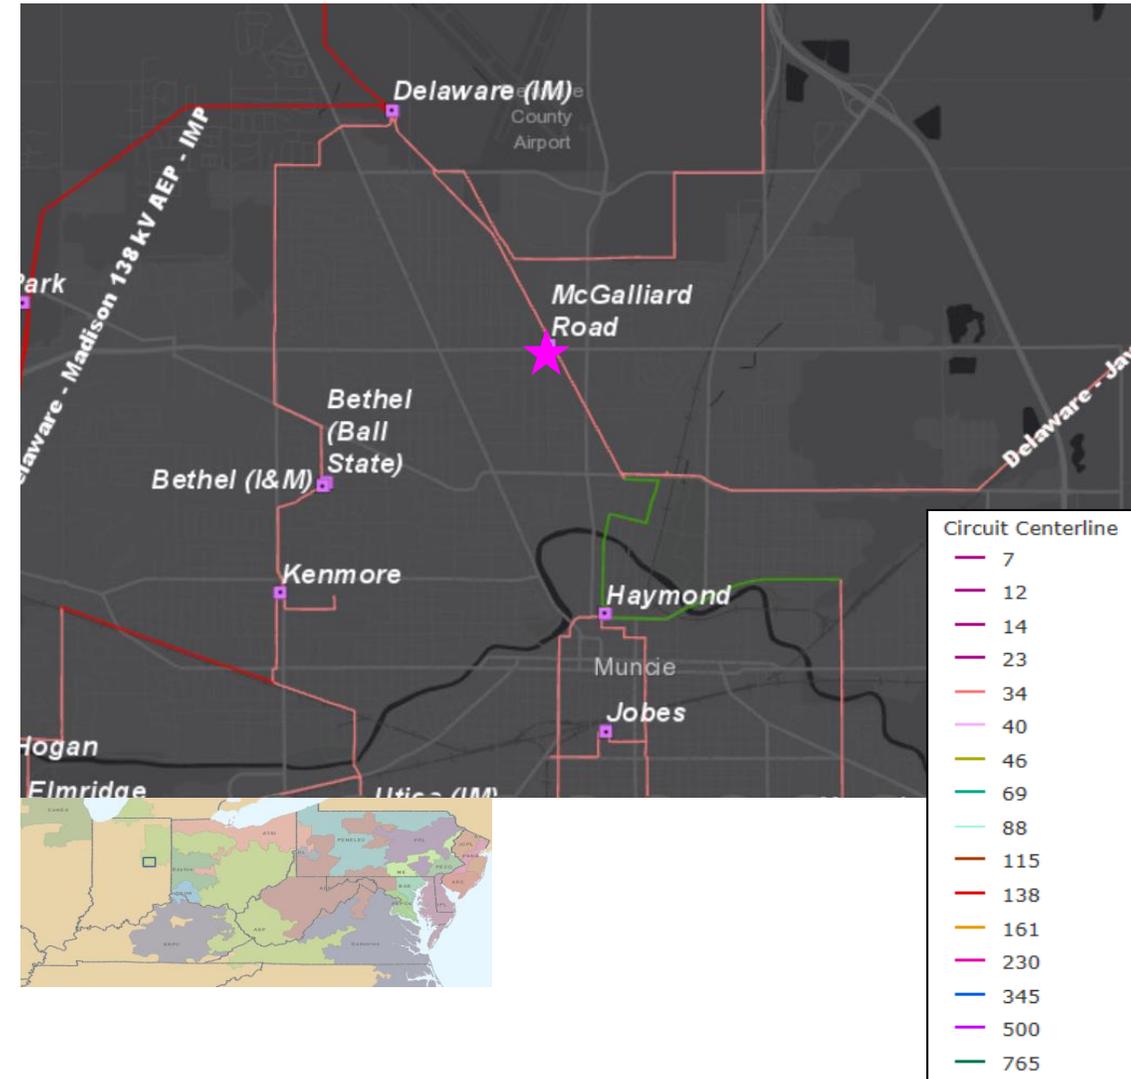
**McGalliard Road 34.5 kV:**

- The McGalliard Road 34.5 kV Moab switches “A” and “B” have Delta Star SF22 mechanisms that are no longer supported by the manufacturer
- Both switches are over 70 years old
- The 34.5 kV Moab “A” is a center break switch that is in a deteriorated condition and is no longer supported by the manufacturer
- The 34.5 kV Moab “B” is a vertical break switch that does not fully open and is in a deteriorated condition
- The structure foundations are in deteriorating condition
- Need on the switches was identified with Distribution concerns around 12kV equipment at the station

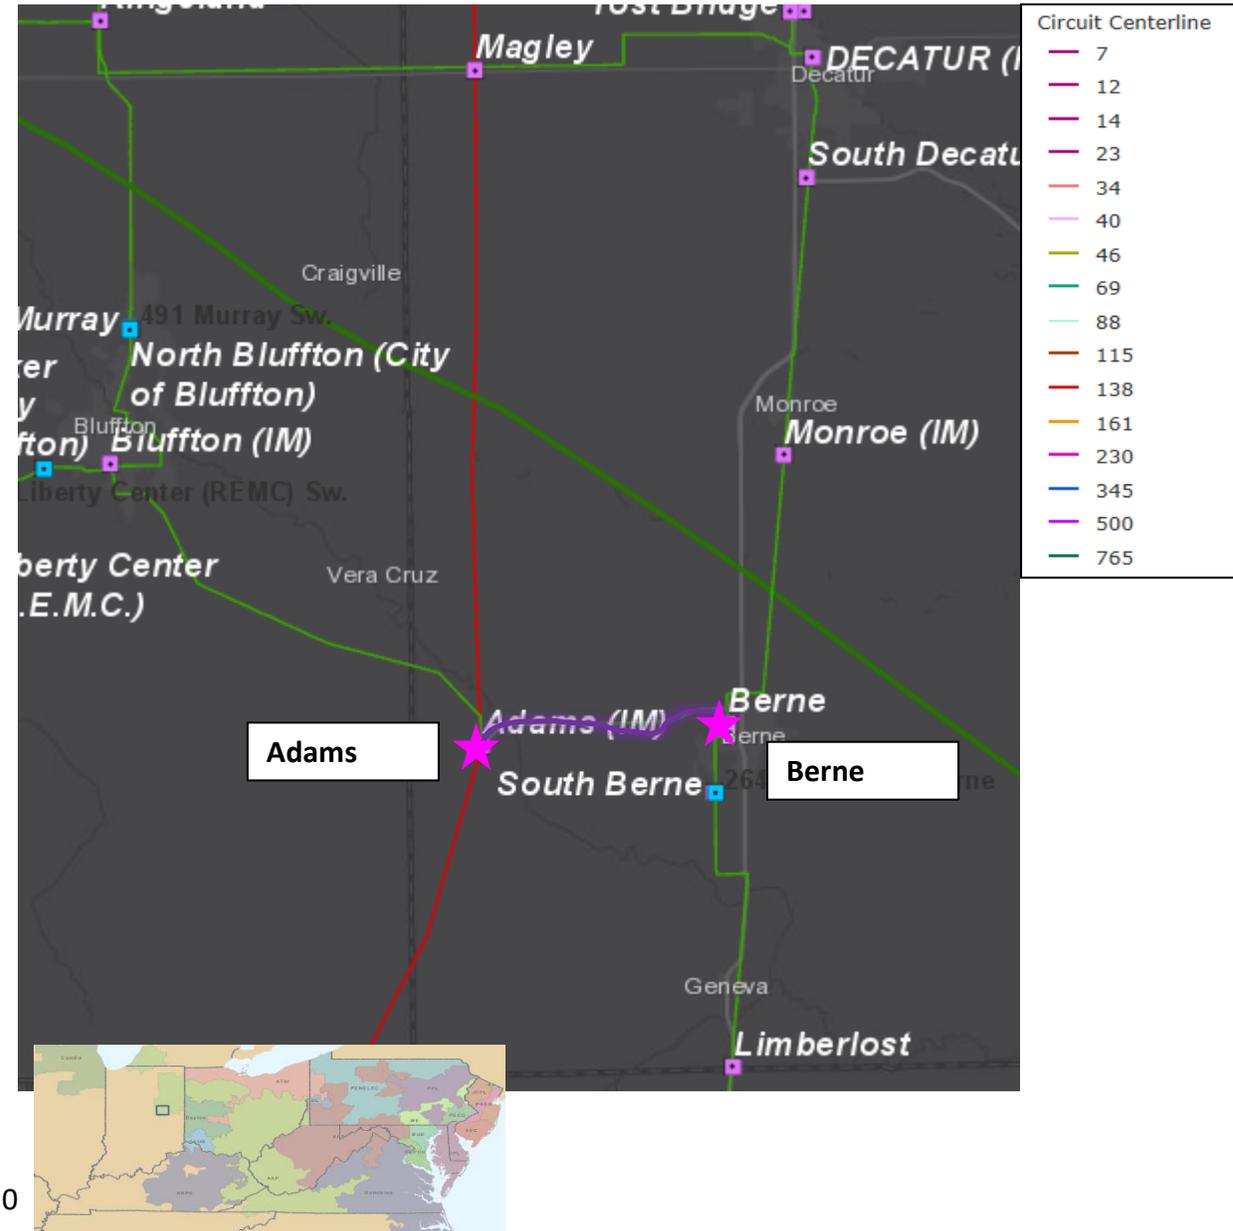
- Legacy brown porcelain horizontal line post insulators which are prone to base or cap separation failures.
- Conductor Type:
  - 556,500 CM ALUM/1350 19 Dahlia

- Condition Summary
  - Momentary outages: 2
  - Number of open conditions: 17 structure open conditions with 6 structure related open conditions.
    - Open conditions include X-brace, knee brace, pole insect damage, broken poles, pole rot conditions and missing ground lead wire.

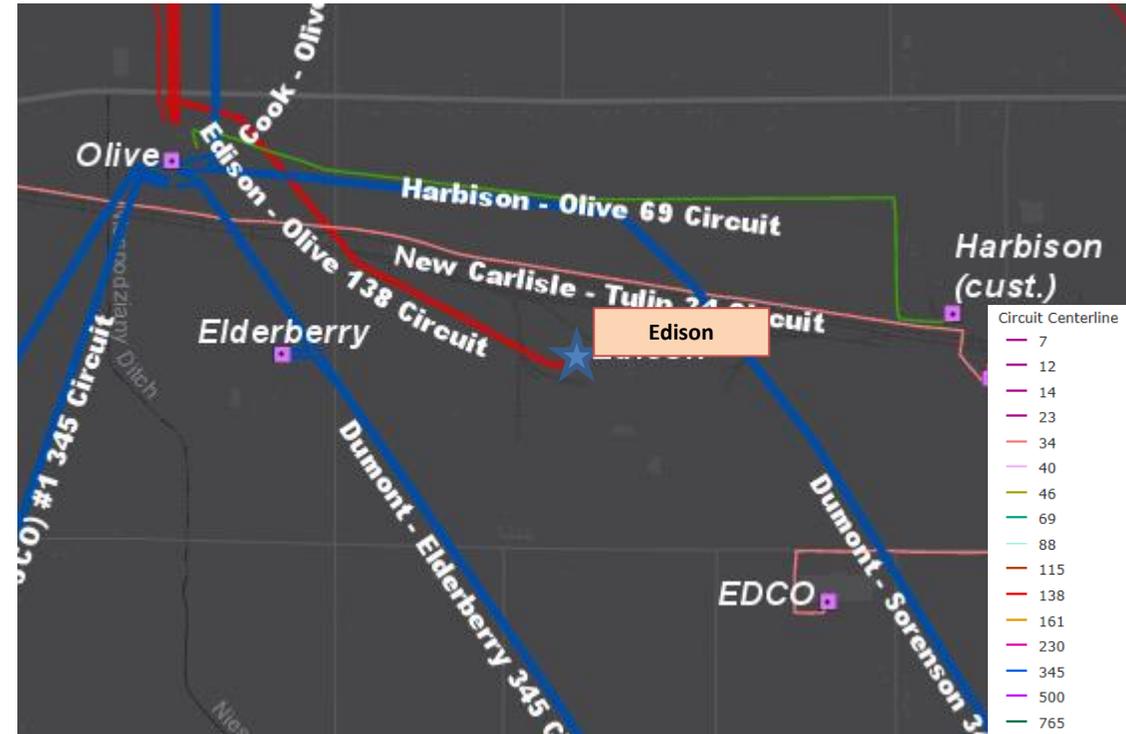
#### Edison 138kV

- Circuit breakers A, B, and C are 1988 138kV 145-PA type breakers.
  - As of May 11, 2020, there have been 437 recorded malfunctions of this 145-PA model family on the AEP System. The most common issues are related to loss of SF6 gas and mis-operations. The expected life of the bushing gaskets and door inspection port seals is 25 years; these units have reached this age. Seals that are no longer adequate cause SF6 leaks to become more frequent. SF6 leaks impact the environment. The manufacturer provides no support for this family of circuit breakers and spare parts are not available.
  - Circuit breaker C has experienced 12 fault operations, which is over the manufacturer's recommendation of 10

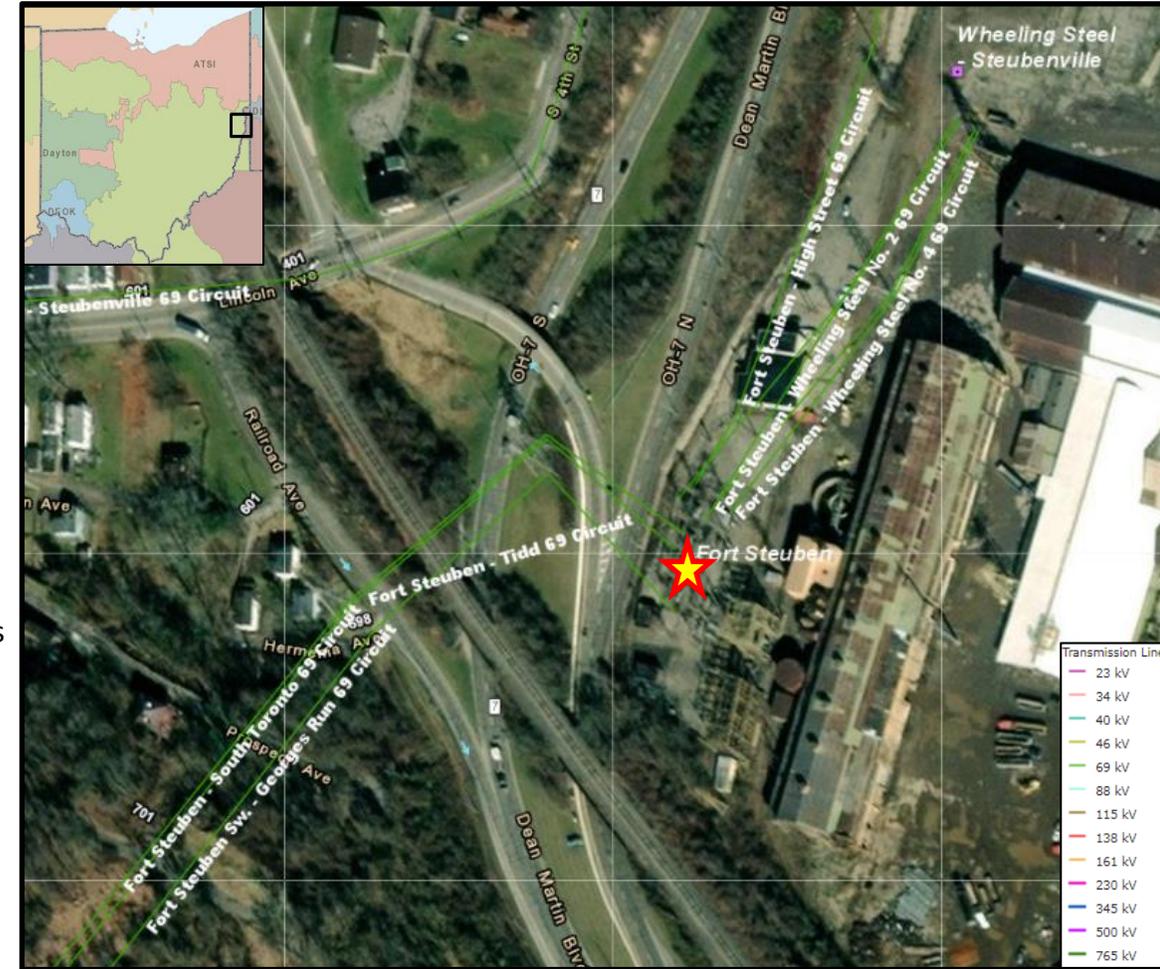
- Breaker Ages: (1975 A, B, C, D, & I)
- Fault Operations: B 13, C 71 (recommended manufacturers limit: 10)
- These breakers are oil filled FK-type without oil containment; oil filled breakers have much more maintenance required due to oil handling that their modern, SF6 counterparts do not require. The manufacturer provides no support for this fleet of circuit breakers and spare parts are not available.

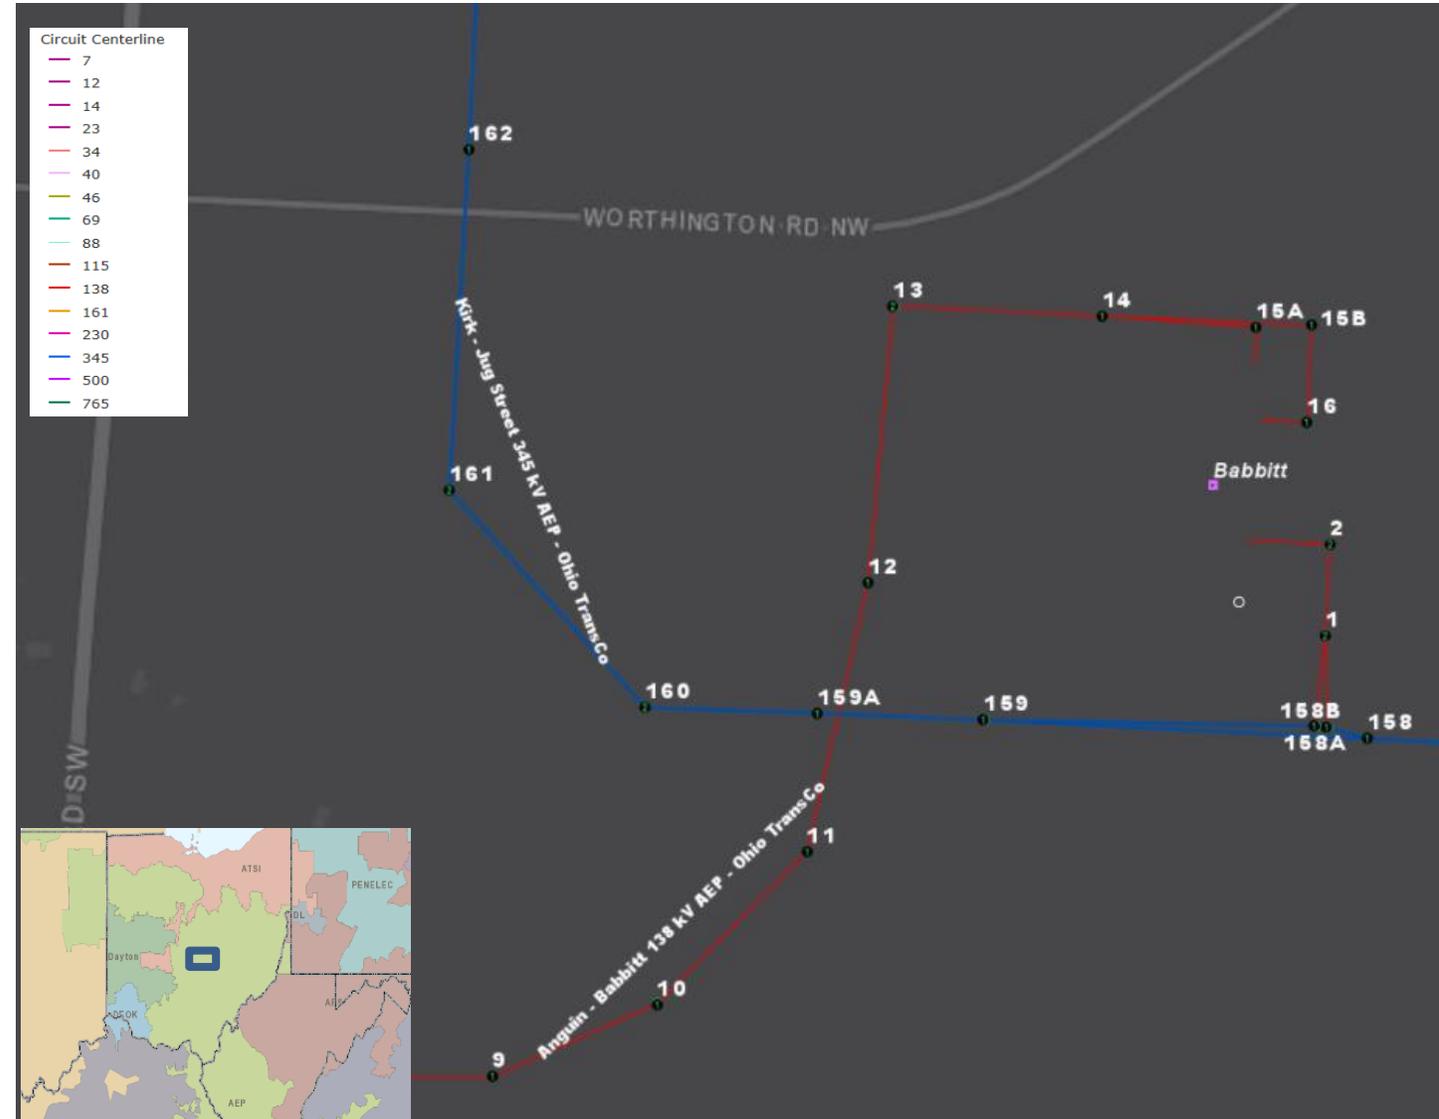
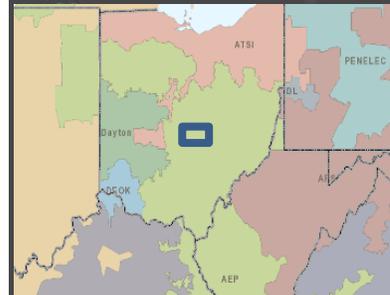
- AEP Ohio has requested a permanent capacity arrangement at Babbitt Station to replace the temporary skid station installed that is currently feeding long term load.
- **Model:** 2025 RTEP

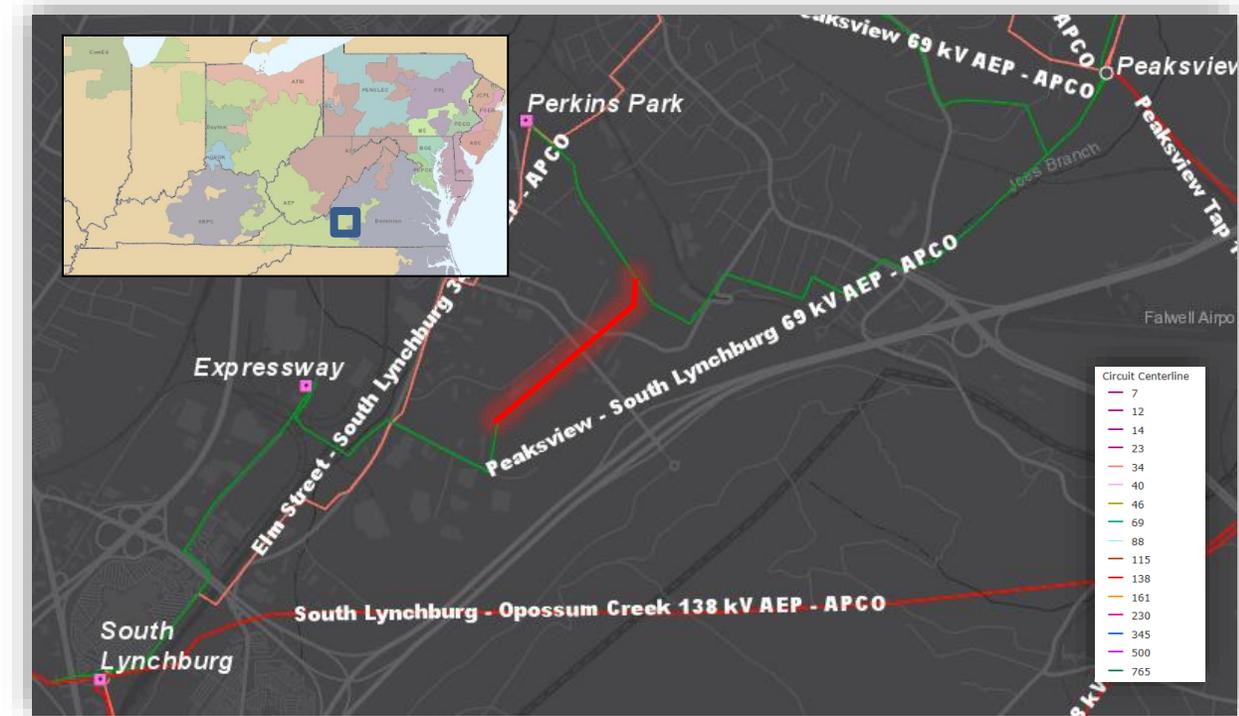
- 0.63 miles of 4/0 COPPER 7 conductor is 1938 vintage
- Structures 443-43 to 443-49 are all wood poles
  - Structure 48 is 2004 vintage
  - 1 of the 3 poles of Structure 443-49 is 2001 Vintage
- 2 Open Structural Conditions on this section (woodpecker damage and corroded cross-arms)

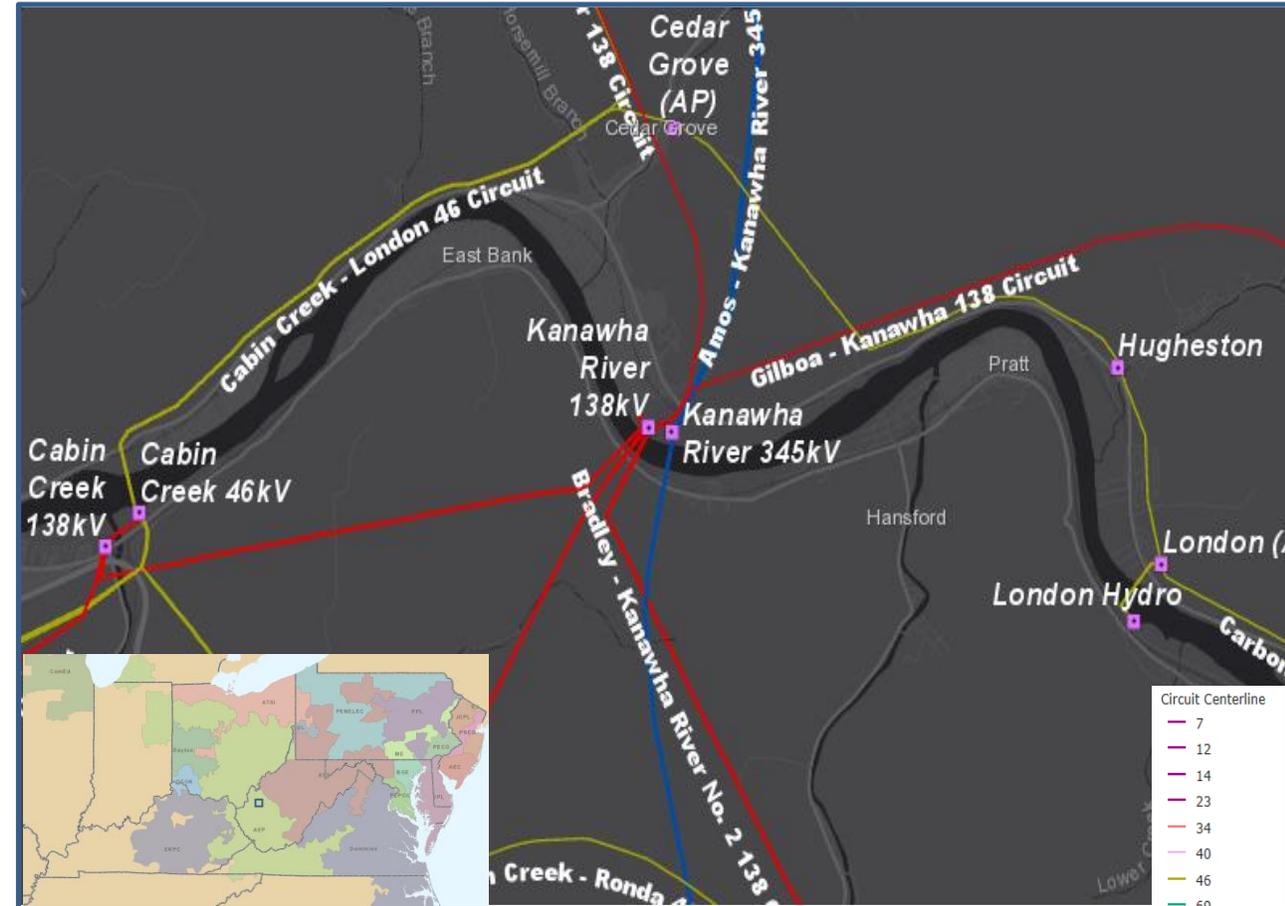
- 9 Structures with at least one open condition (7% of the line)
  - 13 structural conditions include rot top, insect damage, woodpecker holes, bent/damaged steel lacing

- 58 hardware conditions related to rusted/corroded shielding and conductor hardware, broken insulators and guys, worn/cracked conductor hardware
- Since 2014, there have been 9 momentary and 1 permanent outages on the Cabin Creek – London 46 kV circuit

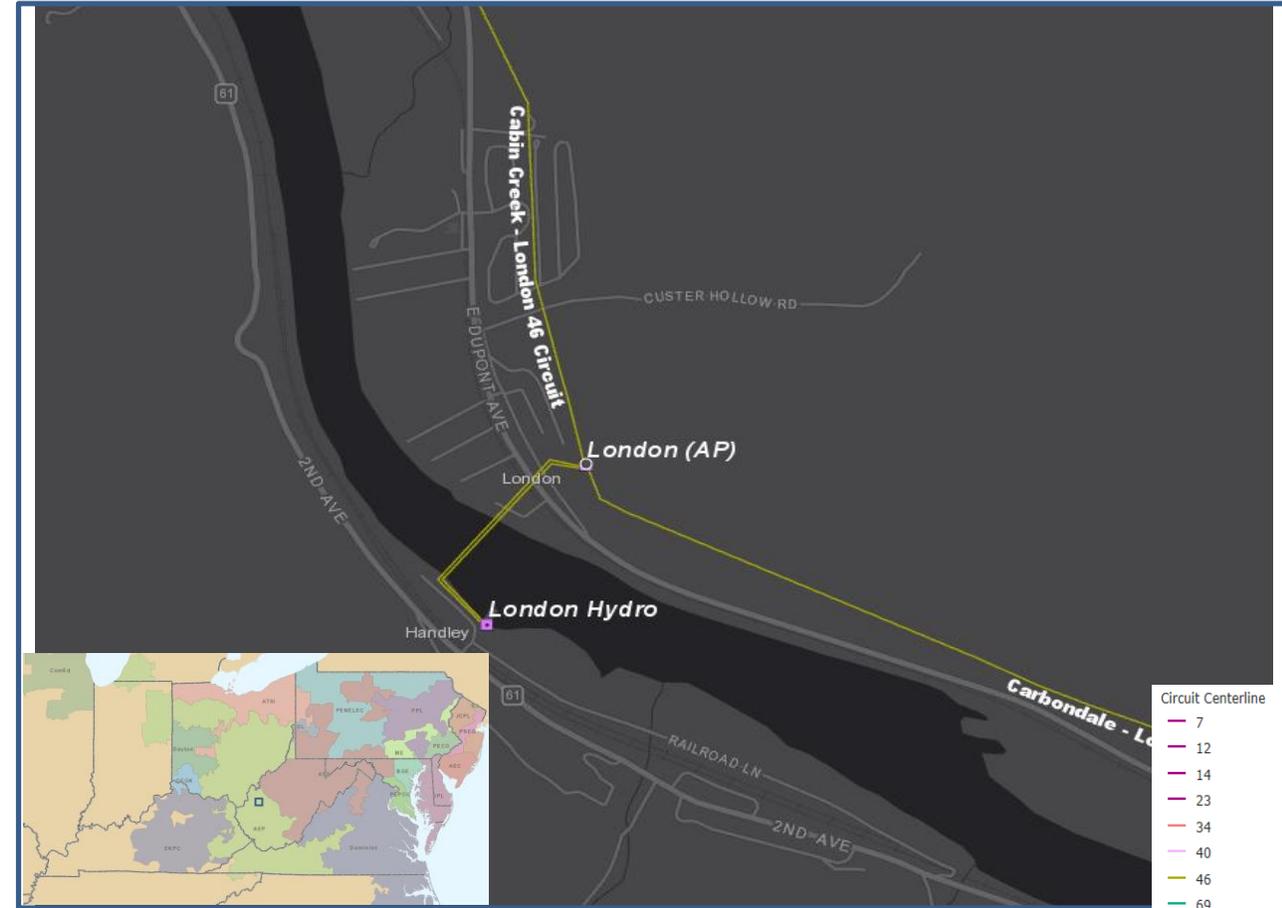
- 15 total fault operations
- London station currently deploys 35 relays
  - 33 out of 35 relays are in need of replacement (94%)
  - 28 are electromechanical relays which have significant limitations with regards to fault data collection

- 5 of the microprocessor relays utilize legacy firmware
- Control House
  - Asbestos/lead paint is present in the control house
- Access road to the station severely limits the ability to deliver large equipment to the station

- 46 kV bus shows significant signs of rust on lattice members and on bolts
