Submission of Supplemental Projects for Inclusion in the Local Plan

ComEd Local Plan - 2024

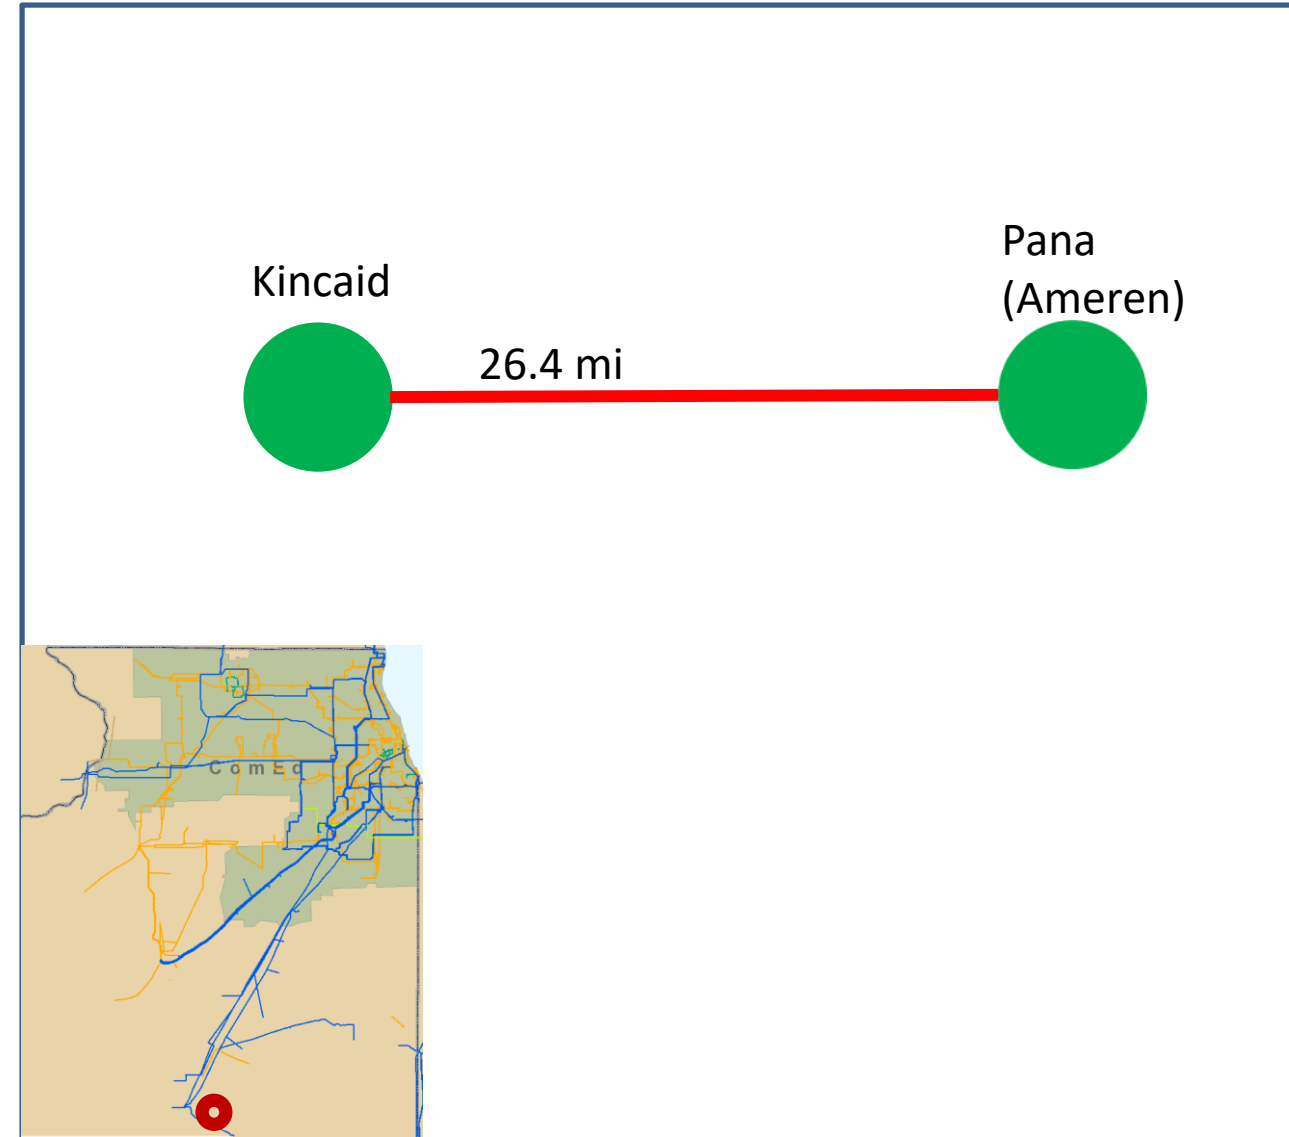
Rebuild approx. 26.4 miles with new structures, OPGW, and 2-1277 ACAR conductor.

SN/SE (MVA)	WN/WE (MVA)
Old rating	1201/1201	1497/1497
New rating	1679/1793	1793/1793

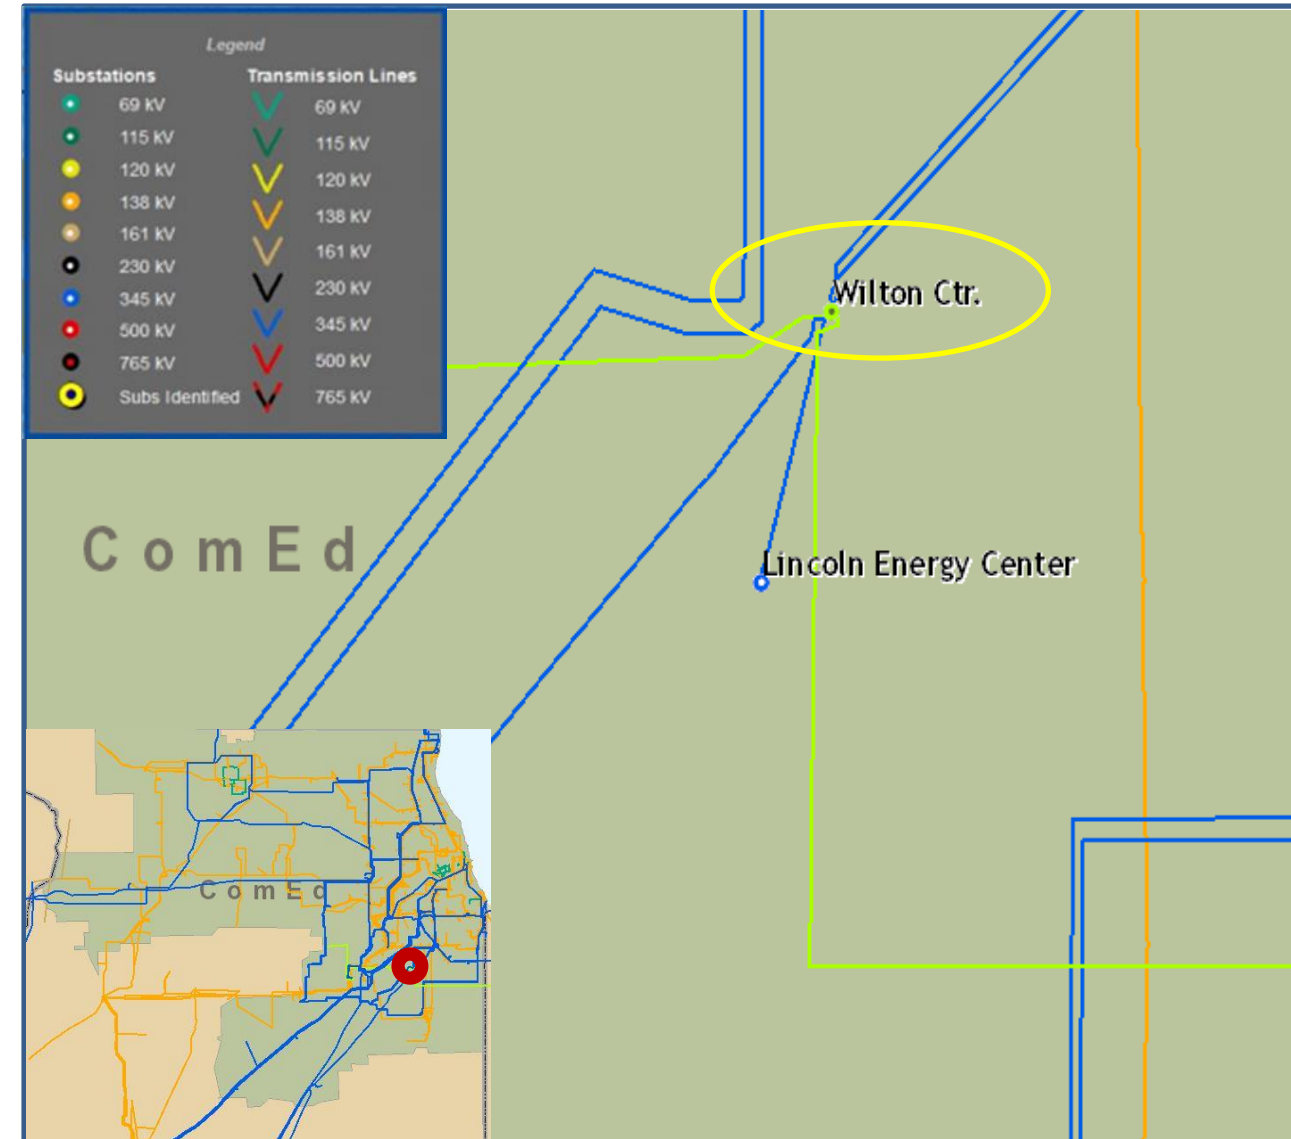
- 345 kV oil circuit breakers BT2-3, BT3-4, BT4-5, BT5-6, BT6-7 at Wilton Center substation were installed in 1970. They are in deteriorating condition, lack replacement parts, and have elevated maintenance cost.

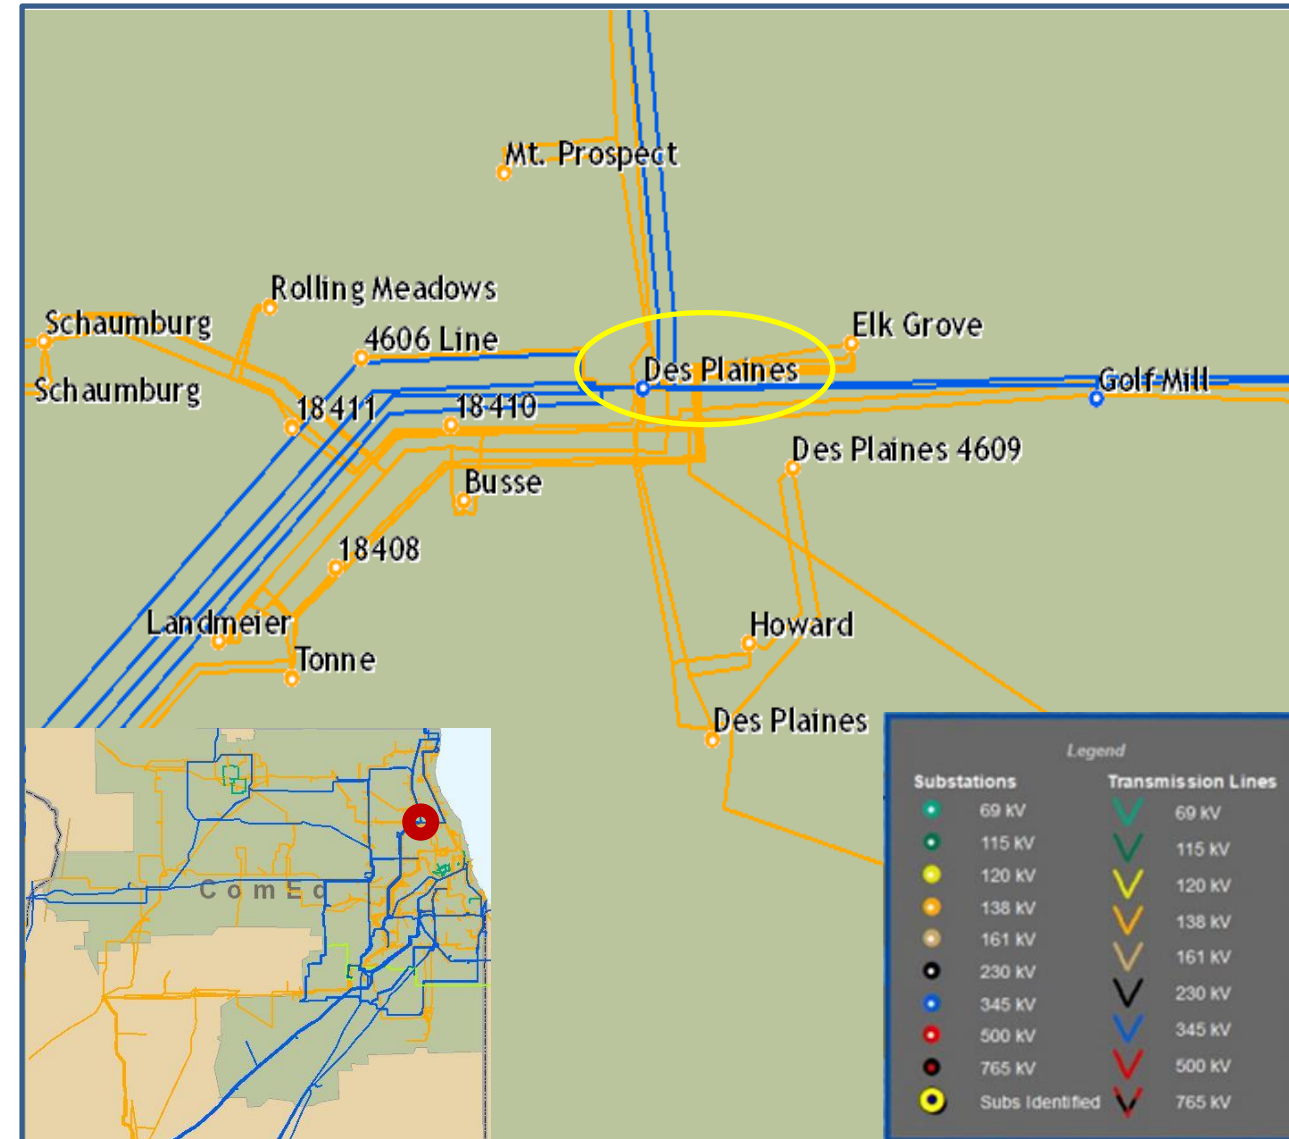
- 345 -138 kV autotransformer 83 was installed in 1993. It is one of five similar transformers purchased by ComEd. Two have failed in service and one other is being replaced on supplemental project S2266.
- Undersized core allows for overexcitation during loading causing overheating of metal, partial discharge, and circulating currents.
- Due to the hydrogen levels, the transformer must be taken out of service periodically and degasified.
- 138 kV TR 83 CB was installed in 1974. It is deteriorating condition, has a lack of replacement parts, and has elevated maintenance costs.
