# Transmission Expansion Advisory Committee PPL Supplemental Projects

September 1, 2020

# PPL Transmission Zone: Supplemental Summit-Lackawanna 1 & 2 230kV

**Need Number: PPL-2020-0001**

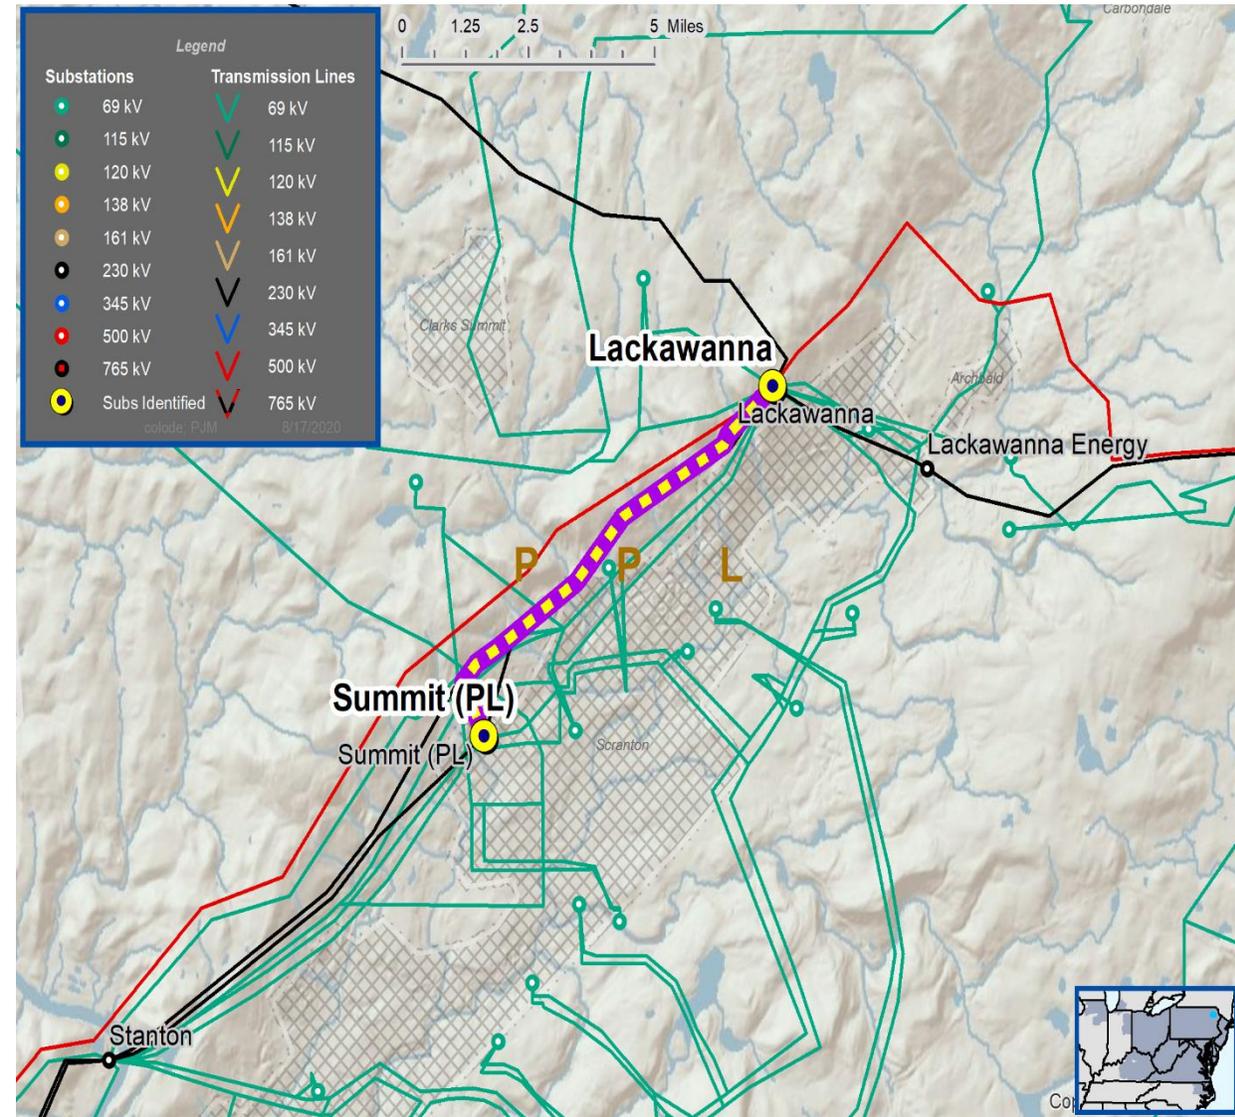
- Over a 5 mile stretch of the Summit-Lackawanna 1 & 2 230kV line, there are 30 weathering steel Corten lattice towers that were installed in 1970.
- 62% of the structures on this line are Corten Towers.
- A third-party inspection and analysis was conducted on a statistically significant sample of 192 out of the 1284 Corten structures on the PPL system. All the towers inspected exhibited section loss on numerous members and over 90% of the joints had visible pack-out.
- The report rated all the Corten towers inspected in poor or worse condition and concluded that the towers require near-term mitigation.
- This is an important 230 kV circuit required to serve the local load. There will be several thermal violations and approximately 175 MW of local load will be out of power for the next N-1 contingency without this circuit.

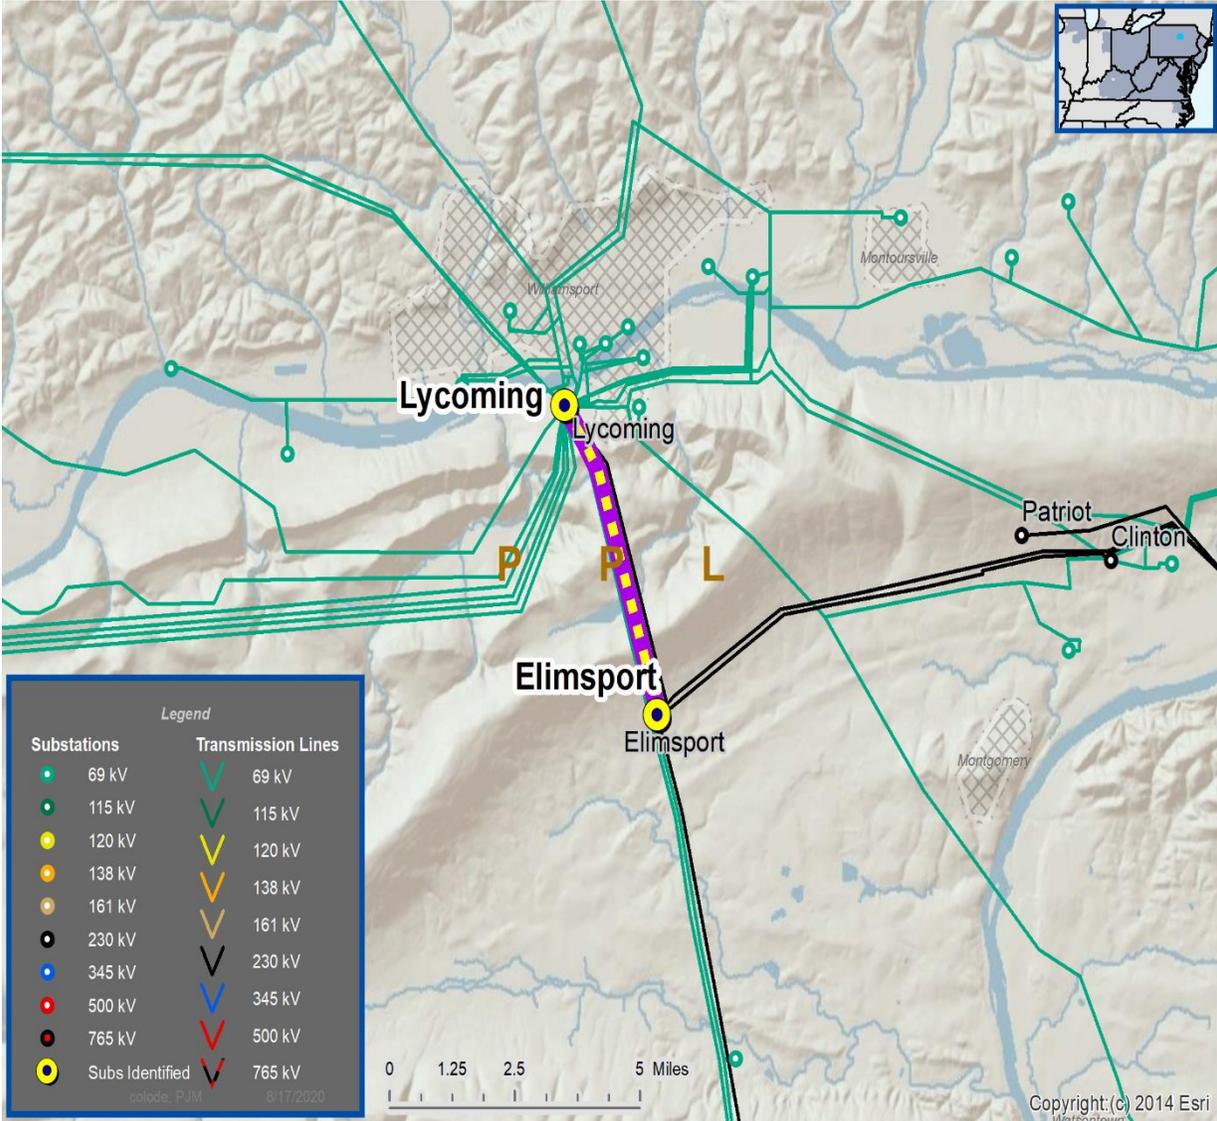
**Need Number: PPL-2020-0002**

- Over a 4.1 mile stretch of the Elimsport-Lycoming 2 & 3 230kV line, there are 25 weathering steel Corten lattice towers that were installed in 1971.
- 76% of the structures on this line are Corten Towers.
- A third-party inspection and analysis was conducted on a statistically significant sample of 192 out of the 1284 Corten structures on the PPL system. All the towers inspected exhibited section loss on numerous members and over 90% of the joints had visible pack-out.
- The report rated all the Corten towers inspected in poor or worse condition and concluded that the towers require near-term mitigation.
- This is an important 230 kV circuit required to serve the local load. Approximately 315 MW of local load will be out of power for the next N-1 contingency without this circuit.

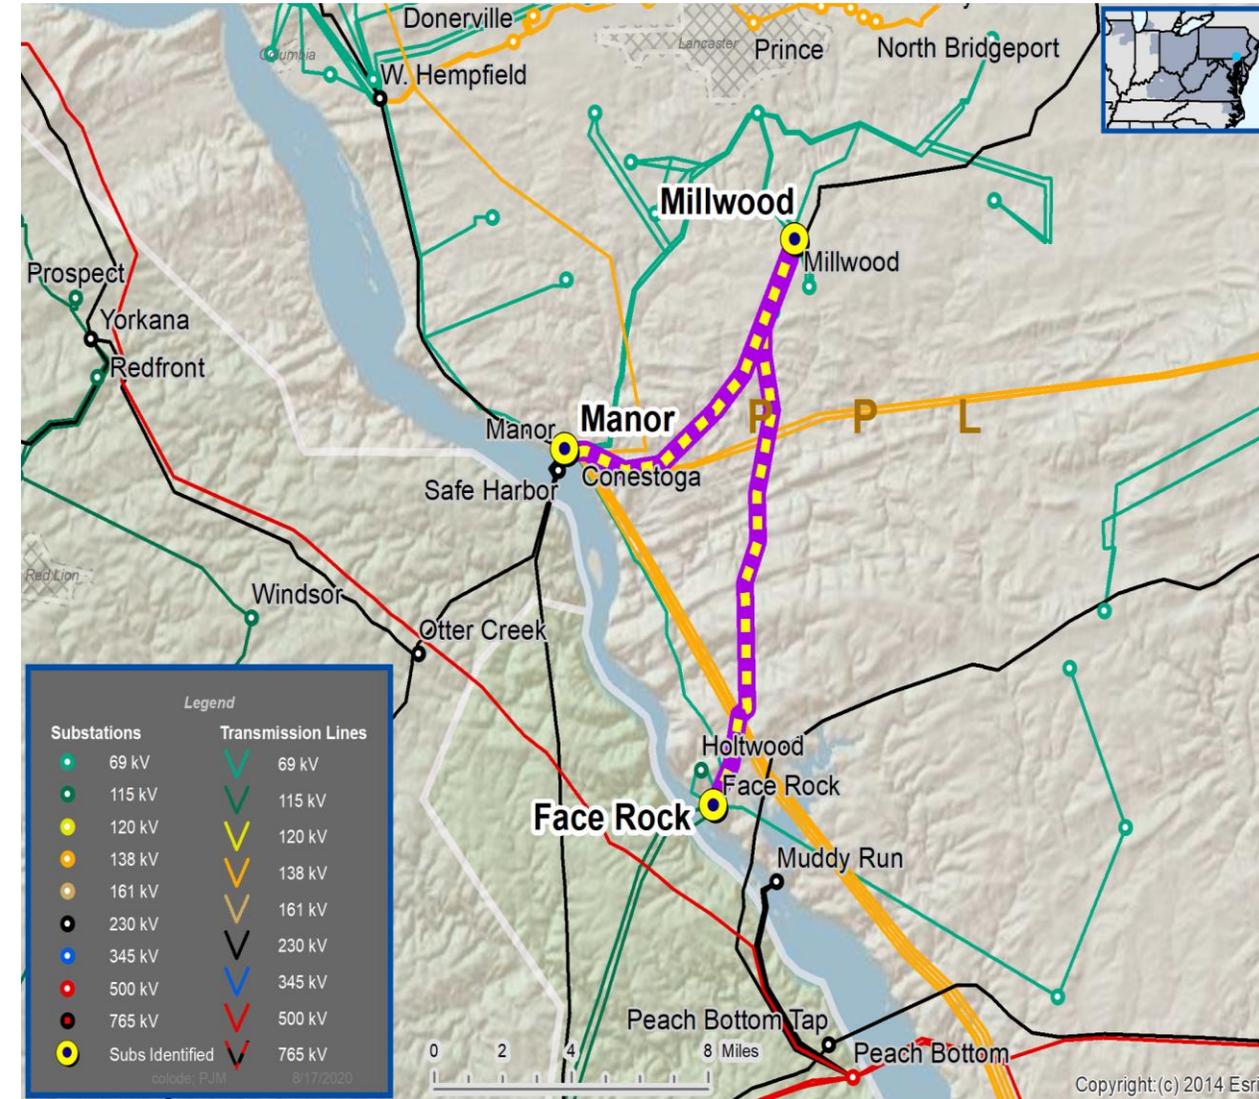
**Need Number: PPL-2020-0003**

- Over a 5.2 mile stretch of the Manor-Millwood 230kV line and Face Rock-Millwood 1 69kV line, there are 28 weathering steel Corten lattice towers that were installed in 1967.
- 83% of the structures on this line are Corten Towers.
- A third-party inspection and analysis was conducted on a statistically significant sample of 192 out of the 1284 Corten structures on the PPL system. All the towers inspected exhibited section loss on numerous members and over 90% of the joints had visible pack-out.
- The report rated all the Corten towers inspected in poor or worse condition and concluded that the towers require near-term mitigation.
- This is an important 230 kV circuit required to serve approximately 200 MW of local load. Absence of this line will cause a thermal violation for the next N-1 contingency.

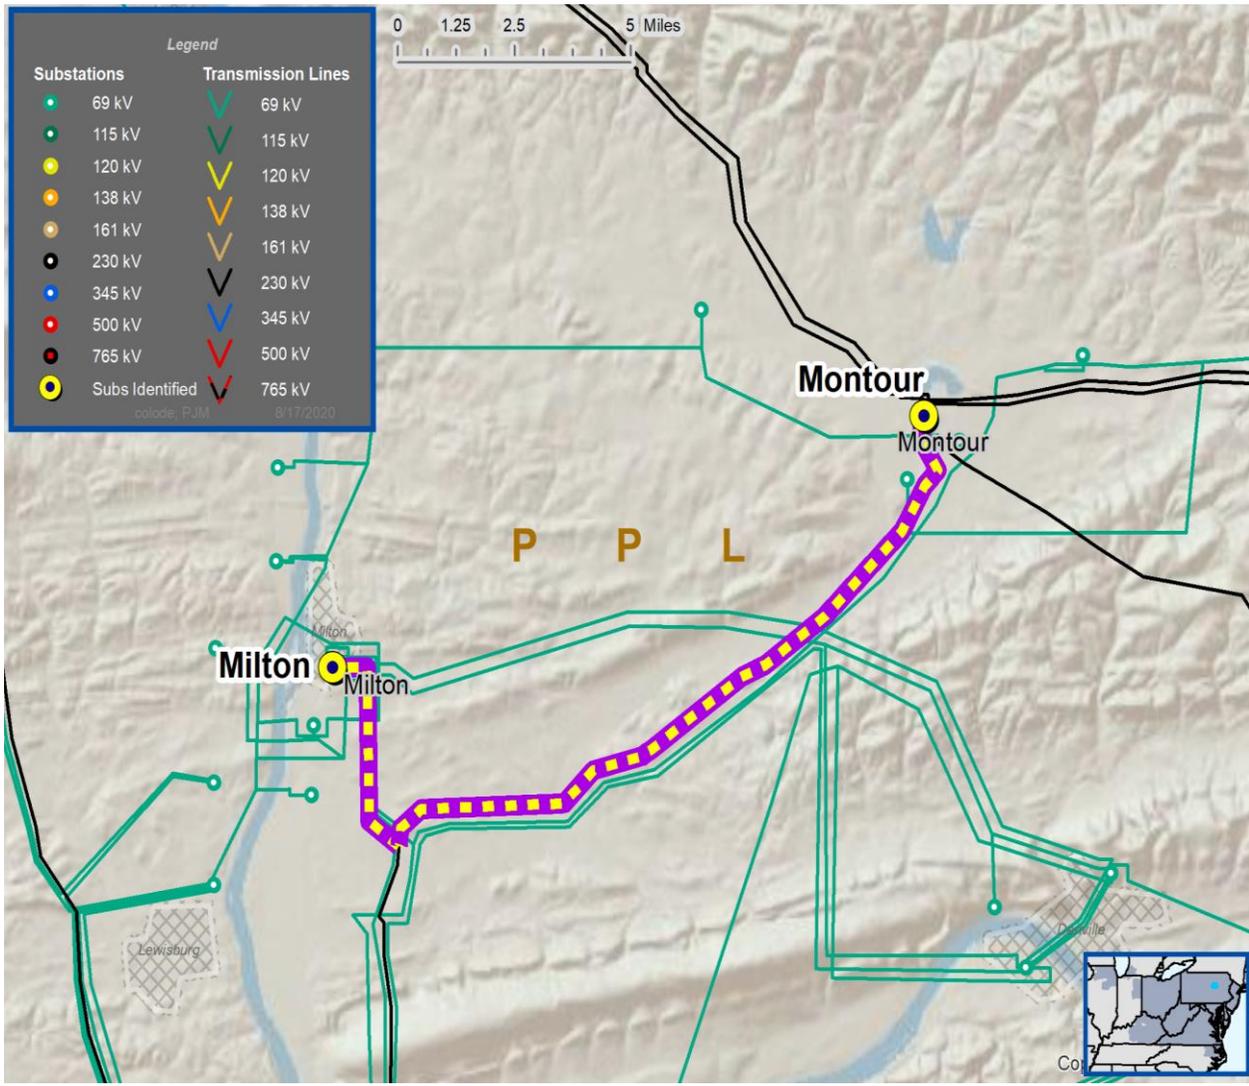
**Need Number: PPL-2020-0004**

- Over a 10.7 mile stretch of the Montour-Milton 230kV line, there are 63 weathering steel Corten lattice towers that were installed in 1971.
- 72% of the structures on this line are Corten Towers.
- A third-party inspection and analysis was conducted on a statistically significant sample of 192 out of the 1284 Corten structures on the PPL system. All the towers inspected exhibited section loss on numerous members and over 90% of the joints had visible pack-out.
- The report rated all the Corten towers inspected in poor or worse condition and concluded that the towers require near-term mitigation.
- This is an important 230 kV circuit required to serve the local load. There will be several thermal violations and approximately 105 MW of local load will be out of power for the next N-1 contingency without this circuit.

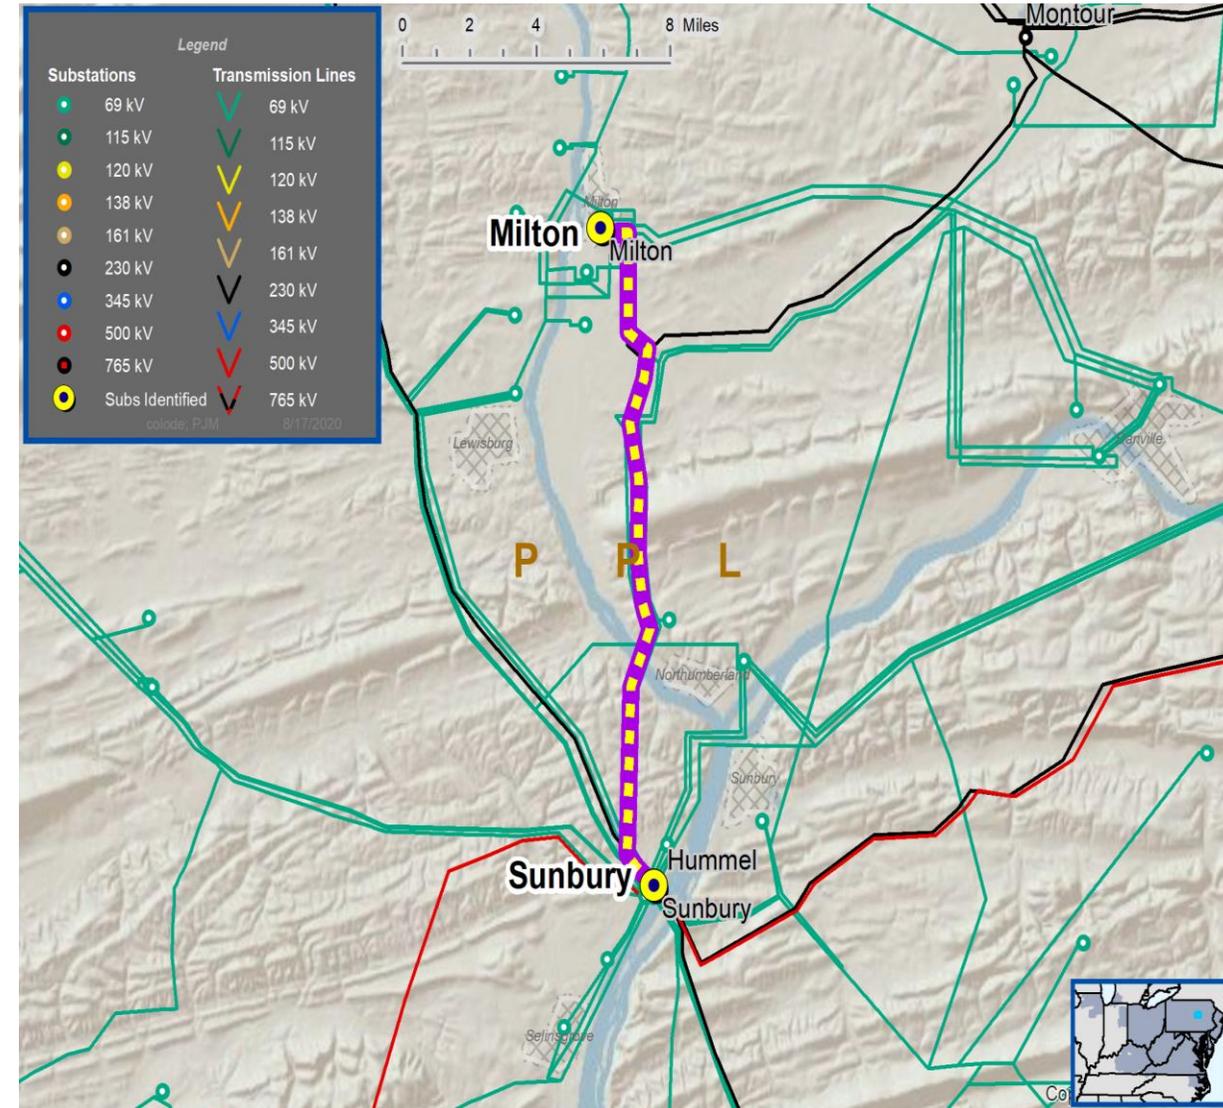
**Need Number: PPL-2020-0005**

- Over a 10.4 mile stretch of the Sunbury-Milton 230kV and Sunbury-Milton 69kV lines, there are 68 weathering steel Corten lattice towers that were installed in 1969.
- 99% of the structures on this line are Corten Towers.
- A third-party inspection and analysis was conducted on a statistically significant sample of 192 out of the 1284 Corten structures on the PPL system. All the towers inspected exhibited section loss on numerous members and over 90% of the joints had visible pack-out.
- The report rated all the Corten towers inspected in poor or worse condition and concluded that the towers require near-term mitigation.
- This is an important 230 kV circuit required to serve the local load. There will be several thermal violations and approximately 105 MW of local load will be out of power for the next N-1 contingency without this circuit.

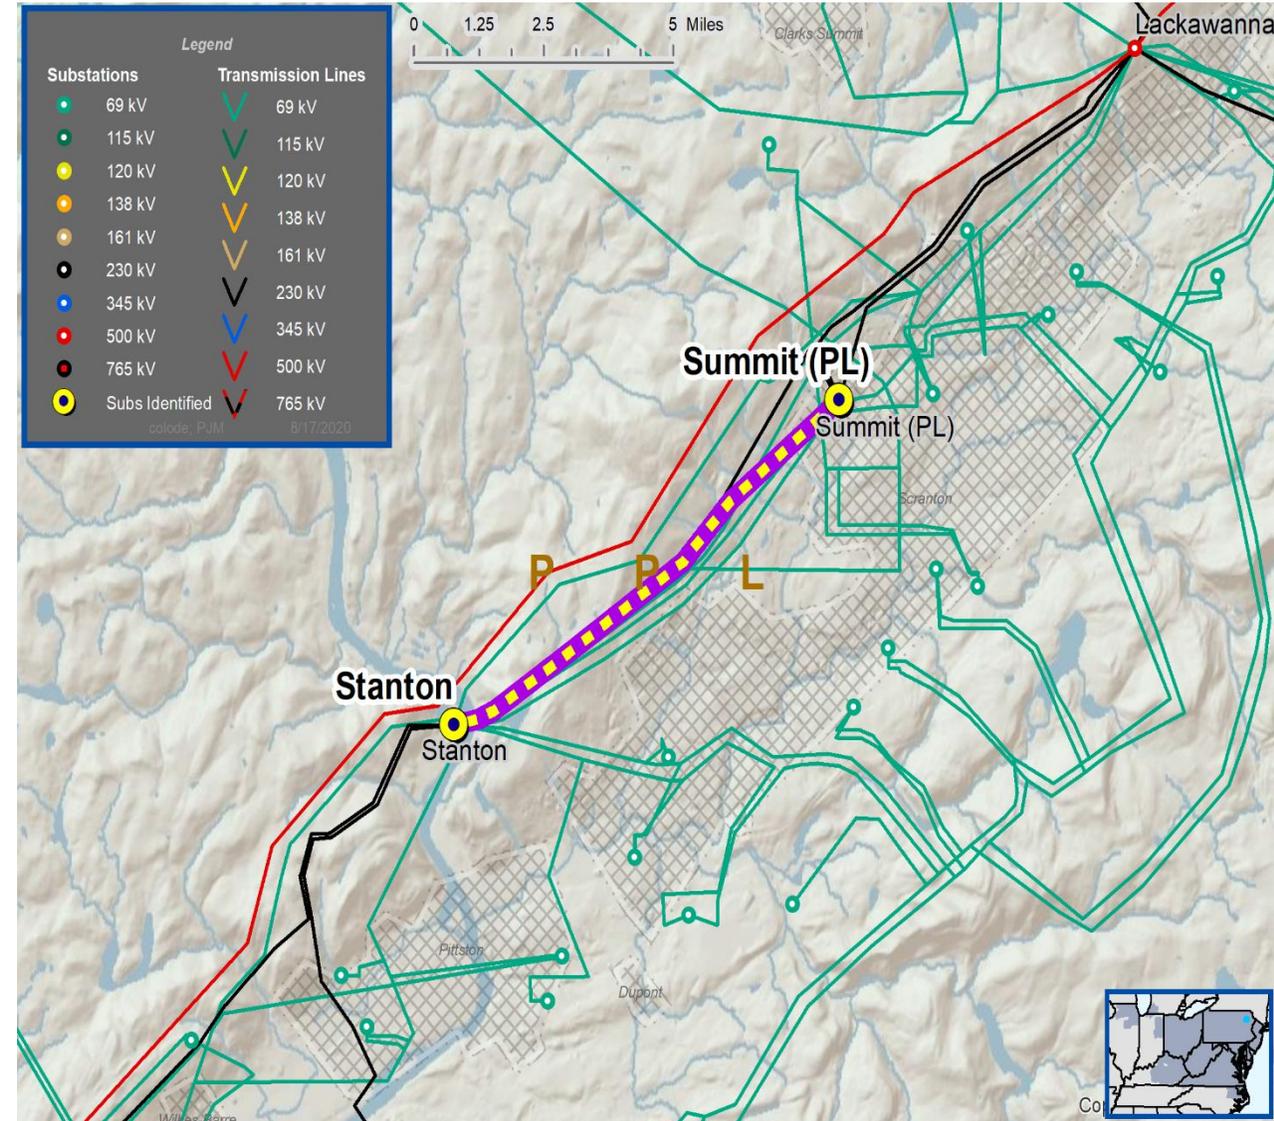
**Need Number: PPL-2020-0006**

- Over a 7.7 mile stretch of the Stanton-Summit 3 & 4 230kV lines, there are 46 weathering steel Corten lattice towers that were installed in 1970.
- 76% of the structures on this line are Corten Towers.
- A third-party inspection and analysis was conducted on a statistically significant sample of 192 out of the 1284 Corten structures on the PPL system. All the towers inspected exhibited section loss on numerous members and over 90% of the joints had visible pack-out.
- The report rated all the Corten towers inspected in poor or worse condition and concluded that the towers require near-term mitigation.
- This is an important 230 kV circuit required to serve the local load. There will be thermal and voltage violations and approximately 175 MW of local load will be out of power for the next N-1 contingency without this circuit.

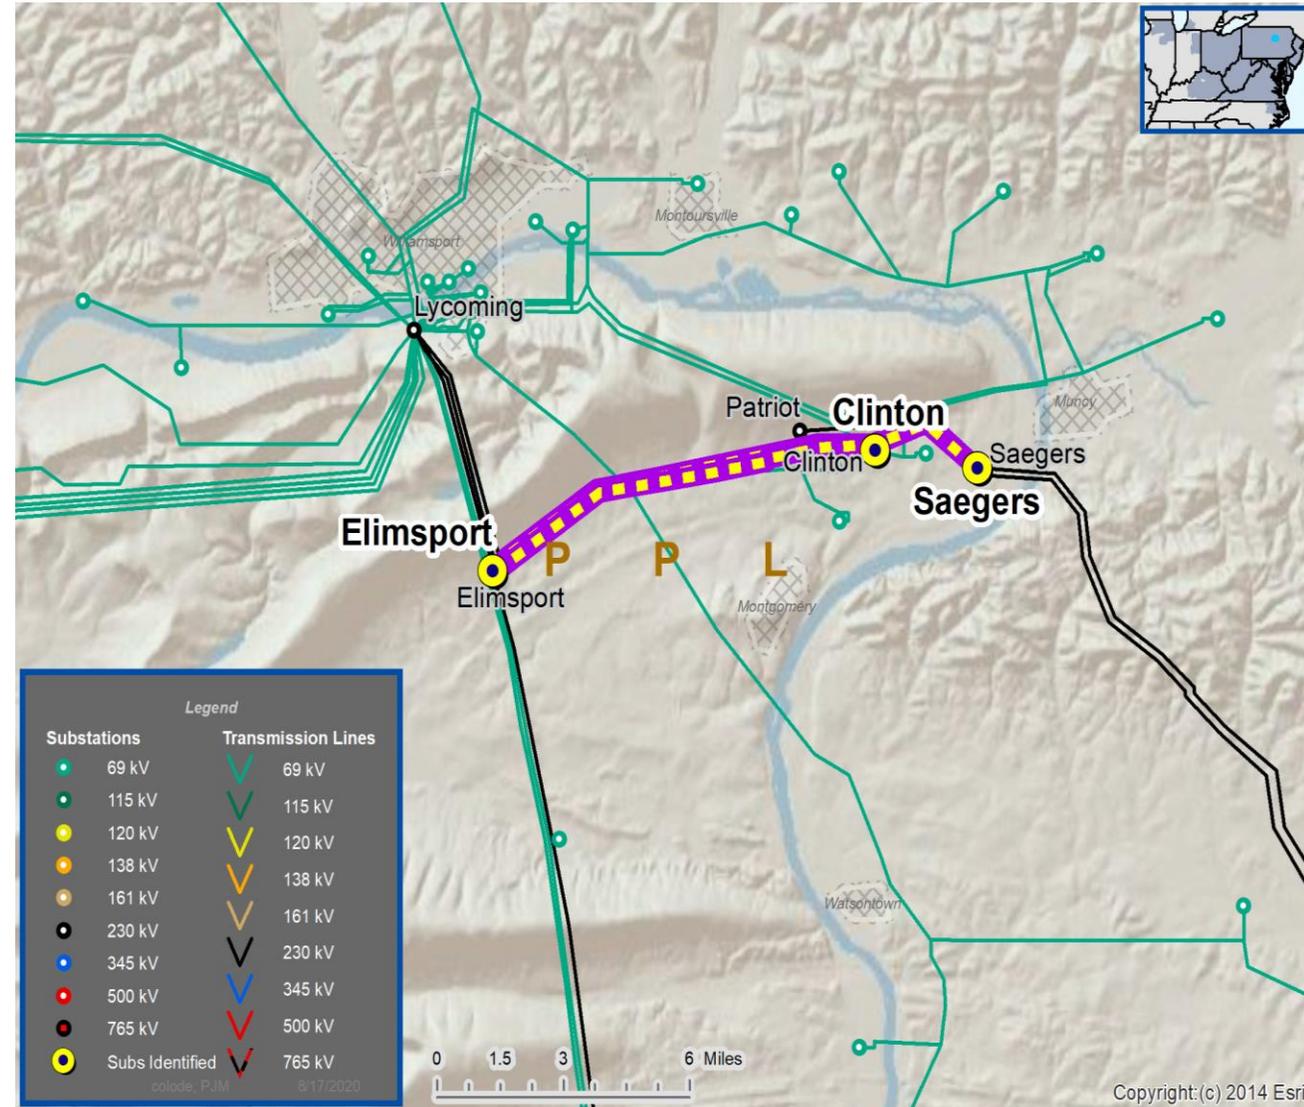
**Need Number: PPL-2020-0007**

- Over an 8.0 mile stretch of the Saegers-Elimsport and Clinton-Elimsport/Clinton-Saegers 230kV lines, there are 48 weathering steel Corten lattice towers that were installed in 1971.
- 69% of the structures on this line are Corten Towers.
- A third-party inspection and analysis was conducted on a statistically significant sample of 192 out of the 1284 Corten structures on the PPL system. All the towers inspected exhibited section loss on numerous members and over 90% of the joints had visible pack-out.
- The report rated all the Corten towers inspected in poor or worse condition and concluded that the towers require near-term mitigation.
- This is an important 230 kV circuit required to serve the local load. Approximately 465 MW of local load will be out of power for the next N-1 contingency without this circuit.

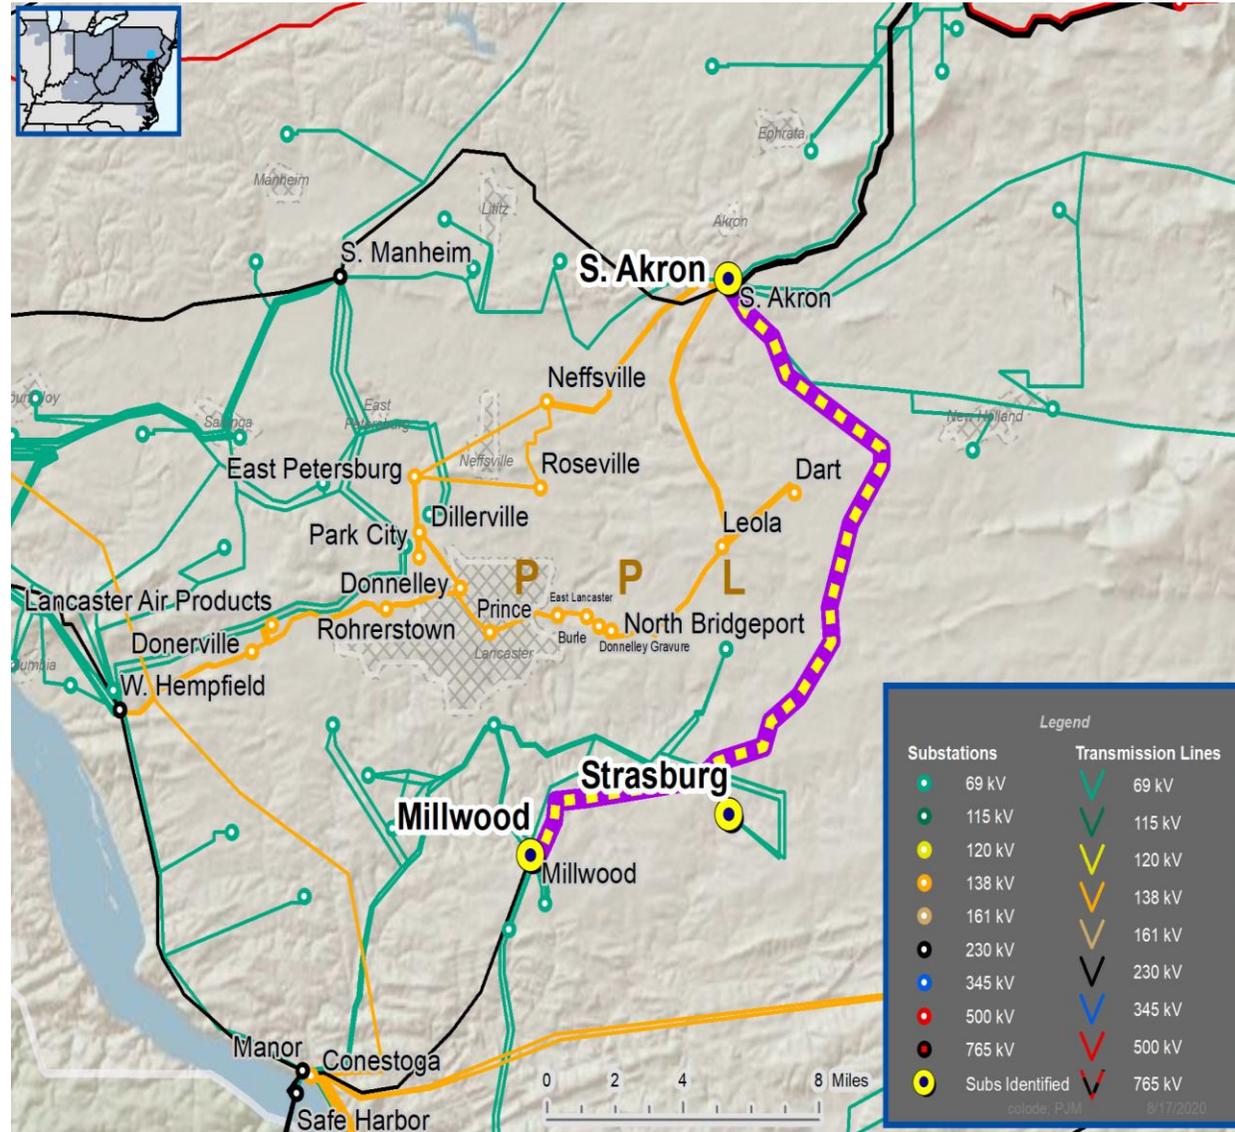
**Need Number:** PPL-2020-0008

- Over a 20.4 mile stretch of the South Akron-Millwood 230kV and the Millwood-Strasburg tie 69kV lines, there are 125 weathering steel Corten lattice towers that were installed in 1967.
- 97% of the structures on this line are Corten Towers.
- A third-party inspection and analysis was conducted on a statistically significant sample of 192 out of the 1284 Corten structures on the PPL system. All the towers inspected exhibited section loss on numerous members and over 90% of the joints had visible pack-out.
- The report rated all the Corten towers inspected in poor or worse condition and concluded that the towers require near-term mitigation.
- This is an important 230/69 kV circuit required to serve approximately 25 MW of local load. Absence of this circuit will cause several thermal and voltage violations in the area for the next N-1 contingency.

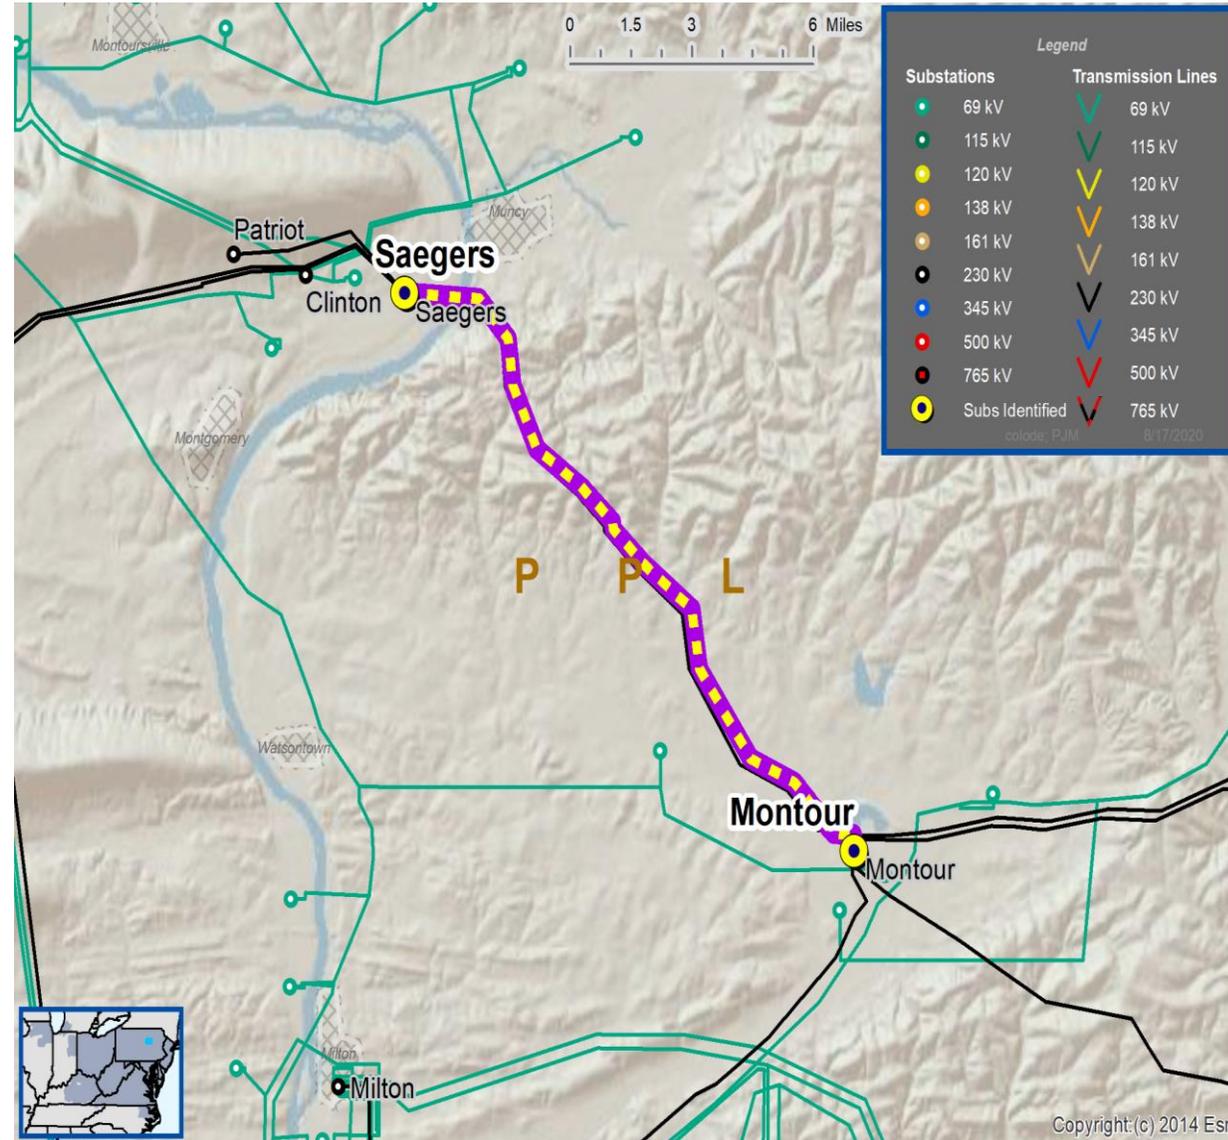
## Need Number: PPL-2020-0009

- Over a 6.2 mile stretch of the Montour-Saegers 1 & 2 230kV lines, there are 38 weathering steel Corten lattice towers that were installed in 1971.
- 35% of the structures on this line are Corten Towers.
- A third-party inspection and analysis was conducted on a statistically significant sample of 192 out of the 1284 Corten structures on the PPL system. All the towers inspected exhibited section loss on numerous members and over 90% of the joints had visible pack-out.
- The report rated all the Corten towers inspected in poor or worse condition and concluded that the towers require near-term mitigation.
- This is an important 230 kV circuit required to serve the local load. Approximately 465 MW of local load will be out of power for the next N-1 contingency without this circuit.

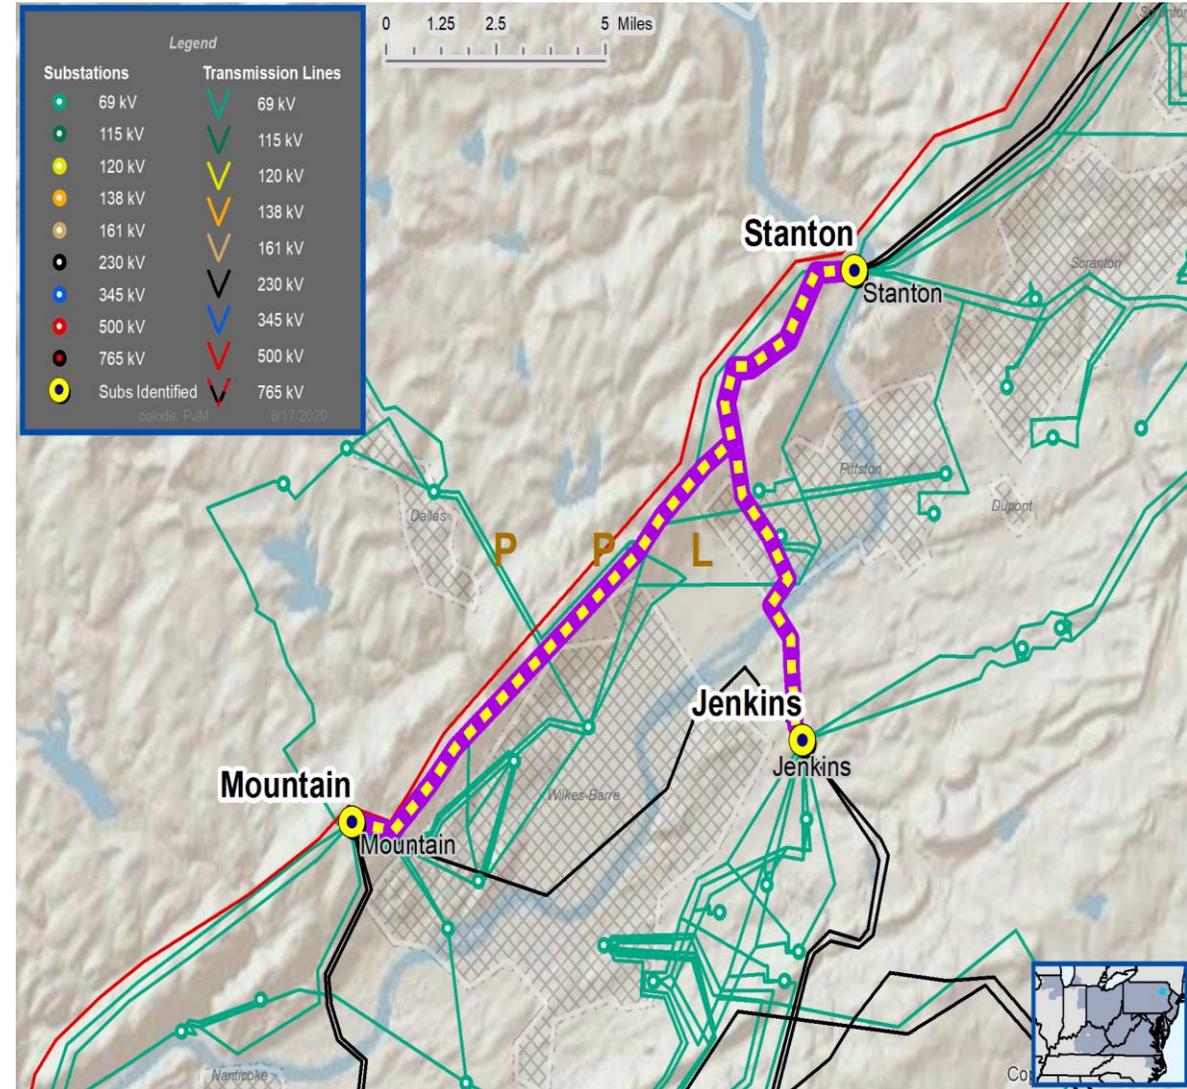
**Need Number: PPL-2020-0010**

- Over an 8.5 mile stretch of the Jenkins-Stanton and Mountain-Stanton 230kV lines, there are 49 weathering steel Corten lattice towers that were installed in 1972.
- 95% of the structures on this line are Corten Towers.
- A third-party inspection and analysis was conducted on a statistically significant sample of 192 out of the 1284 Corten structures on the PPL system. All the towers inspected exhibited section loss on numerous members and over 90% of the joints had visible pack-out.
- The report rated all the Corten towers inspected in poor or worse condition and concluded that the towers require near-term mitigation.
- This is an important 230 kV circuit required to serve the local load. There will be thermal and voltage violations and approximately 175 MW of local load will be out of power for the next N-1 contingency without this circuit.

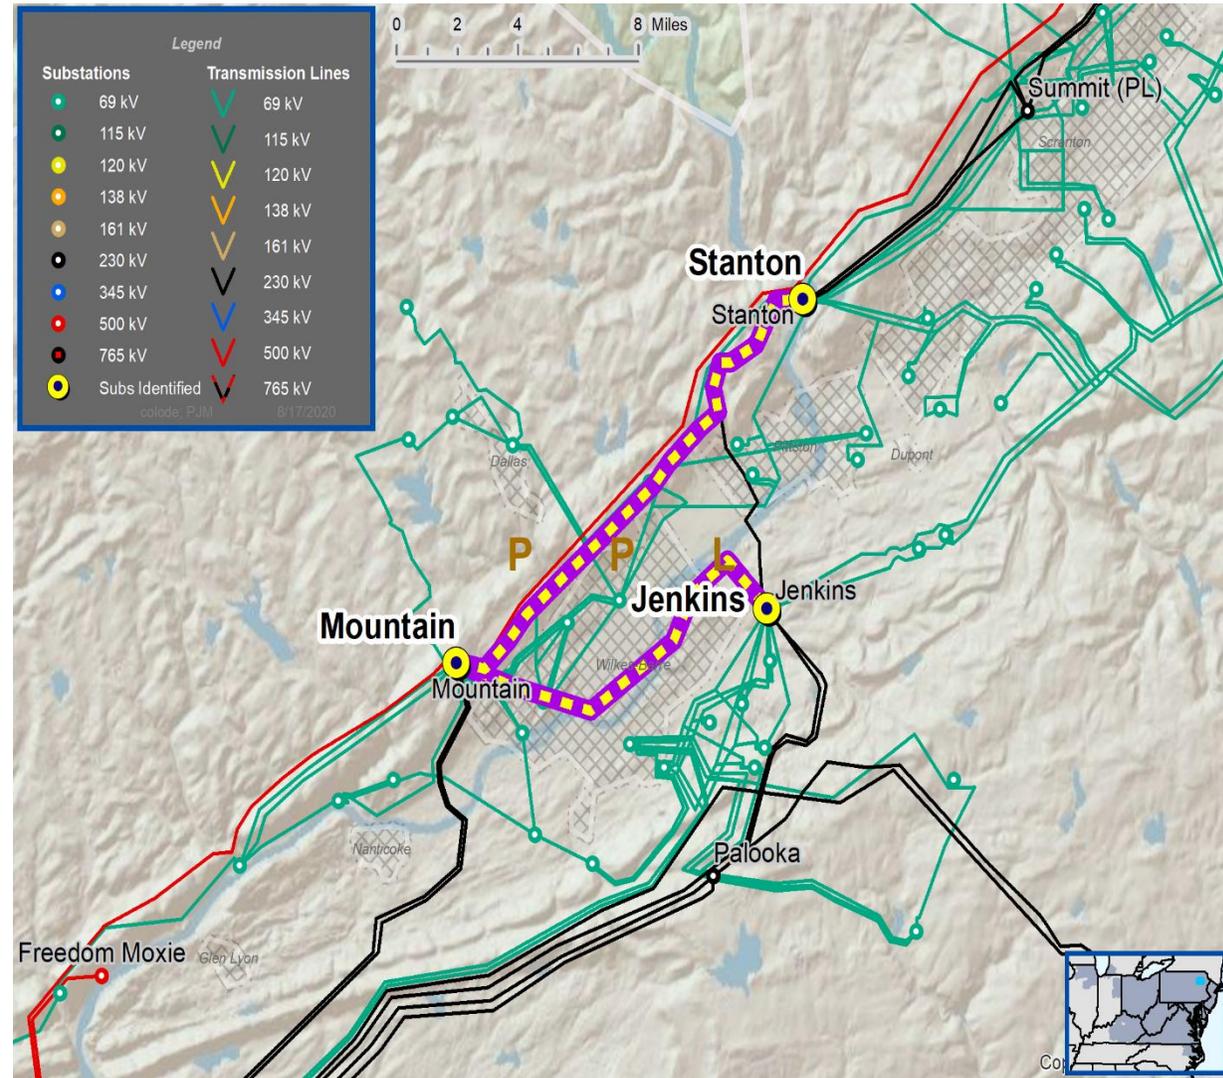
**Need Number: PPL-2020-0011**

- Over a 9.8 mile stretch of the Mountain-Stanton and Mountain-Jenkins 230kV lines, there are 55 weathering steel Corten lattice towers that were installed in 1972.
- 97% of the structures on this line are Corten Towers.
- A third-party inspection and analysis was conducted on a statistically significant sample of 192 out of the 1284 Corten structures on the PPL system. All the towers inspected exhibited section loss on numerous members and over 90% of the joints had visible pack-out.
- The report rated all the Corten towers inspected in poor or worse condition and concluded that the towers require near-term mitigation.
- This is an important 230 kV circuit required to serve the local load. Approximately 190 MW of local load will be out of power for the next N-1 contingency without this circuit.

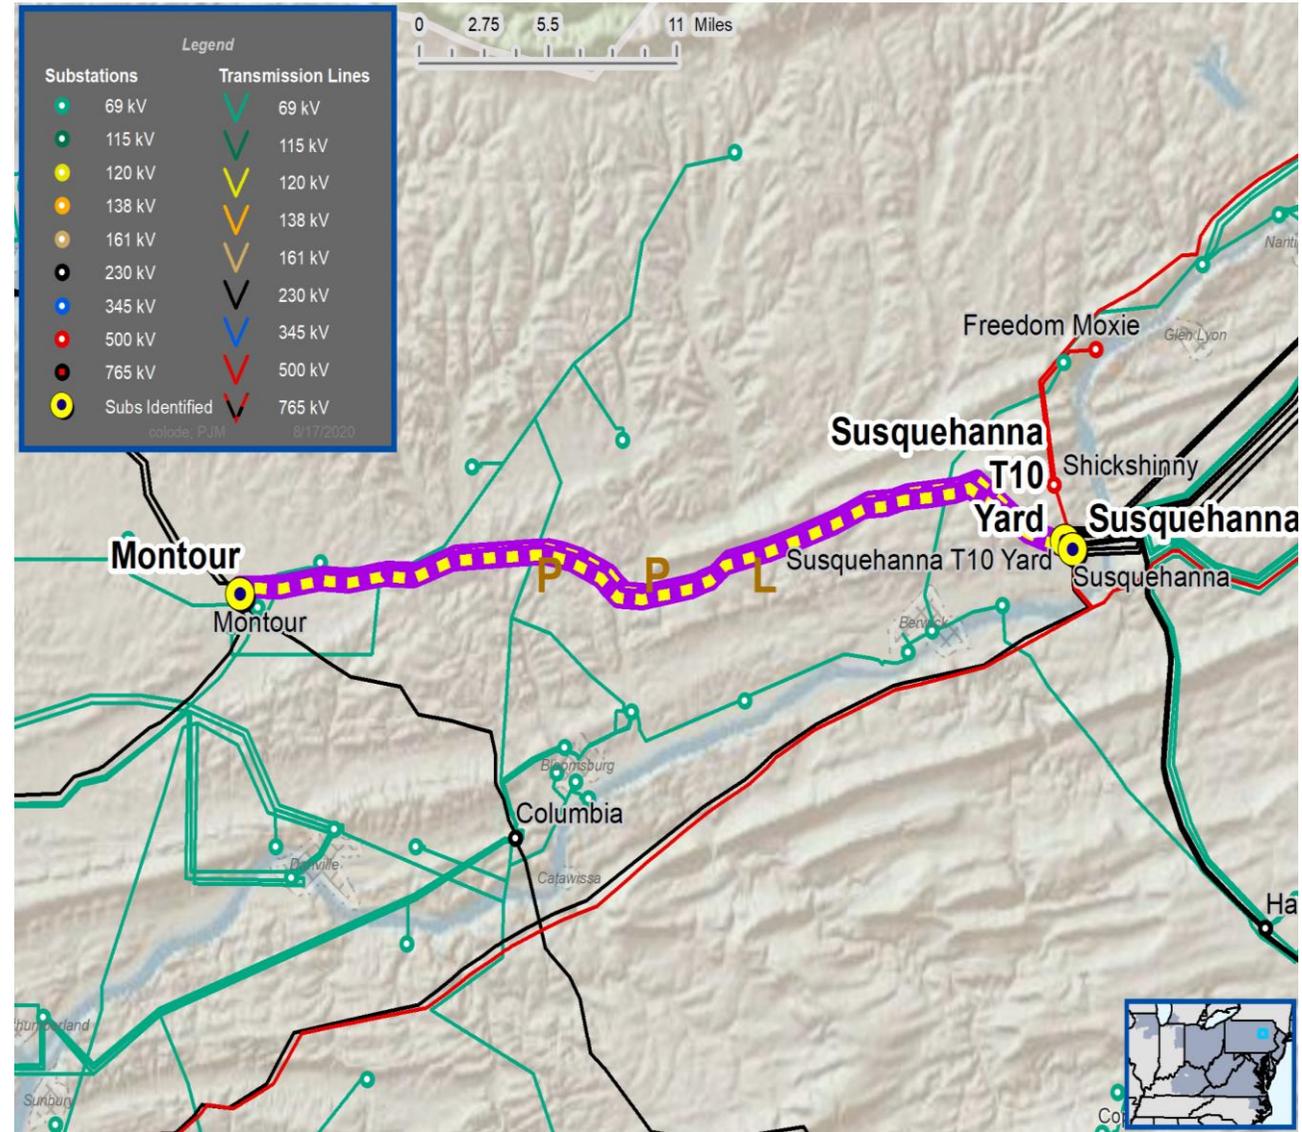
**Need Number: PPL-2020-0012**

- Over a 21.9 mile stretch of the Montour-Susquehanna and Montour-Susquehanna T10 230kV lines, there are 132 weathering steel Corten lattice towers that were installed in 1971.
- 74% of the structures on this line are Corten Towers.
- A third-party inspection and analysis was conducted on a statistically significant sample of 192 out of the 1284 Corten structures on the PPL system. All the towers inspected exhibited section loss on numerous members and over 90% of the joints had visible pack-out.
- The report rated all the Corten towers inspected in poor or worse condition and concluded that the towers require near-term mitigation.
- This is an important 230 kV circuit required to serve the local load. There will be several thermal violations and approximately 60 MW of local load will be out of power for the next N-1 contingency without this circuit.
