Transmission Expansion Advisory Committee FirstEnergy (Penelec) Supplemental Projects

December 5, 2023

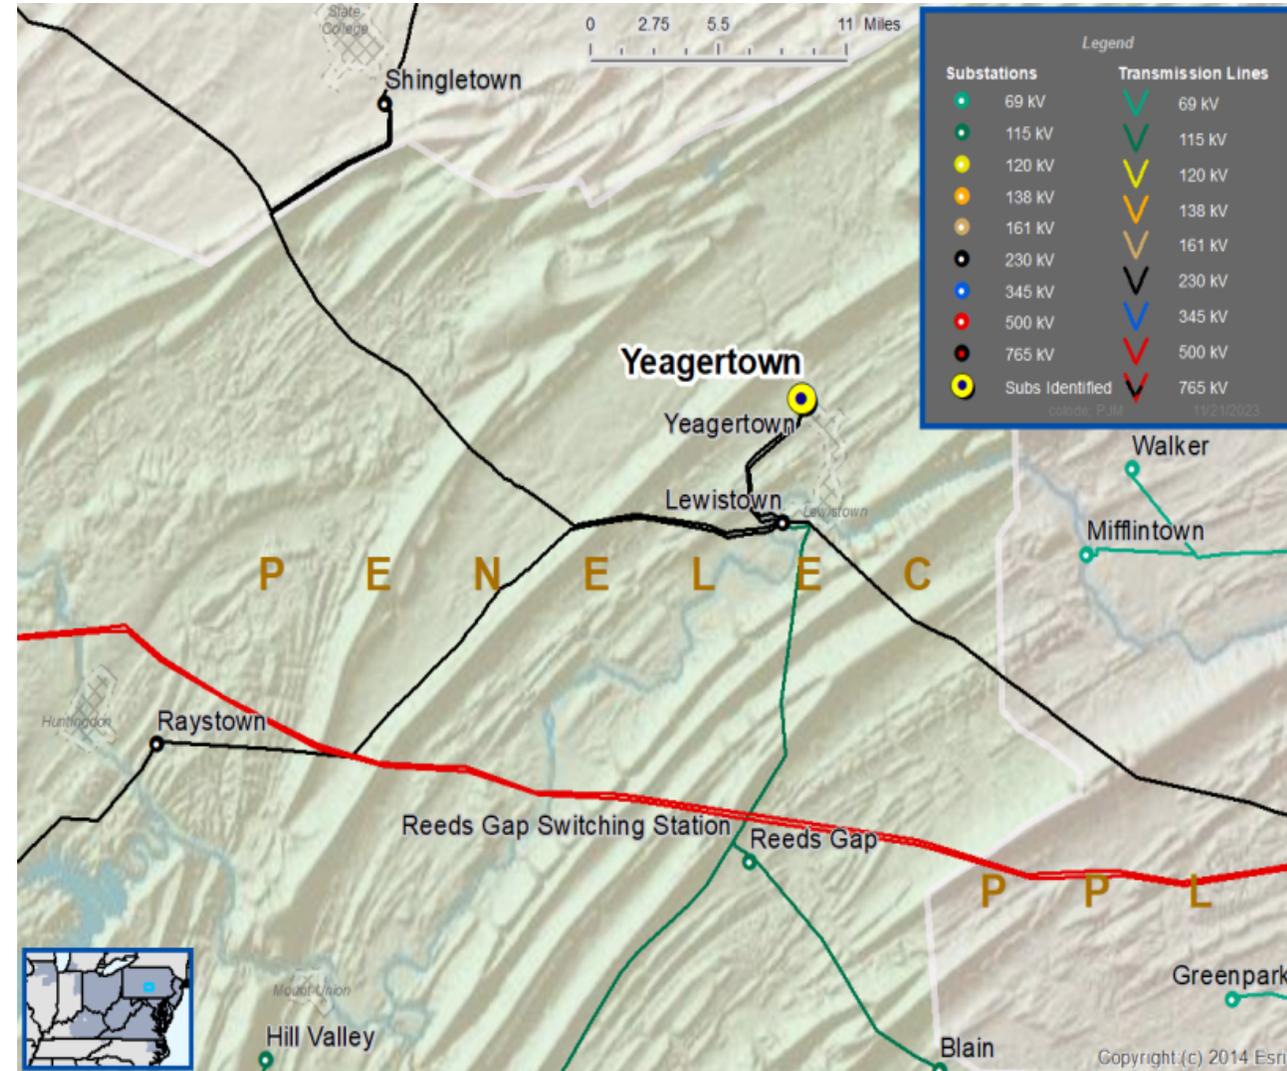
Need Numbers: PN-2023-019

- The existing Yeagertown #1 230-46 kV Transformer is approximately 51 years old and is reaching end of life.
- The transformer is constructed with Type U bushings.
 - Type U bushing designs have been documented to dramatically increase the risk of bushing failures.
- Existing transformer ratings:
 - 83/83/83/83 MVA (SN/SLTE/WN/WLTE)

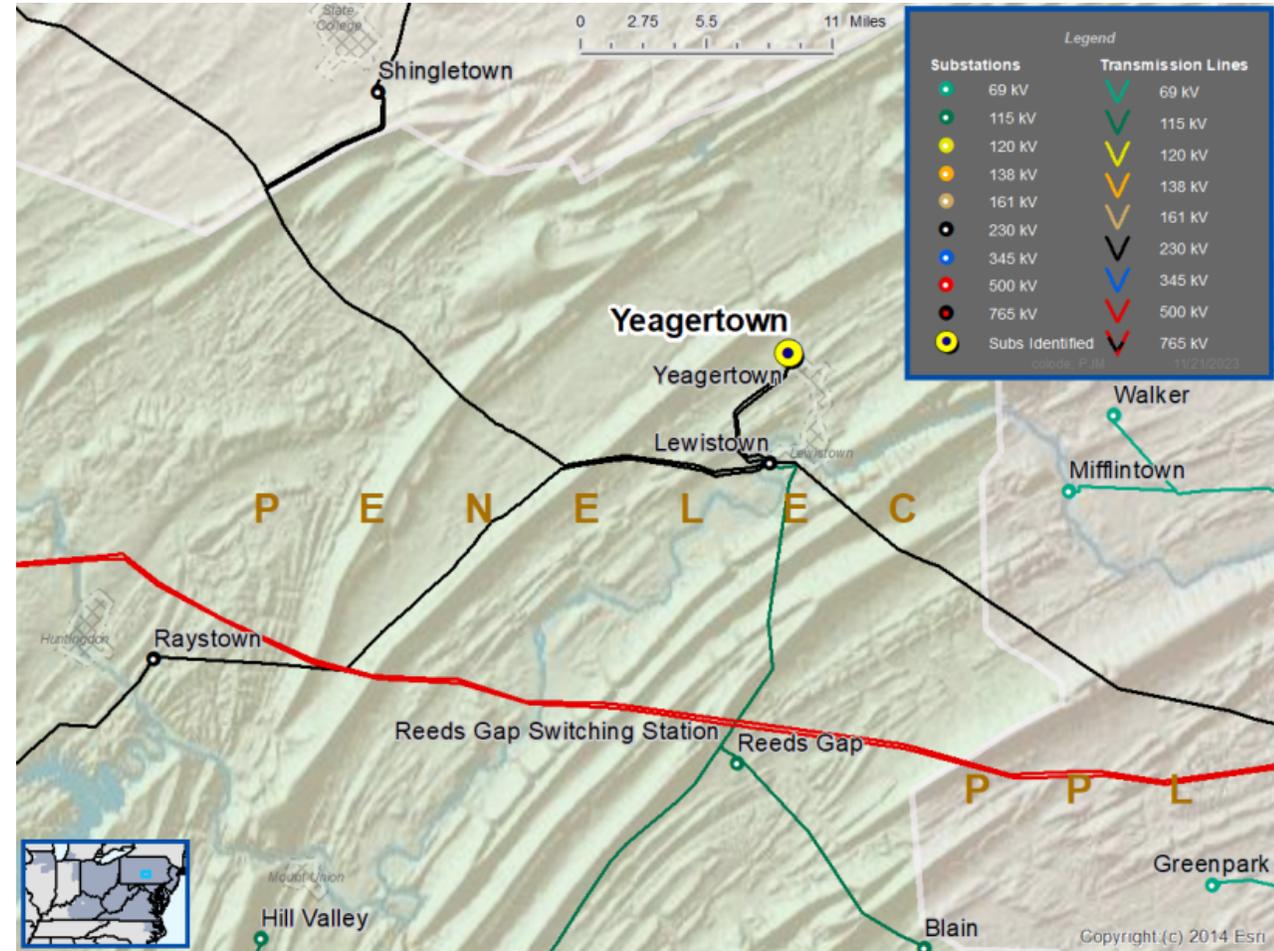
Need Numbers: PN-2023-020

- The existing Yeagertown #2 230-46 kV Transformer is approximately 51 years old and is reaching end of life.
- The transformer is constructed with Type U bushings.
 - Type U bushing designs have been documented to dramatically increase the risk of bushing failures.
- Existing transformer ratings:
 - 69/75/83/83 MVA (SN/SLTE/WN/WLTE)

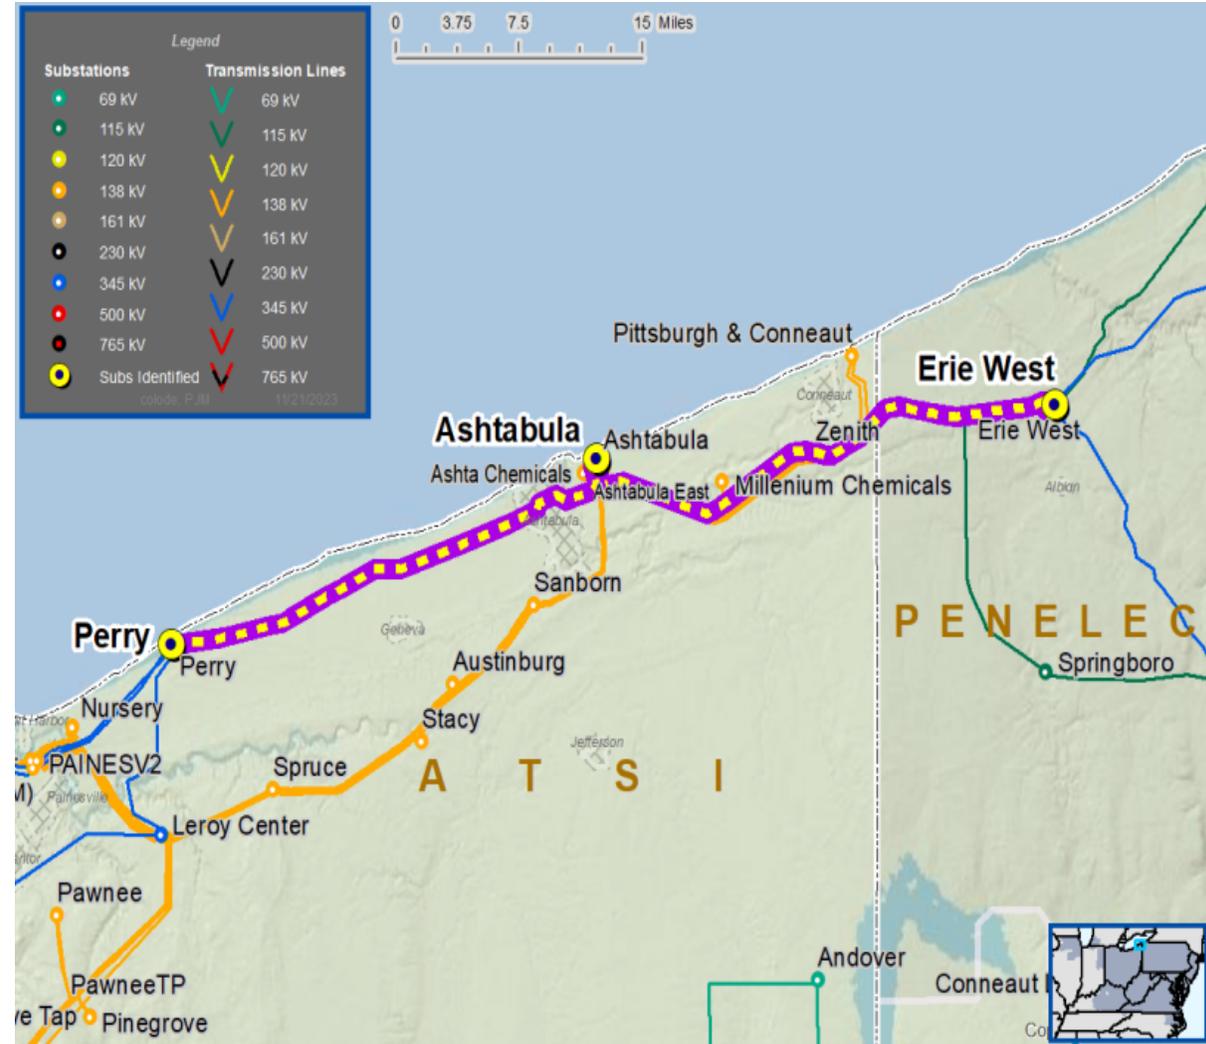
Need Numbers: PN-2023-029

- The Perry-Ashtabula-Erie West 345 kV Line was constructed approximately 60 years ago. It is a critical east-to-west power transfer interface.
- The Ashtabula – Erie West 345 kV Line is approximately 20 miles long with 7.2 miles in the Penelec territory in Pennsylvania.
- The insulators and related hardware are severely corroded and reaching end of life.

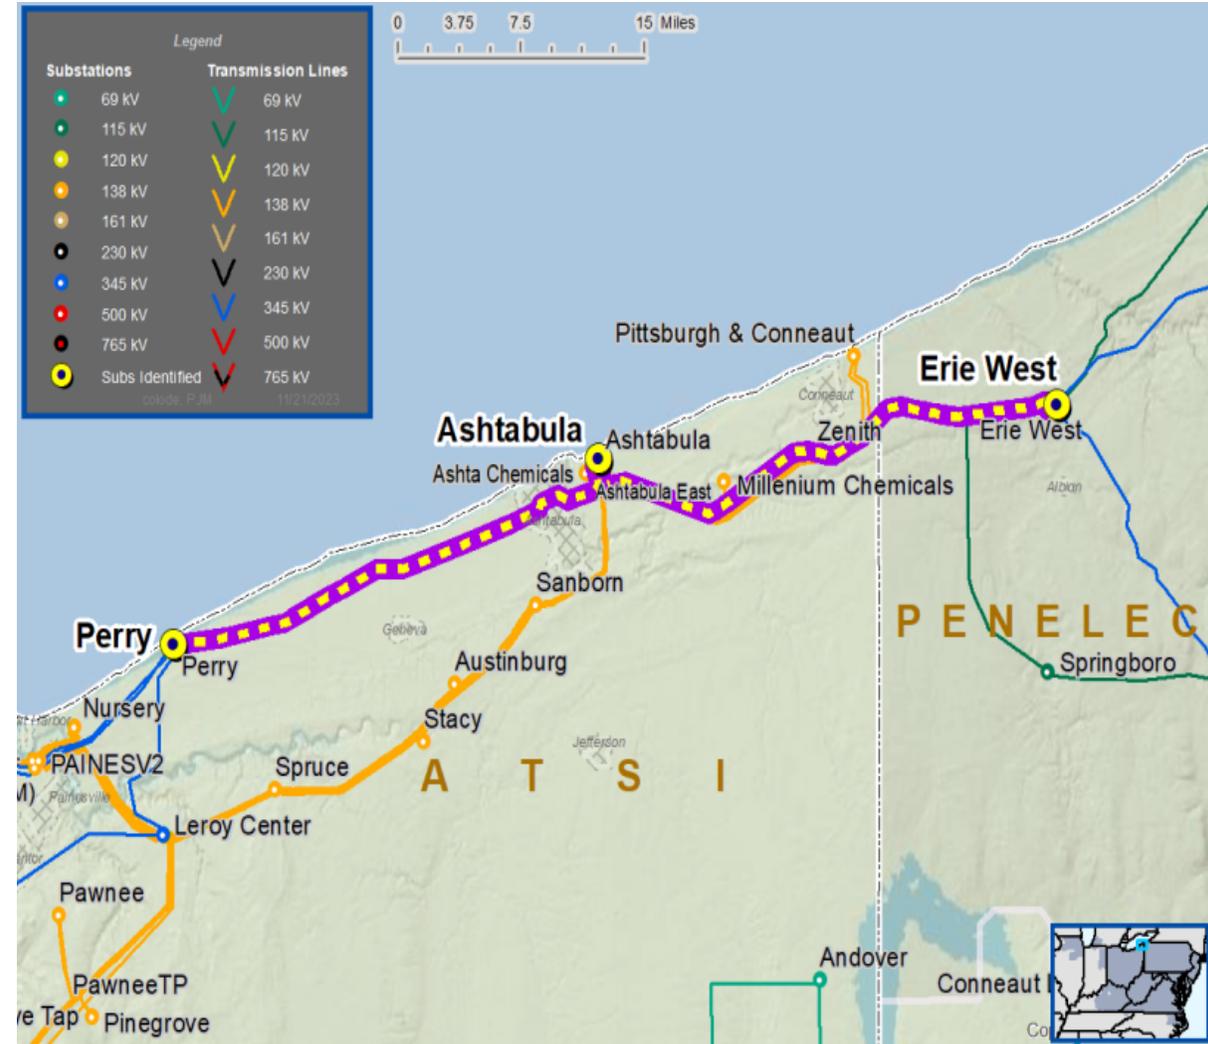
Need Numbers: PN-2023-029

- The 27 of 39 structures in Pennsylvania are H-frame steel-pole structures which are exhibiting extensive coating failure resulting in ongoing corrosion.
- The steel pole structures have hinged bases and use guying for keeping vertical. The guying system at 19 of the 27 steel pole structures is severely deteriorated.
- Many of the original double rod attachments for supporting the crossarms to the steel poles have failed and have been replaced with wire supports.
- Since 2014, the line has had seven scheduled repair outages and four protection-operated outages due to failure of line equipment.

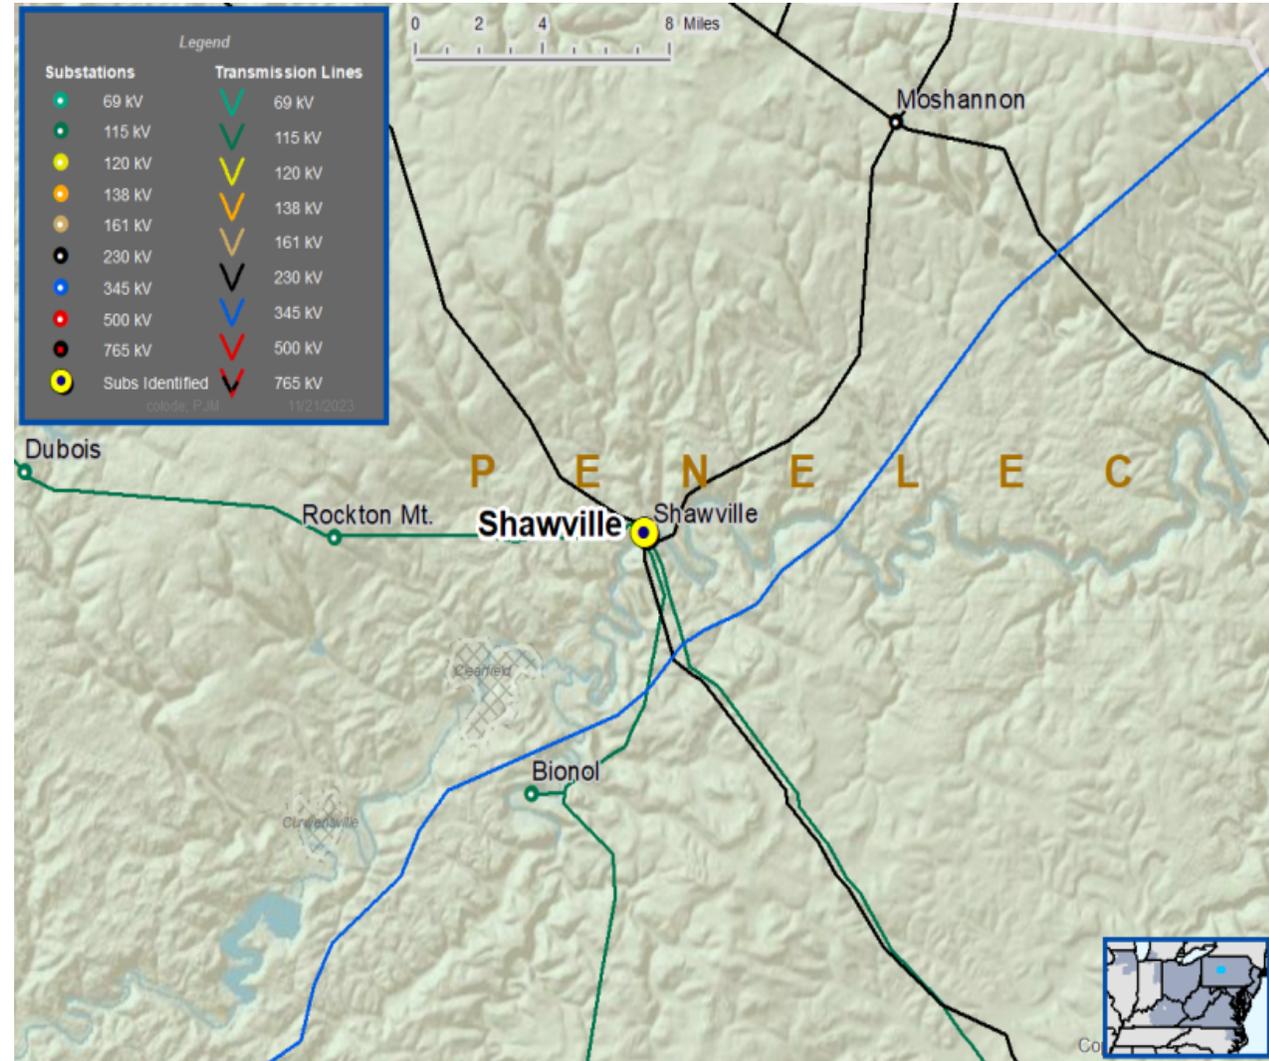
Need Numbers: PN-2023-030

- The Shawville 1A 230/115-17 kV Transformer is approximately 69 years old and serves as both a GSU and transmission transformer.
- The transformer has exhibited maintenance issues and has been requiring more frequent nitrogen additions due to leaks.
- Existing transformer ratings:
 - 141/186/230 MVA SN/SE/SLD
 - 181/222/230 MVA WN/WE/WLD

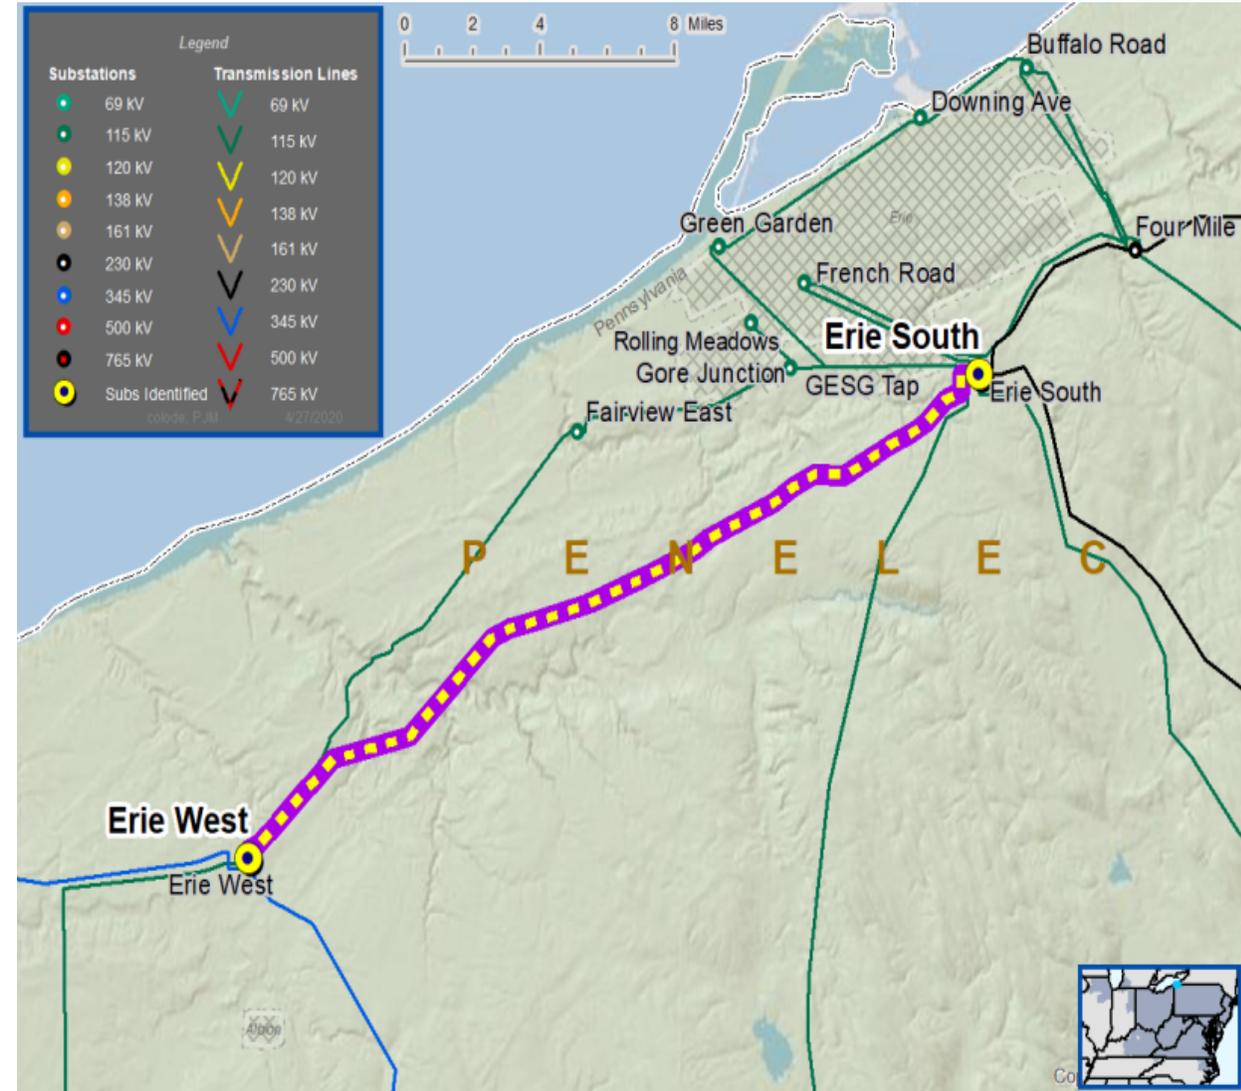
Need Number: PN-2020-005

- FirstEnergy has identified protection schemes using a certain vintage of relays and communication equipment that have a history of misoperation.
- Proper operation of the protection scheme requires all the separate components perform adequately during a fault.
- In many cases the protection equipment cannot be repaired due to a lack of replacement part and available expertise in the outdated technology.
- Transmission line ratings are limited by terminal equipment.

Need Number	Transmission Line / Substation Locations	Existing Line Rating (SN / SE)	Existing Conductor Rating (SN / SE)	Limiting Terminal Equipment
PN-2020-005	Erie South – Erie West 345 kV Line	1216 / 1308	1631 / 1989

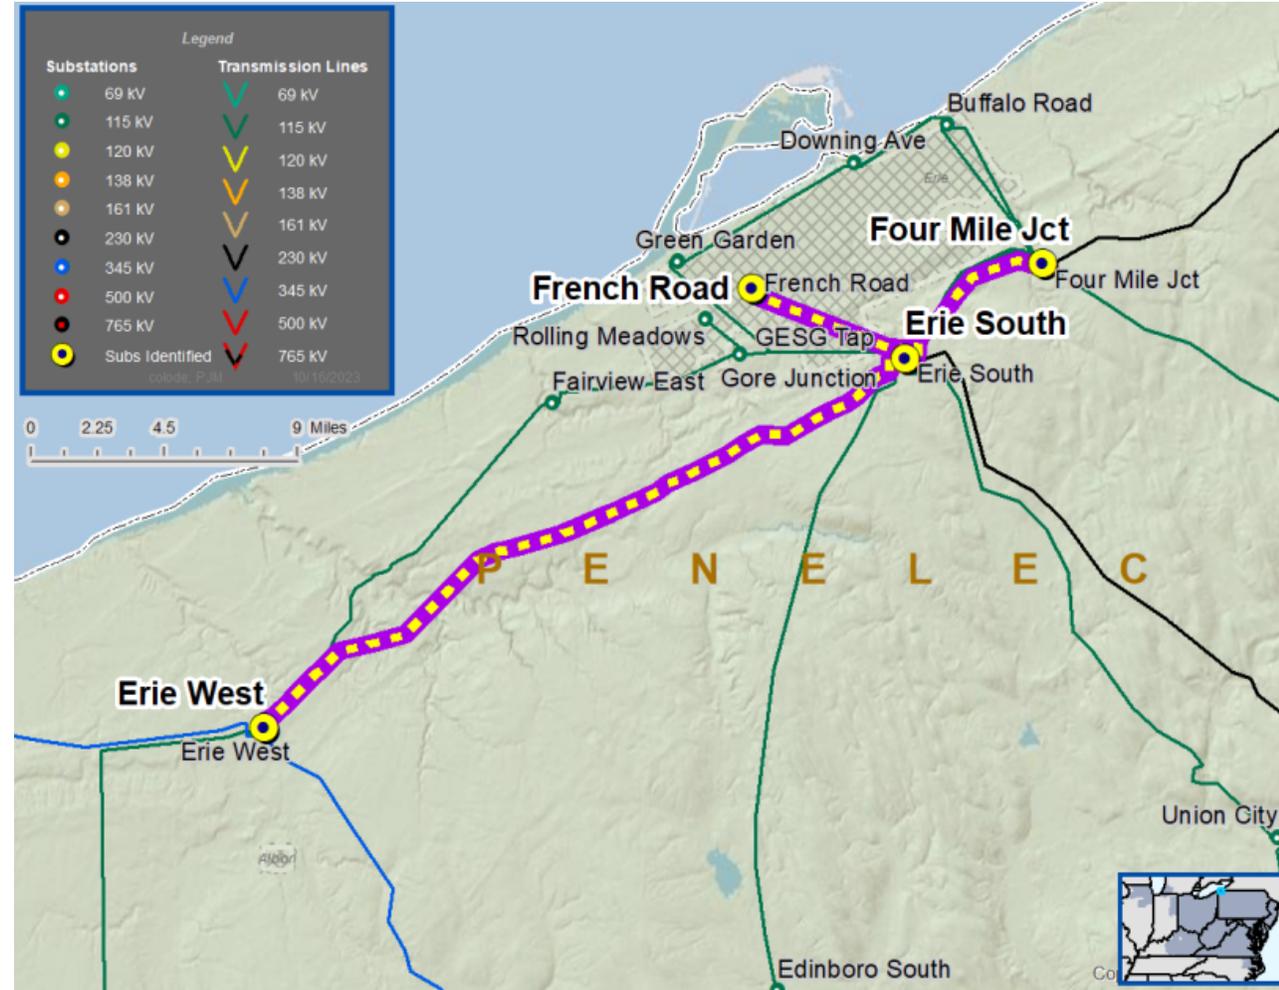
Need Numbers: PN-2023-018

- The existing control building at Erie South is congested. There is not sufficient space for relay panel upgrades.
- FirstEnergy has identified protection schemes using a certain vintage of relays and communication equipment that have a history of misoperation.
- Proper operation of the protection scheme requires all the separate components perform adequately during a fault.
- In many cases the protection equipment cannot be repaired due to a lack of replacement parts and available expertise in the outdated technology.
- Transmission line ratings are limited by terminal equipment.

Penelec Transmission Zone M-3 Process Erie South Substation

Need #	Transmission Line	New MVA Line Rating (SN / SE / WN / WE)	Scope of Work	Estimated Cost	Target ISD
PN-2020-005 and PN-2023-018	Erie South – Erie West 345 kV	1631 / 1989 / 1848 / 2358	<ul style="list-style-type: none"> At Erie South, replace relaying & line trap At Erie West, replace relaying & line trap 	\$10.7 M	6/3/2028
	Erie South – Warren 230 kV	546 / 666 / 619 / 790	<ul style="list-style-type: none"> At Erie South, replace relaying & line trap 		
	Erie South – Four Mile Junction 230 kV	546 / 666 / 619 / 790	<ul style="list-style-type: none"> At Erie South, replace relaying & substation conductor 		
	Erie South – French Road No. 2 115 kV	137 / 174 / 171 / 201	<ul style="list-style-type: none"> At Erie South, replace relaying
