Subregional RTEP Committee – Mid-Atlantic FirstEnergy Supplemental Projects

Penelec Transmission Zone M-3 Process Cooper and Prospect Substation Terminal Upgrades

Penelec Transmission Zone M-3 Process East Pike – Glory 115 kV Line

Penelec Transmission Zone M-3 Process Blairsville East – Shelocta 115 kV Line

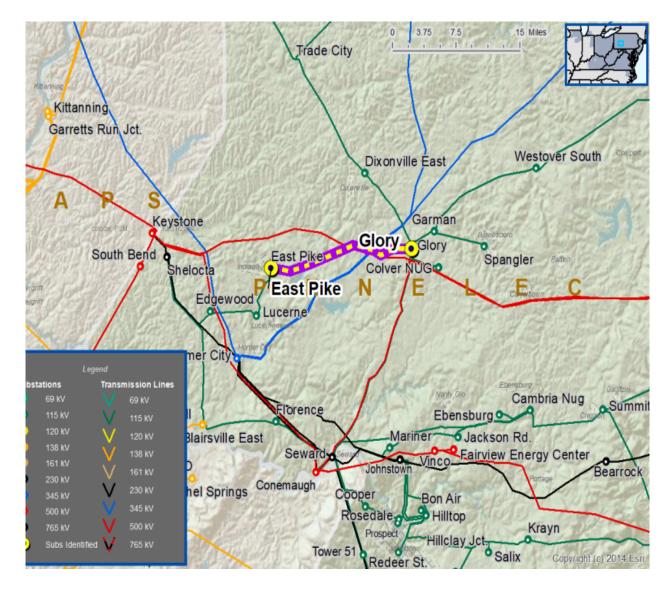
- The East Pike Glory 115 kV Line was constructed approximately 66 years ago and is approaching end of life. The line is approximately 13 miles long with 104 wood pole and two lattice transmission line structures.
- Per recent inspections, the line is exhibiting deterioration. Inspection findings include:
 - 56 structures have cracked/deteriorated wood poles and/or braces.
 - 14 structures are phase raised.
- Since 2019, the line has had two unscheduled, sustained outages.
- East Pike Glory 115 kV Line
 - Existing Transmission Line Rating: 202 / 245 / 228 / 290 MVA (SN/SE/WN/WE)
 - Existing Transmission Conductor Line Rating: 202 / 245 / 228 / 290 MVA (SN/SE/WN/WE)

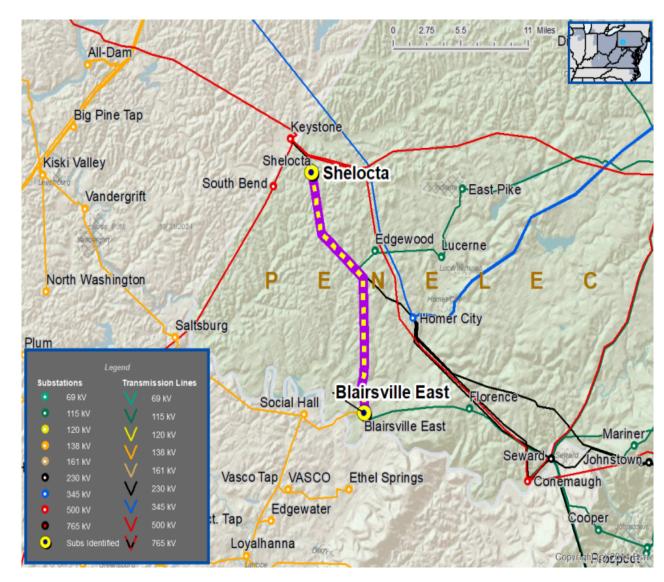
- The Blairsville East Shelocta 115 kV Line was constructed approximately 60 years ago and is approaching end of life. The line is approximately 15 miles long with 96 wood pole and one steel transmission line structures.
- Per recent inspections, the line is exhibiting deterioration. Inspection findings include:
 - 29 structures have woodpecker damage and require replacement.
 - 93 structures have shell rot.
 - 118 historical repair conditions on structures due to hardware degradation.
- Since 2020, the line has had four unscheduled, sustained outages.
- The line is currently limited by terminal equipment.
- Blairsville East Shelocta 115 kV Line
 - Existing Transmission Line Rating: 147 / 191 / 211 / 237 MVA (SN/SE/WN/WE)
 - Existing Transmission Line Conductor Rating: 201 / 244 / 227 / 288 MVA (SN/SE/WN/WE)
