Subregional RTEP Committee – Mid-Atlantic FirstEnergy Supplemental Projects

JCPL Transmission Zone

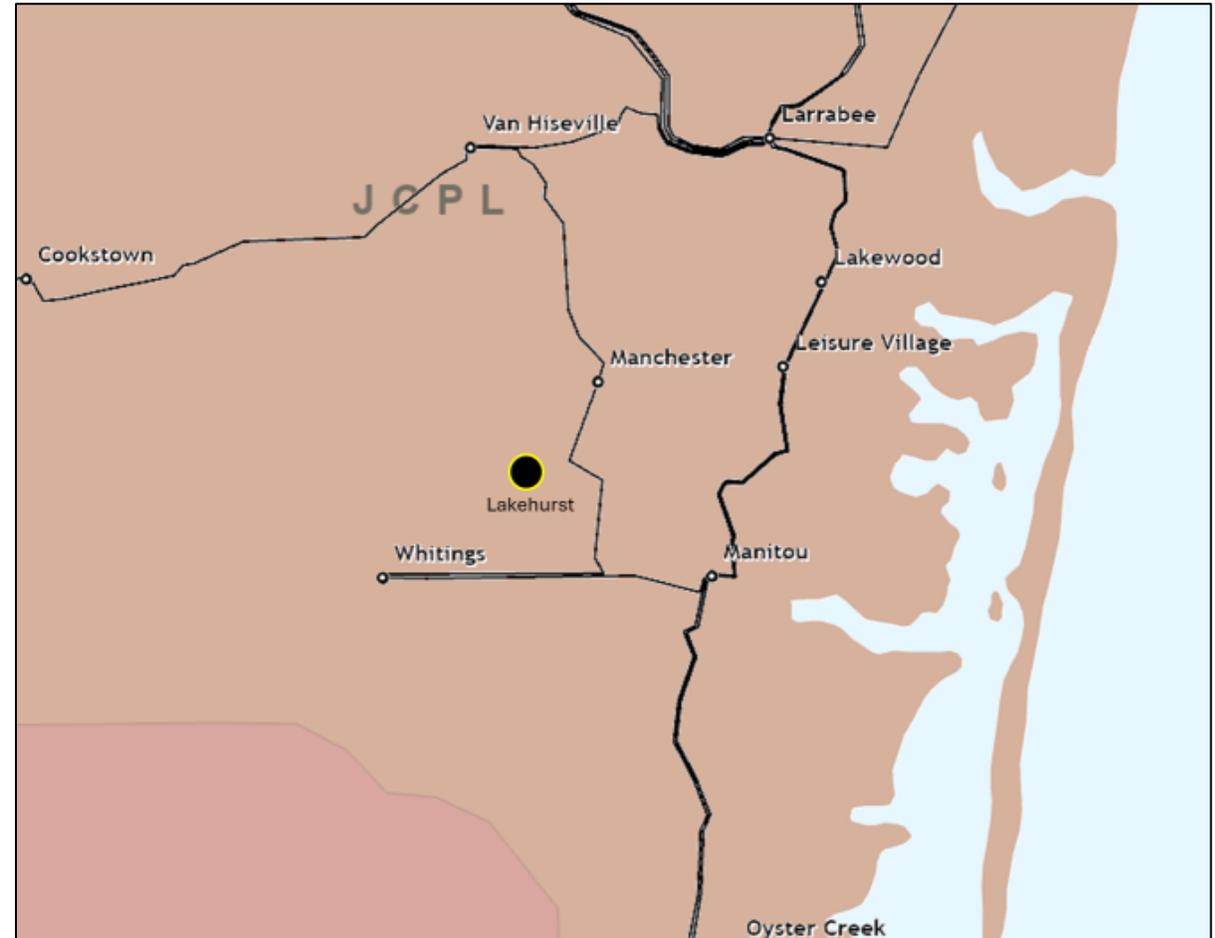
Need Number: JCPL-2026-006

The existing Lakehurst 34.5 kV oil circuit breakers N223, O41, W777, BK2A, BK2B, E109, N140 are over 50 years old and are approaching end of life.

- Lakehurst - Ship Test 34.5 kV E109 Line - 25 / 25 / 25 / 25 MVA (SN/SE/WN/WE)
- Lakehurst - Navy 34.5 kV E109 Line - 18 / 18 / 19 / 19 MVA (SN/SE/WN/WE)

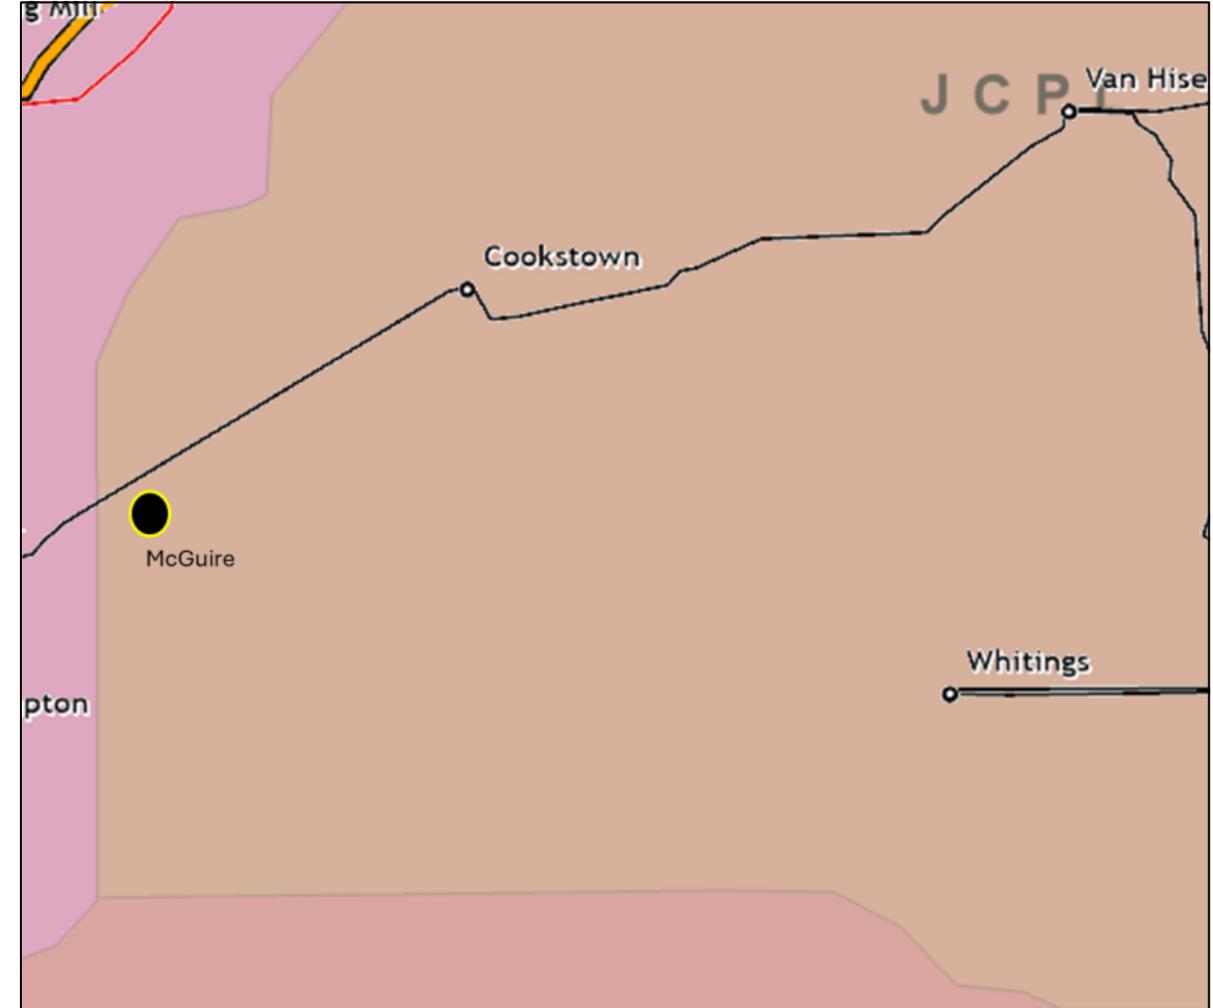
Need Number: JCPL-2026-007

A bus fault or breaker fault at McGuire Substation results in the loss of the entire McGuire Substation. McGuire Substation serves 4,000 customers and approximately 30 MW of load.

Cookstown - McGuire 34.5 kV G33 Line:

- Existing line rating: 27 / 34 / 34 / 38 MVA (SN/SE/WN/WE)
- Existing conductor rating: 44 / 53 / 50 / 63 MVA (SN/SE/WN/WE)

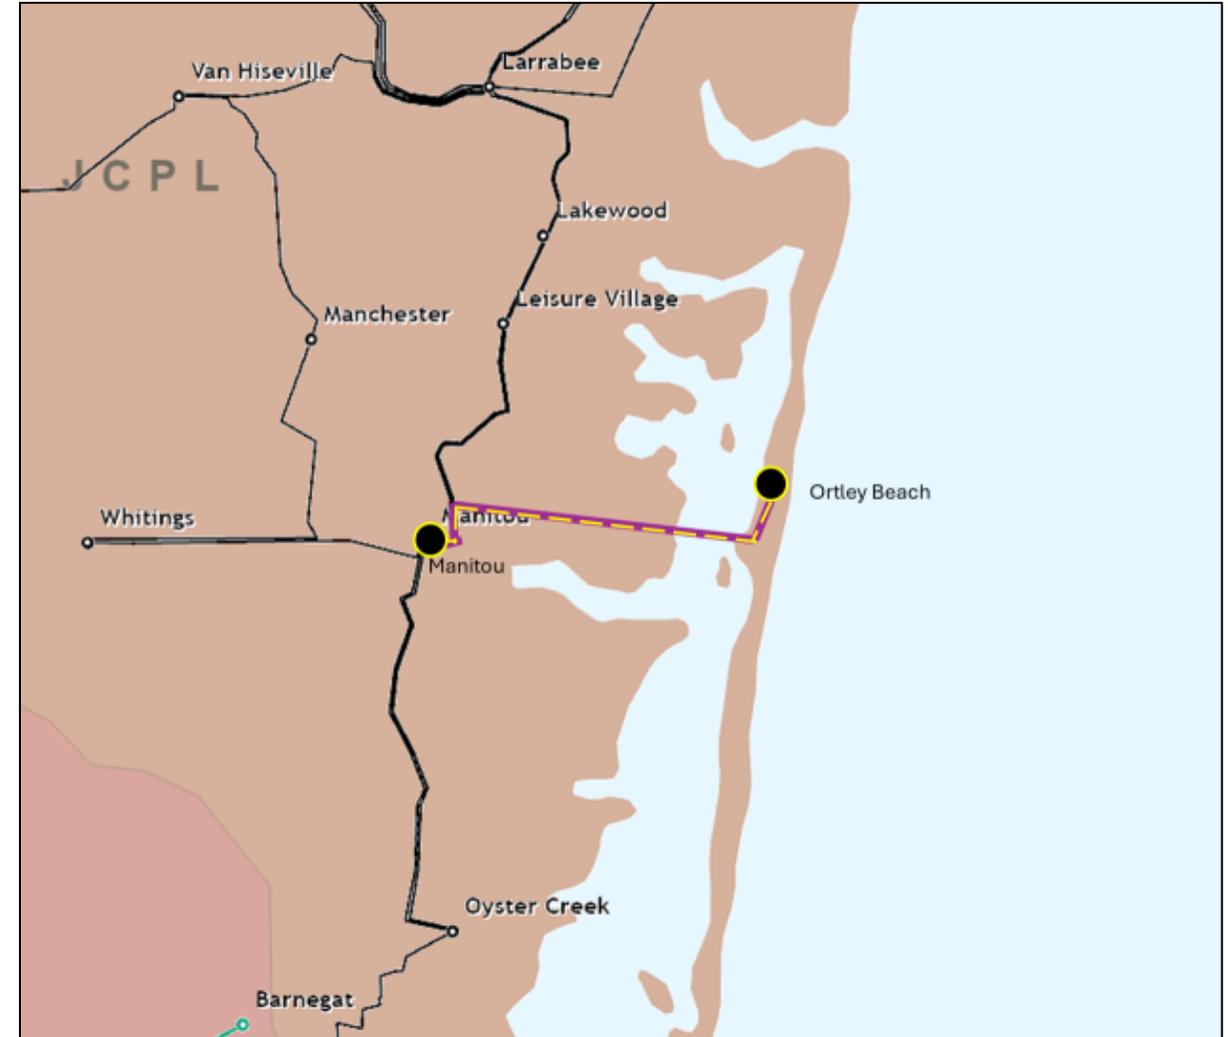
Need Number: JCPL-2026-008

The Manitou - Ortley Beach 34.5 kV V126 Line was constructed approximately 75 years ago and is approaching end of life. It is 9.6 miles long with 238 wood pole transmission line structures.

- 35 / 44 / 35 / 44 MVA (SN/SE/WN/WE)

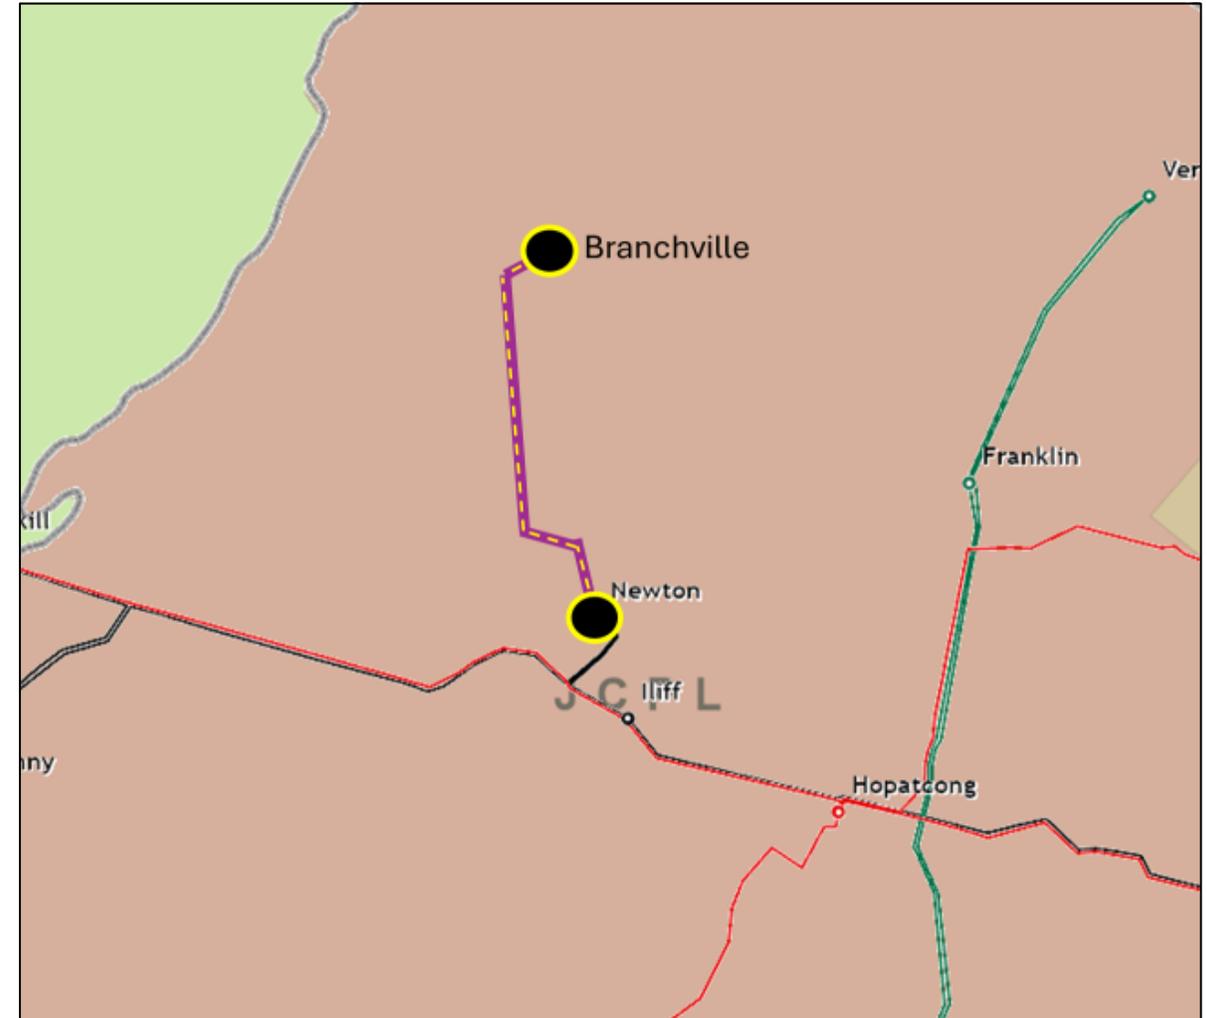
Need Number: JCPL-2026-022

The Branchville - Newton 34.5 kV F708 Line has experienced real-time overloads during high-load conditions, particularly when local battery storage facilities charge. These overloads exceed normal and occasionally emergency ratings, requiring operational intervention. Transmission Operations has curtailed the generating unit(s) to alleviate the overload. The Branchville - Newton 34.5 kV F708 Line directly serves 5,500 customers and 10 MVA of load.

- 44 / 53 / 50 / 63 MVA (SN/SE/WN/WE)

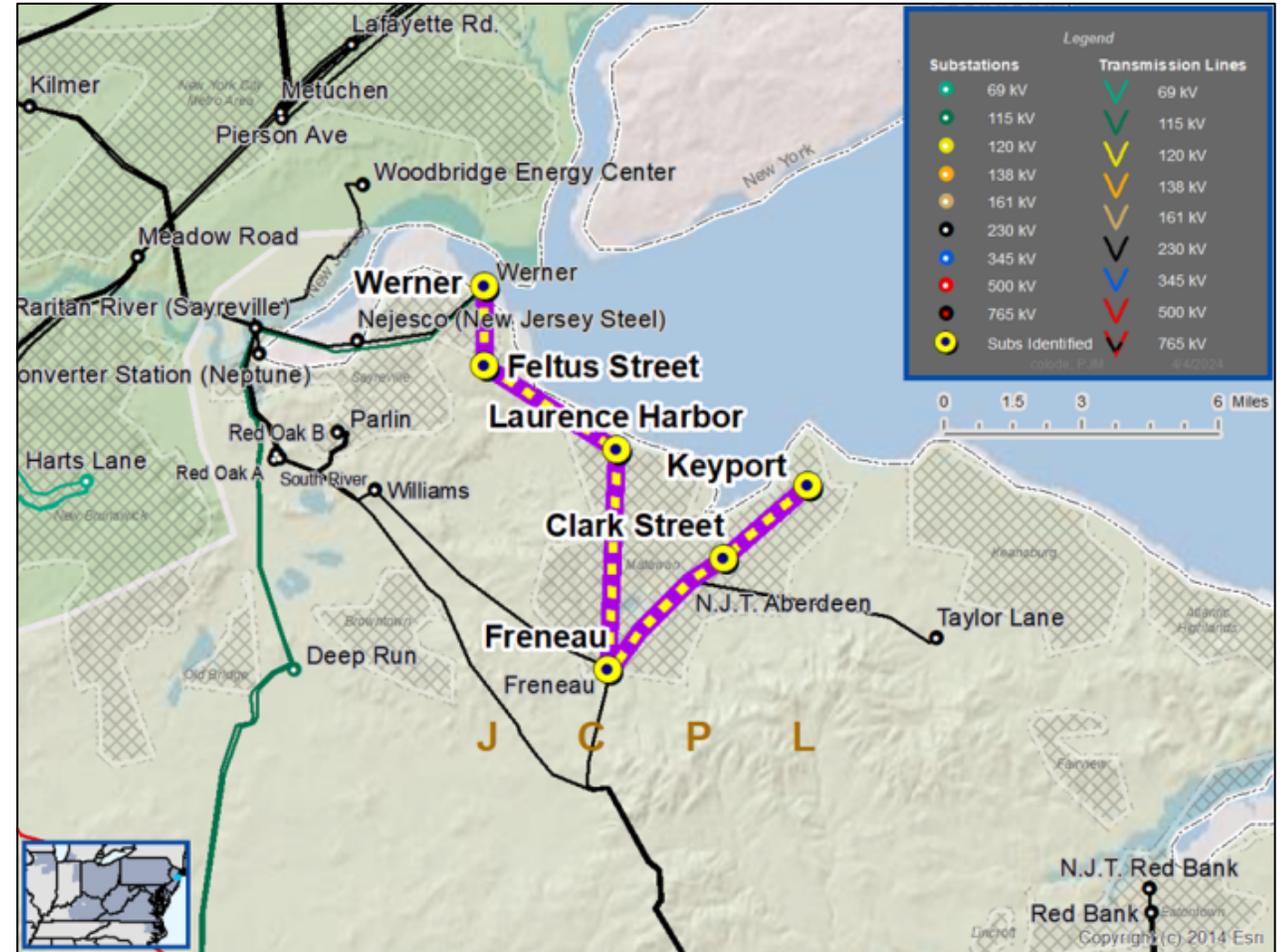
Need Number: JCPL-2024-012

- The EH Werner – Freneau – Keyport 34.5 kV E31 Line was constructed approximately 92 years ago and is approaching end of life. It is approximately 13 miles long with 424 wood pole transmission line structures.
- The line is exhibiting deterioration resulting in increased maintenance costs.

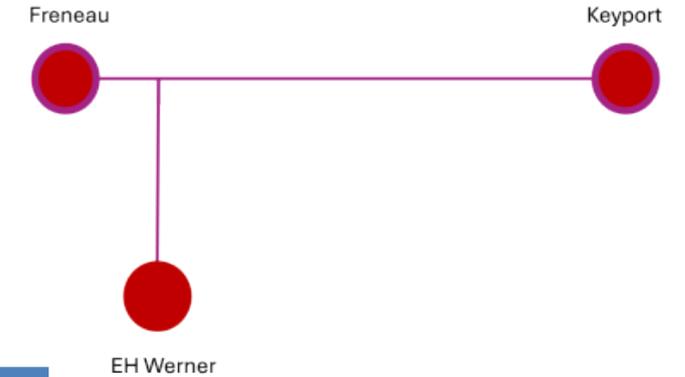
- Rebuild the EH Werner- Freneau- Keyport 34.5 kV E31 Line (6.9 miles total) with new conductor.
- Replace limiting sub conductor at Freneau and Keyport substations.

Transmission Line	Before Proposed Solution MVA (SN / SE / WN / WE)	After Proposed Solution MVA (SN / SE / WN / WE)
Clark Street – Keyport 34.5 kV E31 Line	44 / 53 / 50 / 63	55 / 67 / 63 / 79
Clark St - Clark St Tap E31 34.5 kV Line	55 / 67 / 63 / 79	55 / 67 / 63 / 79
Clark St Tap - Freneau E31 34.5 kV Line	53 / 62 / 63 / 71	55 / 67 / 63 / 79
Clark St Tap - Laurence E31 34.5 kV Line	35 / 44 / 35 / 44	55 / 67 / 63 / 79
Feltus St - Laurence E31 34.5 kV Line	35 / 44 / 35 / 44	55 / 67 / 63 / 79
Feltus St - Werner E31 34.5 kV Line	44 / 53 / 50 / 62	55 / 67 / 63 / 79
