Subregional RTEP Committee – Mid-Atlantic FirstEnergy Supplemental Projects Penelec Transmission Zone

Need Number: PN-2026-006

The French Road (Erie South) No. 2 115 kV Line was constructed approximately 64 years ago and is approaching end of life. It is 2.6 miles long with 61 wood H-Frame transmission line structures.

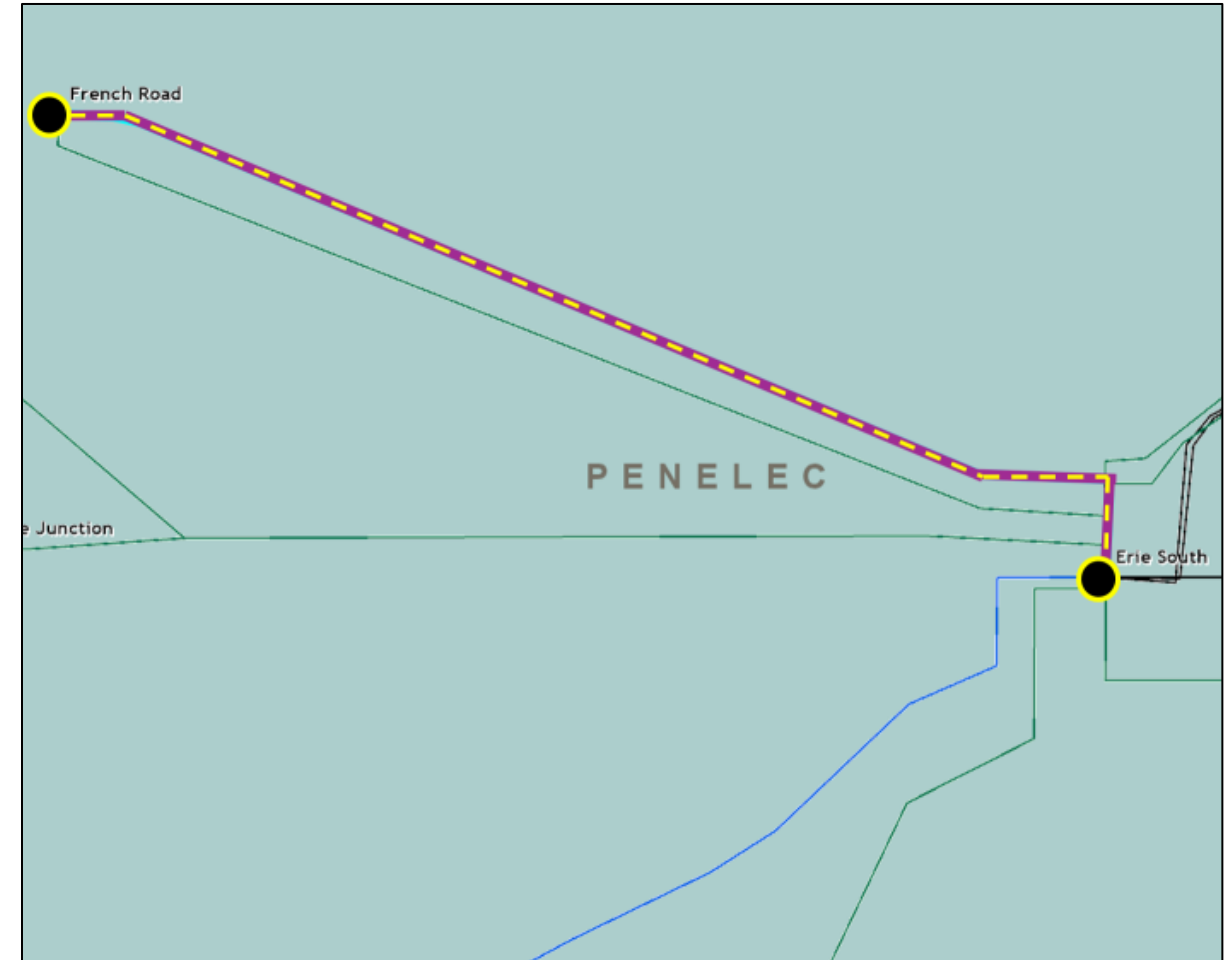
Per recent inspections, the line is exhibiting deterioration. Inspection findings include:

- 24 poles require repair due to deterioration
- 61 poles require replacement due to deterioration
- 61 structures require repairs to insulators and related hardware
- 29 structures failed inspection due to sound test, woodpecker damage, top rot, decay, cracking, and/ or delamination of cross-arms.

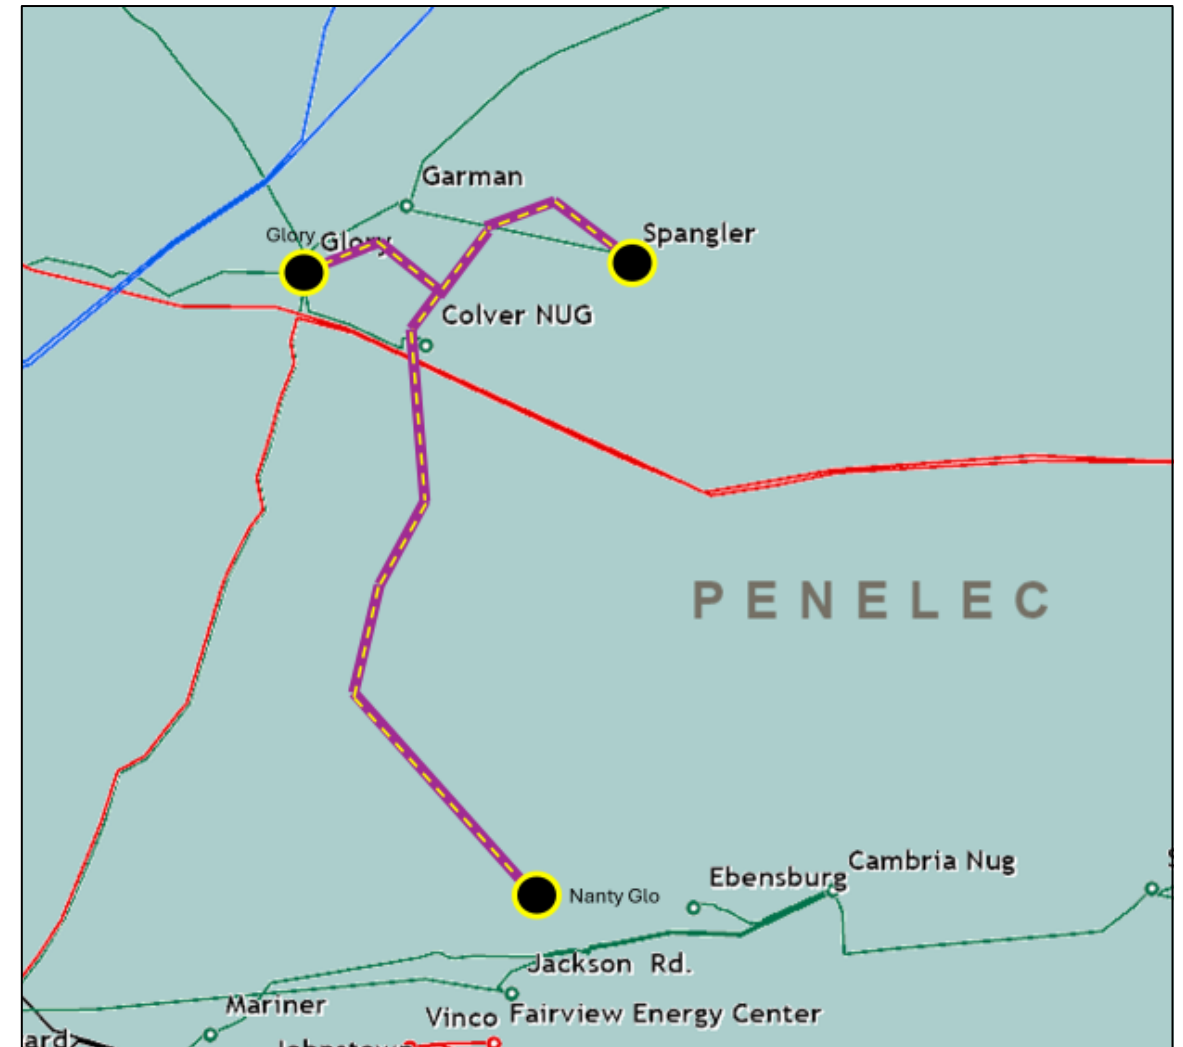
Need Number: PN-2026-007

The existing Glory - Nanty Glo - Spangler 46 kV N Line switches (A-111, A-112, and A-113) are 44 years old and are approaching end of life. Replacement components are difficult to source leading to non-standard repair.

The line is currently limited by terminal equipment.

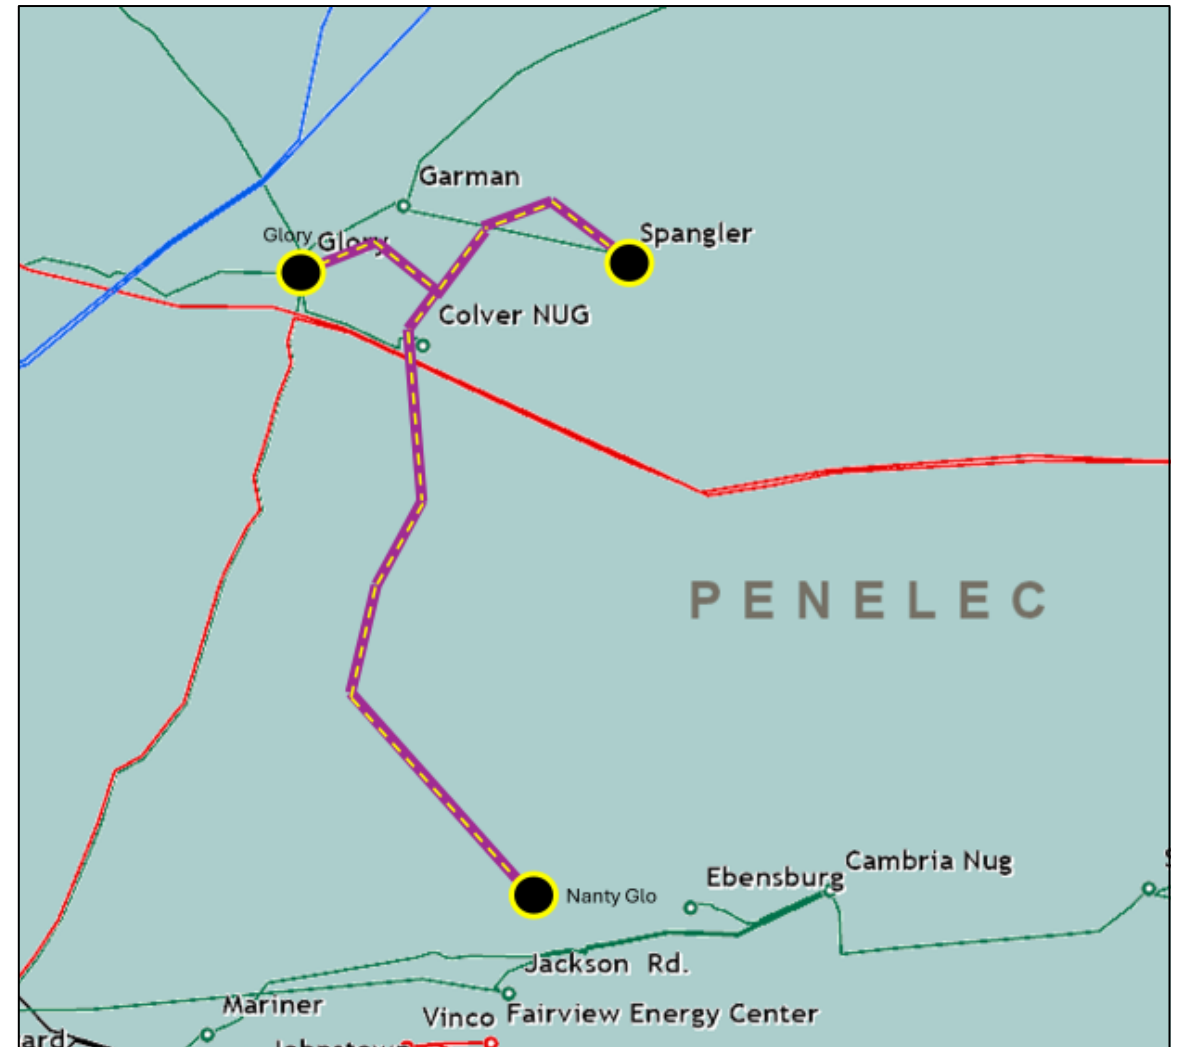
Need Number: PN-2026-007

- Glory - Nicktown Ckt (A-112 Switch) (Glory - Nanty Glo - Spangler 46 kV N Line)
 - Existing Transmission Line Ratings: 34 / 44 / 49 / 55 MVA (SN/SE/WN/WE)
 - Existing Conductor Ratings: 49 / 50 / 55 / 55 MVA (SN/SE/WN/WE)
- Nicktown - Moss Creek Ckt (A-111 Switch) (Glory - Nanty Glo - Spangler 46 kV N Line)
 - Existing Transmission Line Ratings: 55 / 69 / 72 / 83 MVA (SN/SE/WN/WE)
 - Existing Conductor Ratings: 81 / 98 / 91 / 116 MVA (SN/SE/WN/WE)
- Teakettle - Nicktown Ckt (A-113 Switch) (Glory - Nanty Glo - Spangler 46 kV N Line)
 - Existing Transmission Line Ratings: 55 / 69 / 72 / 83 MVA (SN/SE/WN/WE)
 - Existing Conductor Ratings: 81 / 98 / 91 / 116 MVA (SN/SE/WN/WE)

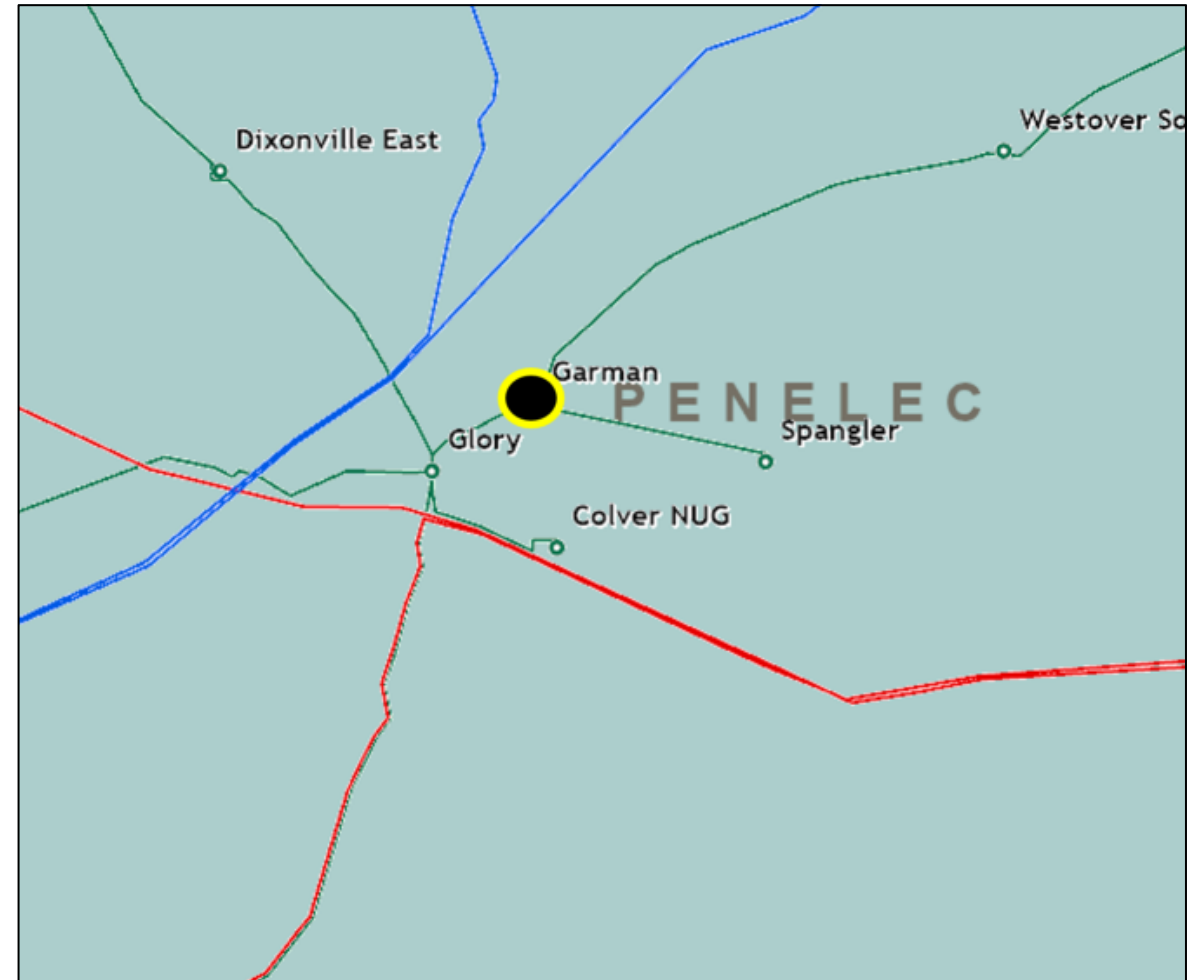
Need Number: PN-2026-008

The existing B3 115 kV breaker at Garman Substation is 59 years old and is approaching end of life.

The line is currently limited by terminal equipment.

- Existing Transmission Line Ratings: 193 / 246 / 242 / 284 MVA (SN/SE/WN/WE)
- Existing Conductor Ratings: 232 / 282 / 263 / 334 MVA (SN/SE/WN/WE)

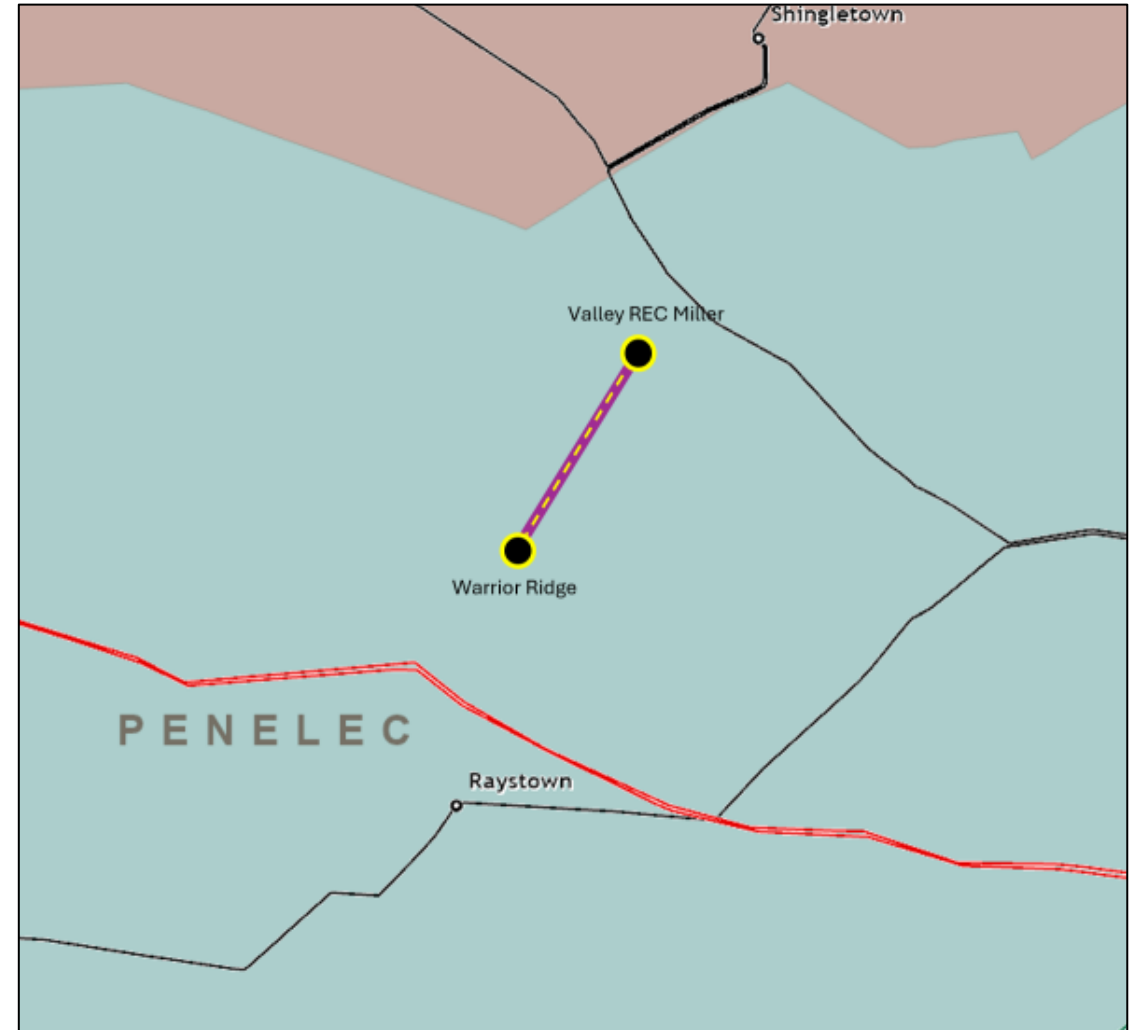
Need Number: PN-2026-010

The Miller REC (Warrior Ridge) 46 kV Line was constructed approximately 76 years ago and is approaching end of life. It is approximately 8 miles long with 90 wood transmission line structures.

The line conductor is exhibiting deterioration. Inspection findings include:

- No static wire for approximately two miles due to cut and clear after a failure
- Of 35% of structures able to be accessed, three poles failed sound test, and all had woodpecker holes, decay, rot and/or cracking.
- Ten unscheduled outages since 2021 including four due to equipment failures

Existing Transmission Line Ratings: 32 / 32 / 35 / 35 MVA (SN/SE/WN/WE)

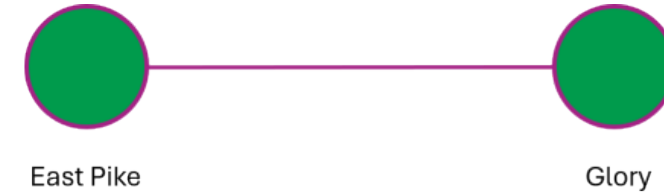
Need number: PN-2024-027

Rebuild 13.04 miles on the East Pike - Glory 115 kV Line and install new conductor.

At East Pike Substation, adjust relay settings as necessary.

At Glory Substation, adjust relay settings as necessary.

- Before Proposed Solution: 137 / 177 / 188 / 245 MVA (SN/SE/WN/WE)
- After Proposed Solution: 232 / 282 / 263 / 334 MVA (SN/SE/WN/WE)
