FirstEnergy – Penelec – 2025 Submission of Supplemental Projects for Inclusion in the Local Plan

- Need Number:** PN-2020-004, APS-2020-003
- Process Stage:** Submission of Supplemental Projects for Inclusion in the Local Plan
- Previously Presented:** Solution Meeting – 08/15/2024
Need Meeting – 04/16/2020
- Project Driver:**
Equipment Material Condition, Performance and Risk
- Specific Assumption Reference:**
System Performance Projects Global Factors
- System reliability and performance
 - Substation/line equipment limits
- Upgrade Relay Schemes
- Obsolete and difficult to repair communication equipment (DTT, Blocking, etc.)
 - Communication technology upgrades
- Continued on next slide...**

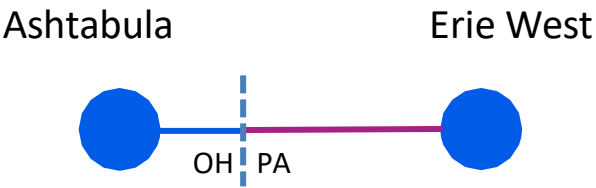
Penelec Transmission Zone M-3 Process Perry – Ashtabula – Erie West 345 kV Line

- Selected Solution:**
- Rebuild the 7.2 mile, Penelec section of the Ashtabula – Erie West 345 kV Line
- At Erie West:
- Replace disconnect switches.
- At Ashtabula:
- Revise relay settings

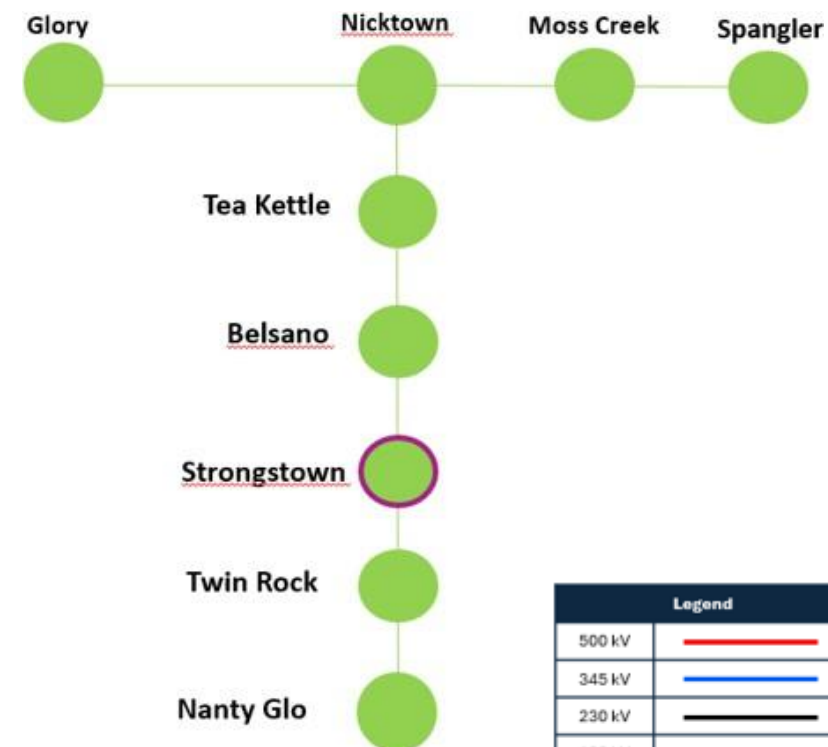
Strongstown - Belsano Replace line switch A119:

- Relocate and replace obsolete and non-repairable line switch Strongstown - Belsano A119.
- Upgrade switch to include SCADA controlled motor operators.
- Remove 4-pole wood structure and replace with appropriate tap structure.

Strongstown - Twin Rock Replace line switch A120:

- Relocate and replace obsolete and non-repairable line switch Strongstown - Twin Rock A120.
- Upgrade switches to include SCADA controlled motor operators.
- Remove 4-pole wood structure and replace with appropriate tap structure.
