Subregional RTEP Committee – Western FirstEnergy Supplemental Projects

March 14, 2025

Need Number: APS-2025-006

Huntingdon - Springdale 138 kV Line:

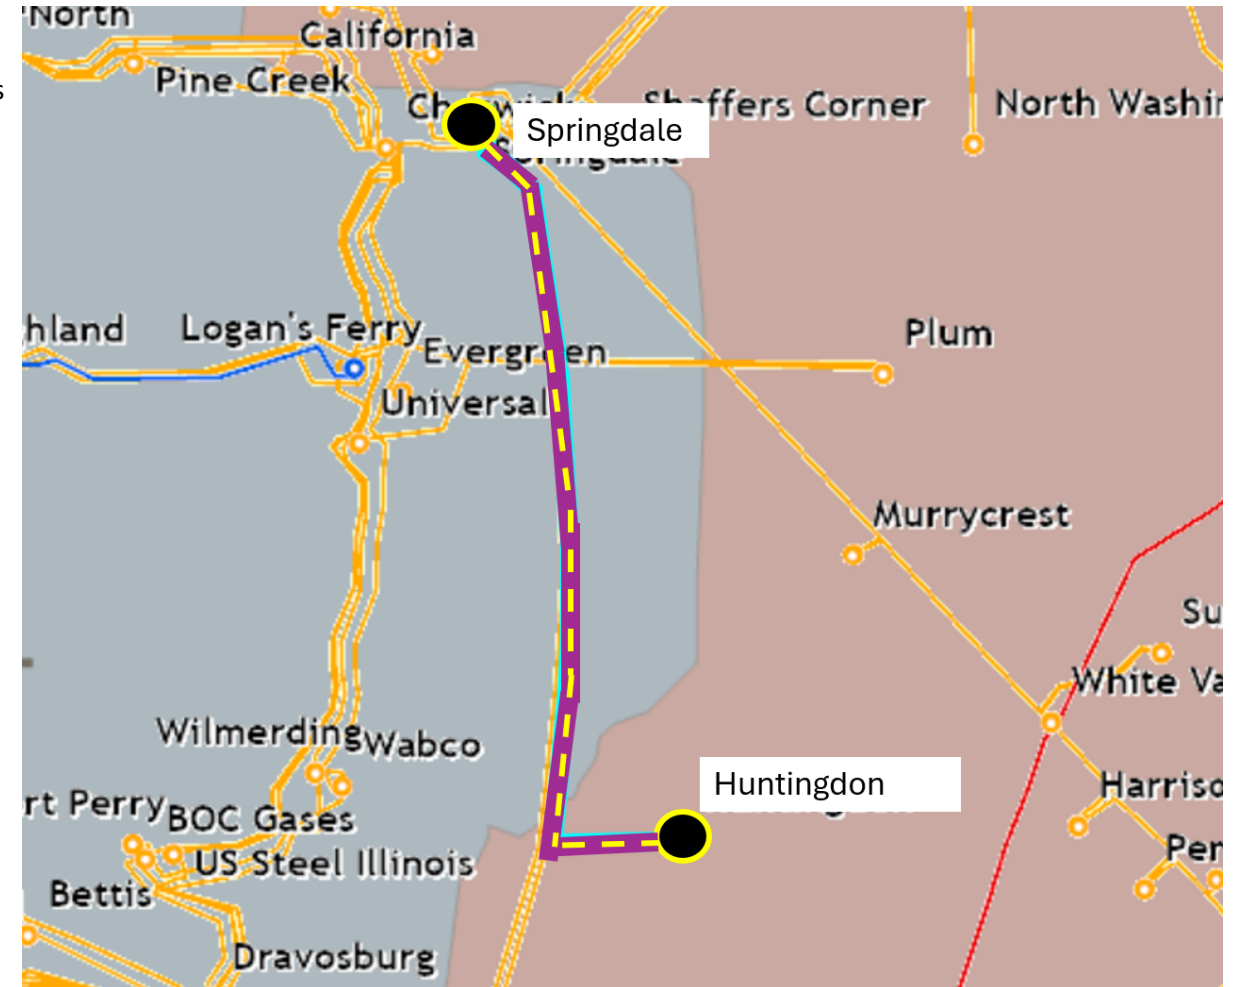
- Existing line ratings: 267 / 287 / 287 / 287 MVA SN/SE/WN/WE
- Existing conductor ratings: 297 / 365 / 345 / 441 MVA SN/SE/WN/WE
