Subregional RTEP Committee – Western FirstEnergy Supplemental Projects

January 16, 2026

Needs

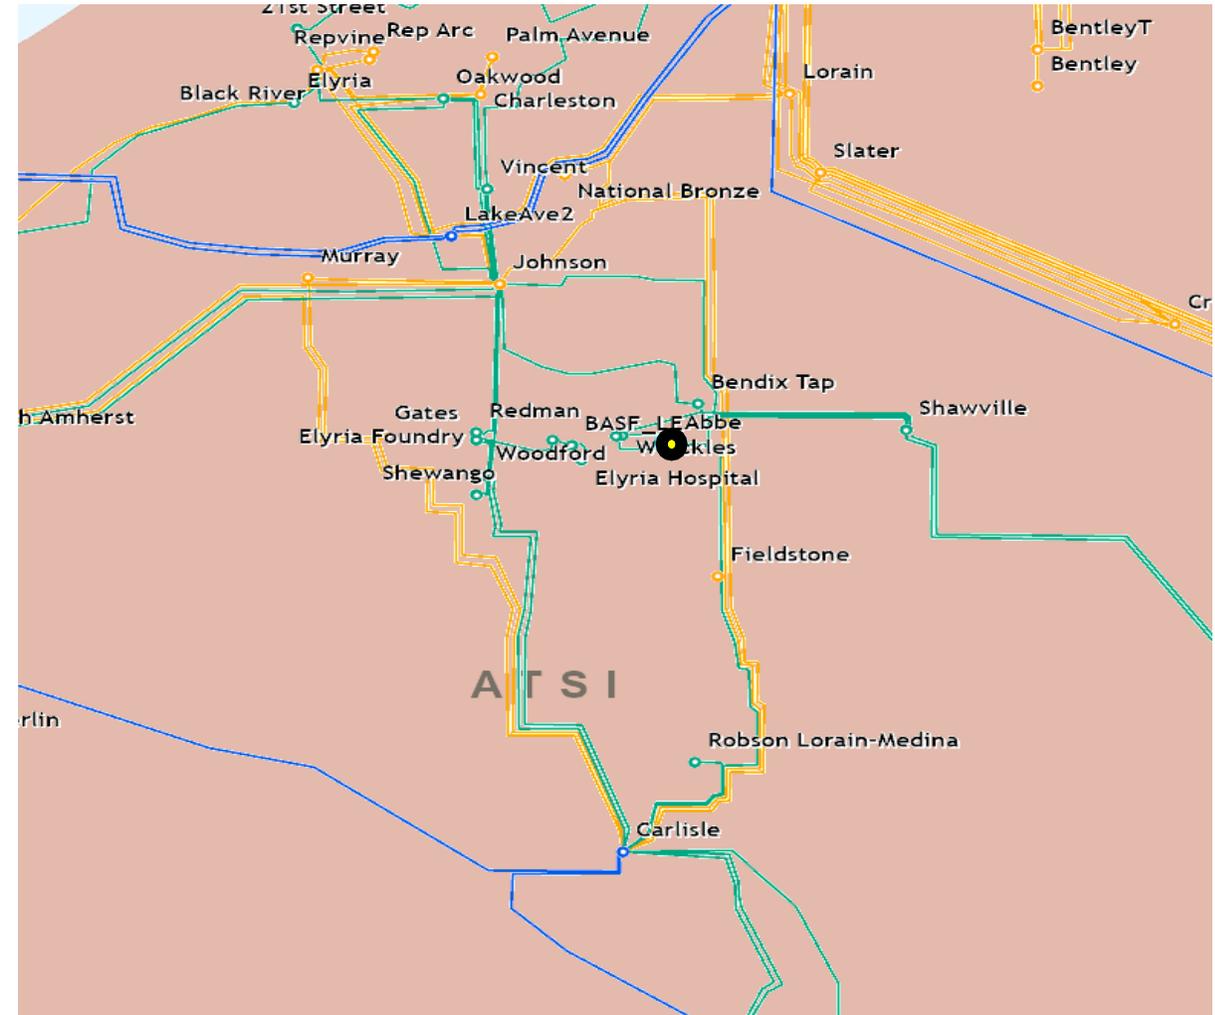
Need Number: ATSI-2026-001
Process Stage: Need Meeting 01/16/2026
Project Driver:
 Operational Flexibility and Efficiency

Problem Statement:
 The Abbe - Carlisle No. 2 69 kV Line is approximately five miles long and operated radially. The line serves the LMREC Robson Muni which has approximately 1,700 customers and 9 MW of load.

The Abbe - Carlisle No. 1 69 kV Line overloads 114.87% of its 115 MVA summer emergency rating for the Johnson 69 kV bus fault contingency in the 2025 RTEP case for 2030 Summer 50/50 case.

Over the past five years, the Abbe - Carlisle No. 1 and No. 2 69 kV lines have experienced three sustained unscheduled outages.

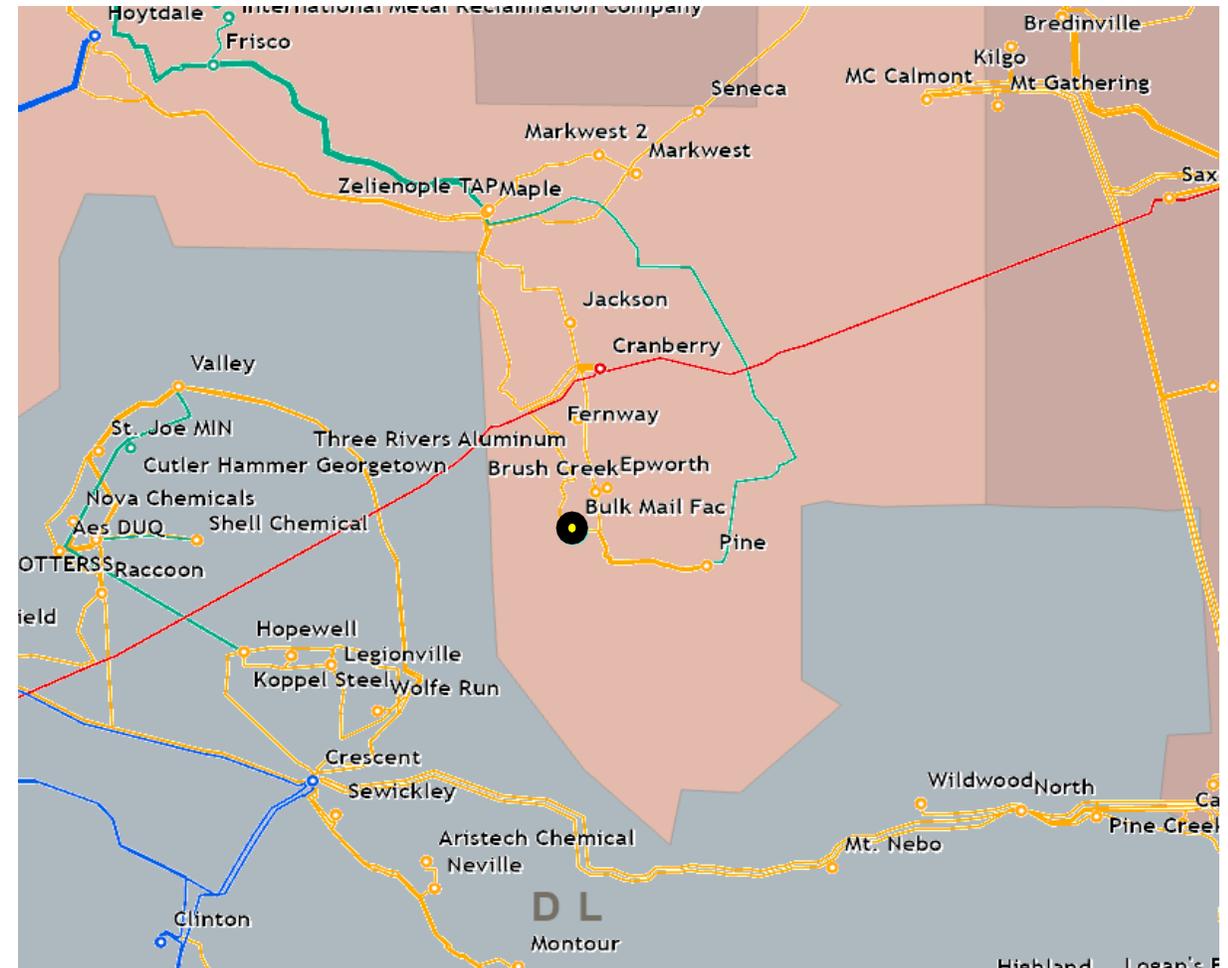
Need Number: ATSI-2026-002

The existing Bulk Mail Facility 138 kV breaker B4 is 61 years old and is approaching end of life. The breaker using a pneumatic system for closing energy. The system has frequent air leaks and are difficult to maintain. Due to frequent air leaks, there is a risk the breaker is unable to close due to low pneumatic pressure.

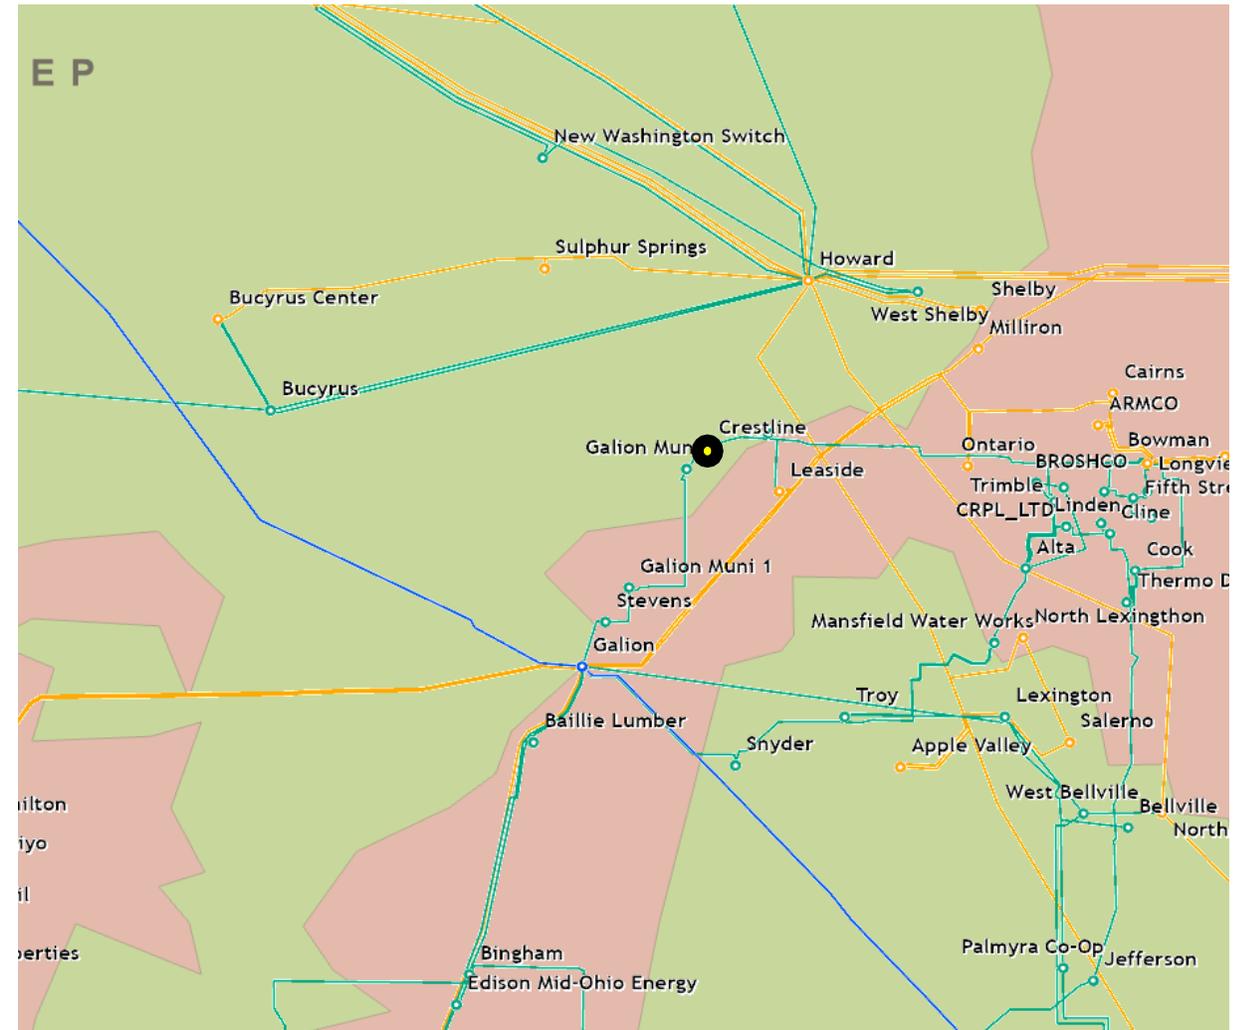
Need Number: ATSI-2026-003
Process Stage: Need Meeting 01/16/2026
Project Driver:
 Equipment Condition/Performance/Risk

Problem Statement:
 The Crestline 69 kV 12.6 MVAR capacitor bank is tapped on the Leaside - Stevens 69 kV Line. In Summer 2024, the capacitor bank tripped several times. The capacitor bank was field inspected and found to have condition issues such as failed cans and bad fuse holders.

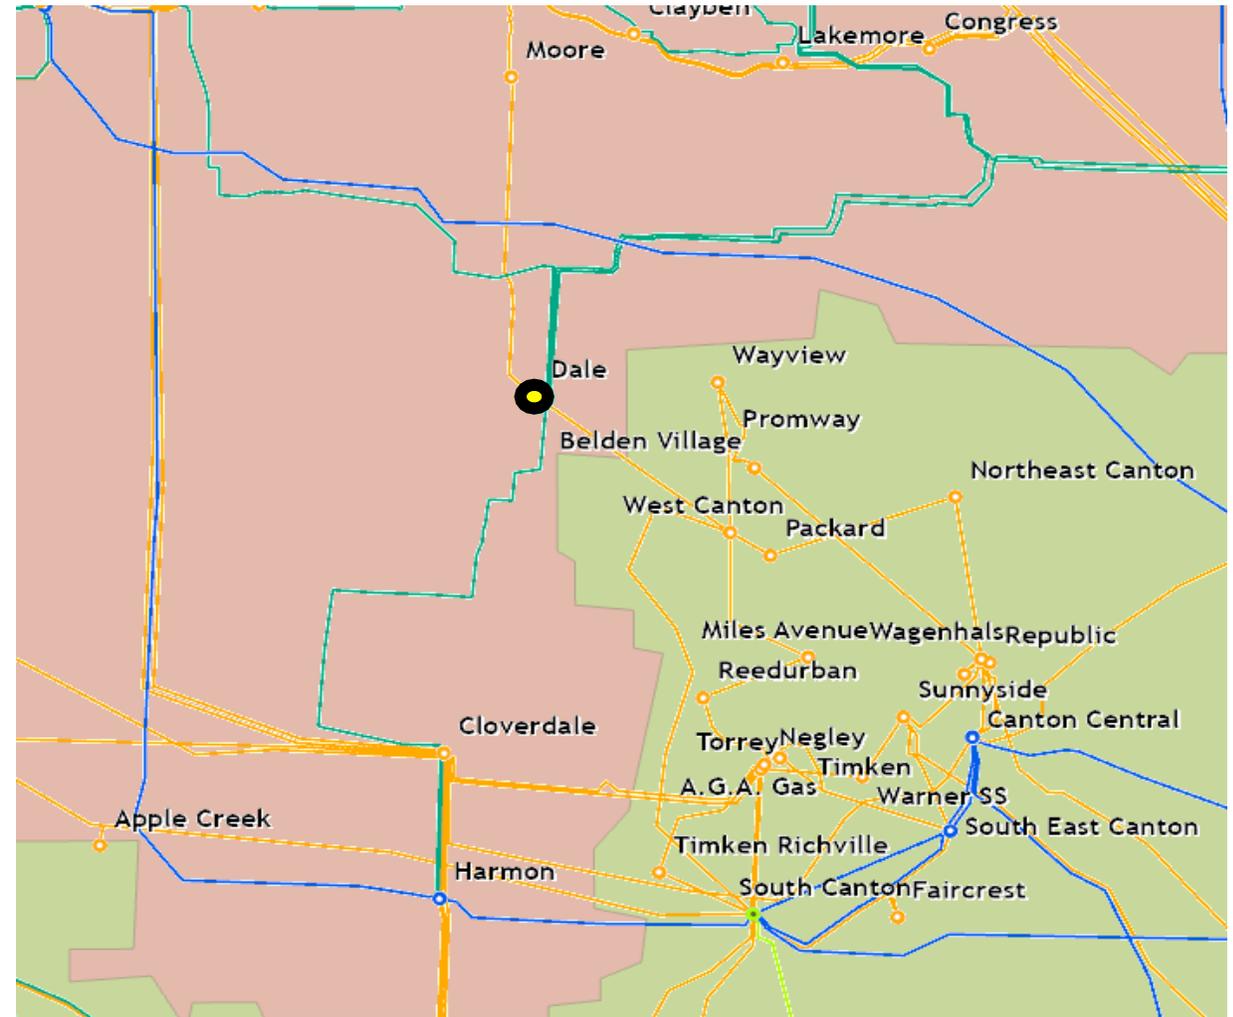
Need Number: ATSI-2026-004
Process Stage: Need Meeting 01/16/2026
Project Driver:
 Equipment Condition/Performance/Risk
 Operational Flexibility and Efficiency

Problem Statement:
 The 138 kV yard at Dale Substation is currently configured as a straight bus with two transmission lines, one 138/69 kV transformer, and one 138-12.47 kV transformer. A fault on the Dale 138 kV bus would result in service interruption to approximately 15,700 customers and 56 MW of load.

Anytime the line section between Dale and Moore substations is interrupted (due to a fault or maintenance) on the Dale - South Akron 138 kV Line, the distribution load at Dale Substation is outaged as well. When this occurs, distribution loads are not able to be transferred to the Strobel Substation due to overloads at Strobel.

The 69 kV yard at Dale Substation is currently configured as a straight bus with a transfer breaker with four transmission lines and one 138/69 kV transformer. A fault on the 69 kV bus or between the bus and the circuit breaker will result in an outage of the entire bus.

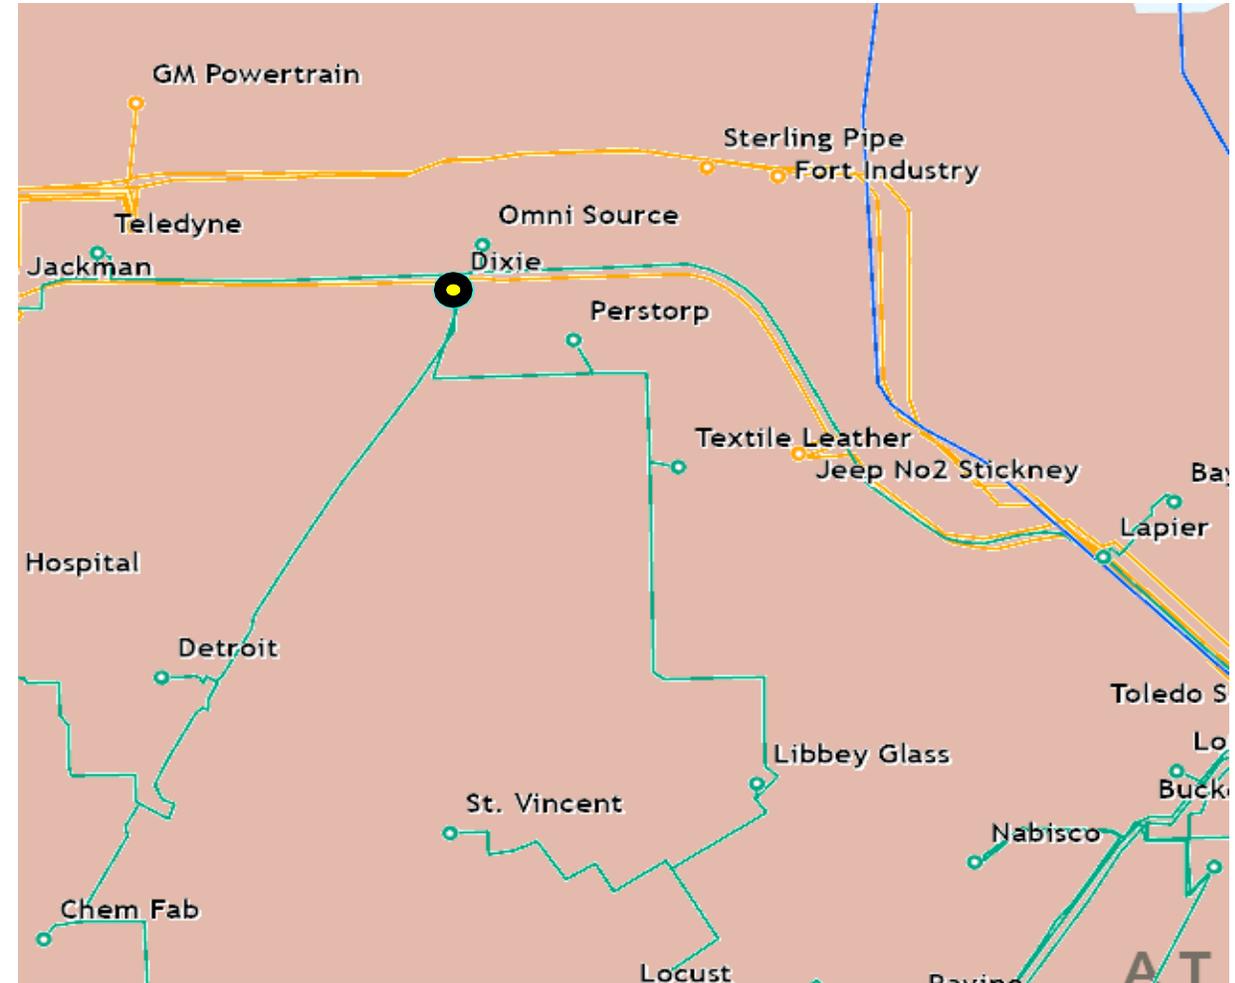
Need Number: ATSI-2026-005
Process Stage: Need Meeting 01/16/2026
Project Driver:
 Equipment Condition/Performance/Risk

Problem Statement:
 The existing Dixie Substation 69 kV breakers B6903, B6904 and B6923 are 60 years old and are approaching end of life. Replacement components for oil circuit breakers are difficult to source in quantity leading to non-standard repairs. The associated disconnect switches and metering PTs/CTs are also past their expected service life.

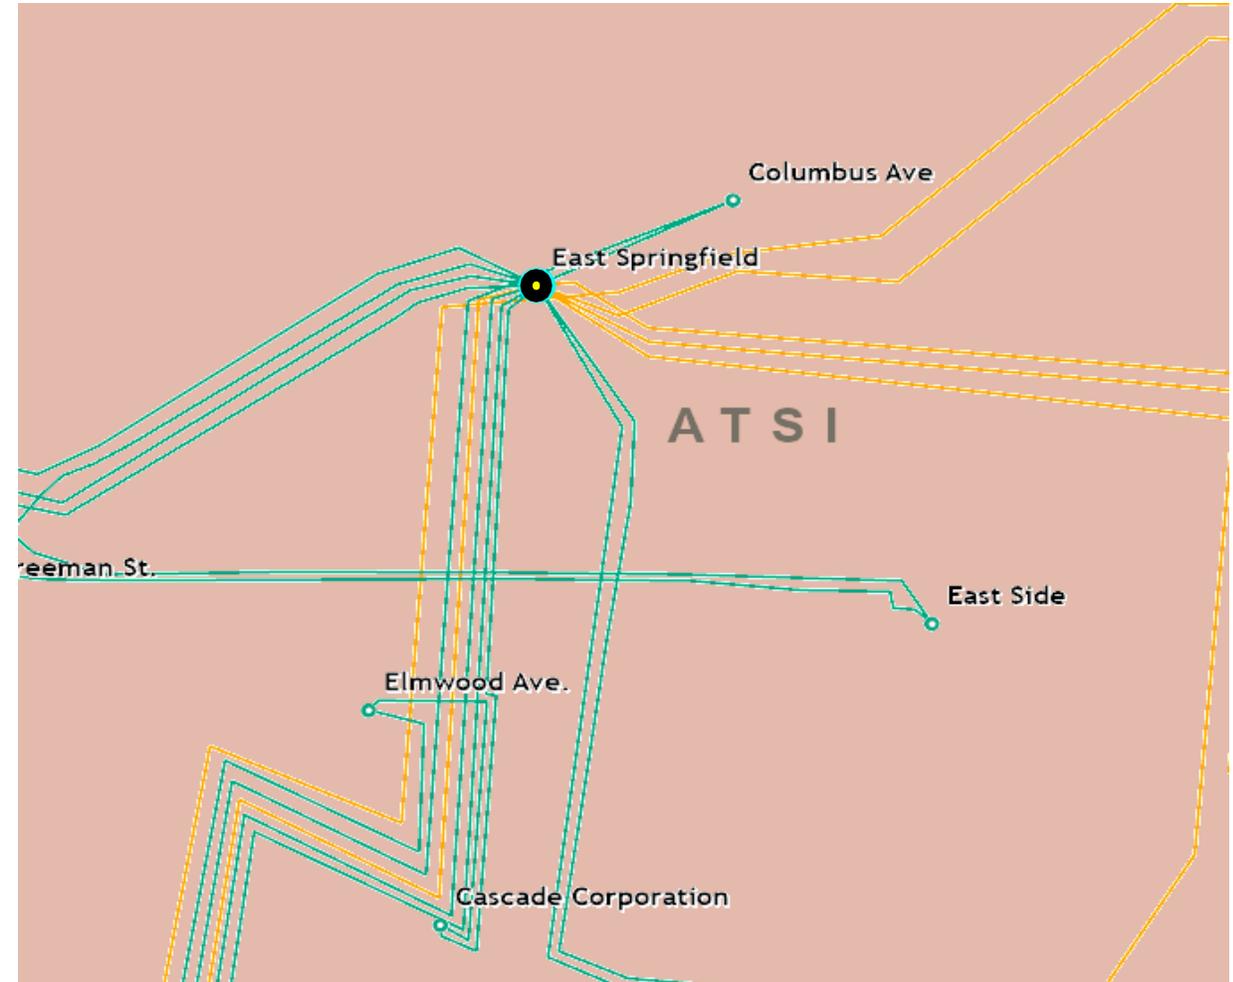
Need Number: ATSI-2026-006
Process Stage: Need Meeting 01/16/2026
Project Driver:
 Operational Flexibility and Efficiency

East Springfield station is the largest source out of only a few into the city and is a convergence point of four 138 kV lines. The East Springfield Substation has four 138 kV lines, three 138/69 kV transformers and one capacitor bank. A bus fault or stuck line/transformer breaker results in loss of two 138 kV lines and either two transformers, or a transformer and a capacitor bank. A stuck bus tie breaker results in loss of the entire substation.

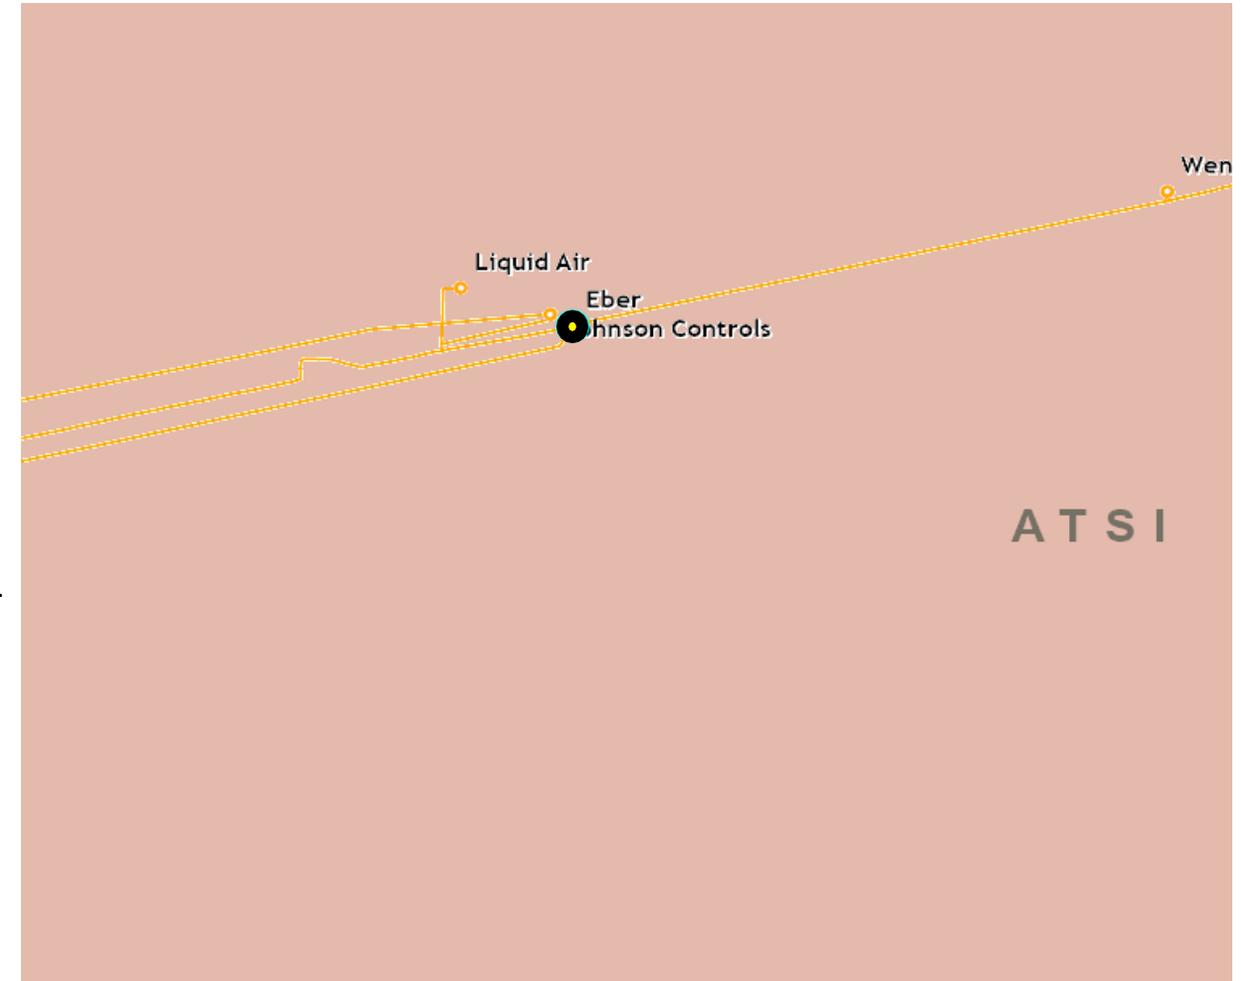
Need Number: ATSI-2026-007

Eber Substation is currently configured as a straight bus design with two transmission lines, one radial line serving two industrial customers and one distribution transformer. A stuck breaker or fault on the bus at Eber Substation results in the loss of the entire Eber Substation. Eber Substation serves 2,700 customers and approximately 13 MW. The stuck breaker or fault on the bus at Eber Substation also impacts two large industrial customers that are radially fed from Eber Substation which results in an additional load loss of 30 MW for a total approximate loss of 43 MW.

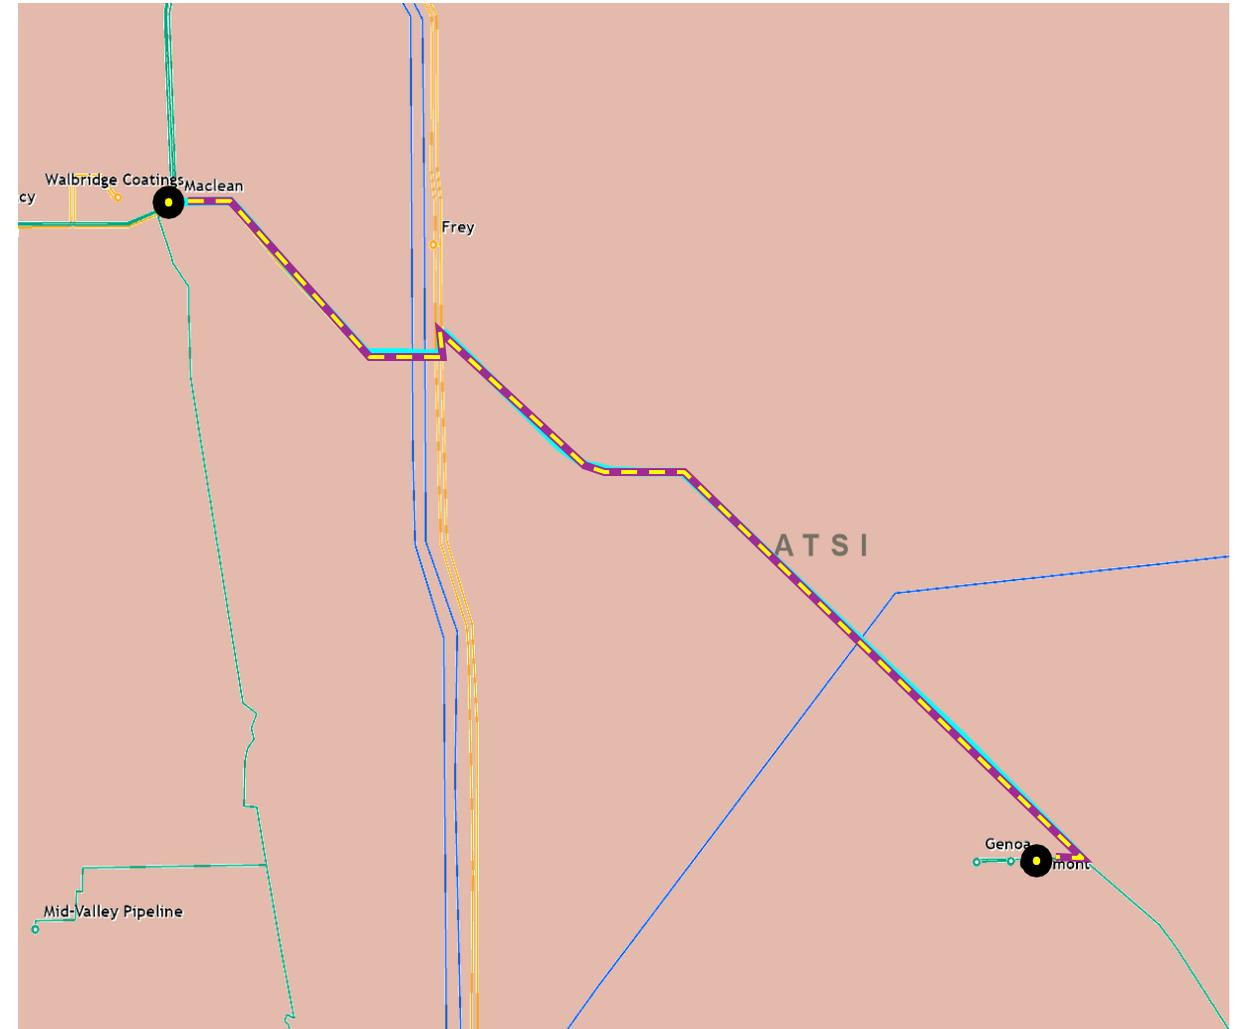
Need Number: ATSI-2026-008

The Genoa - Maclean 69 kV Line was constructed approximately 60 years ago and is approaching end of life. It is approximately eight miles long with 142 wood pole transmission line structures.

Per recent inspections, the line is exhibiting deterioration. Inspection findings include:

92% of structures failed inspection due to decay.

71% of structures failed inspection due to shell rot.

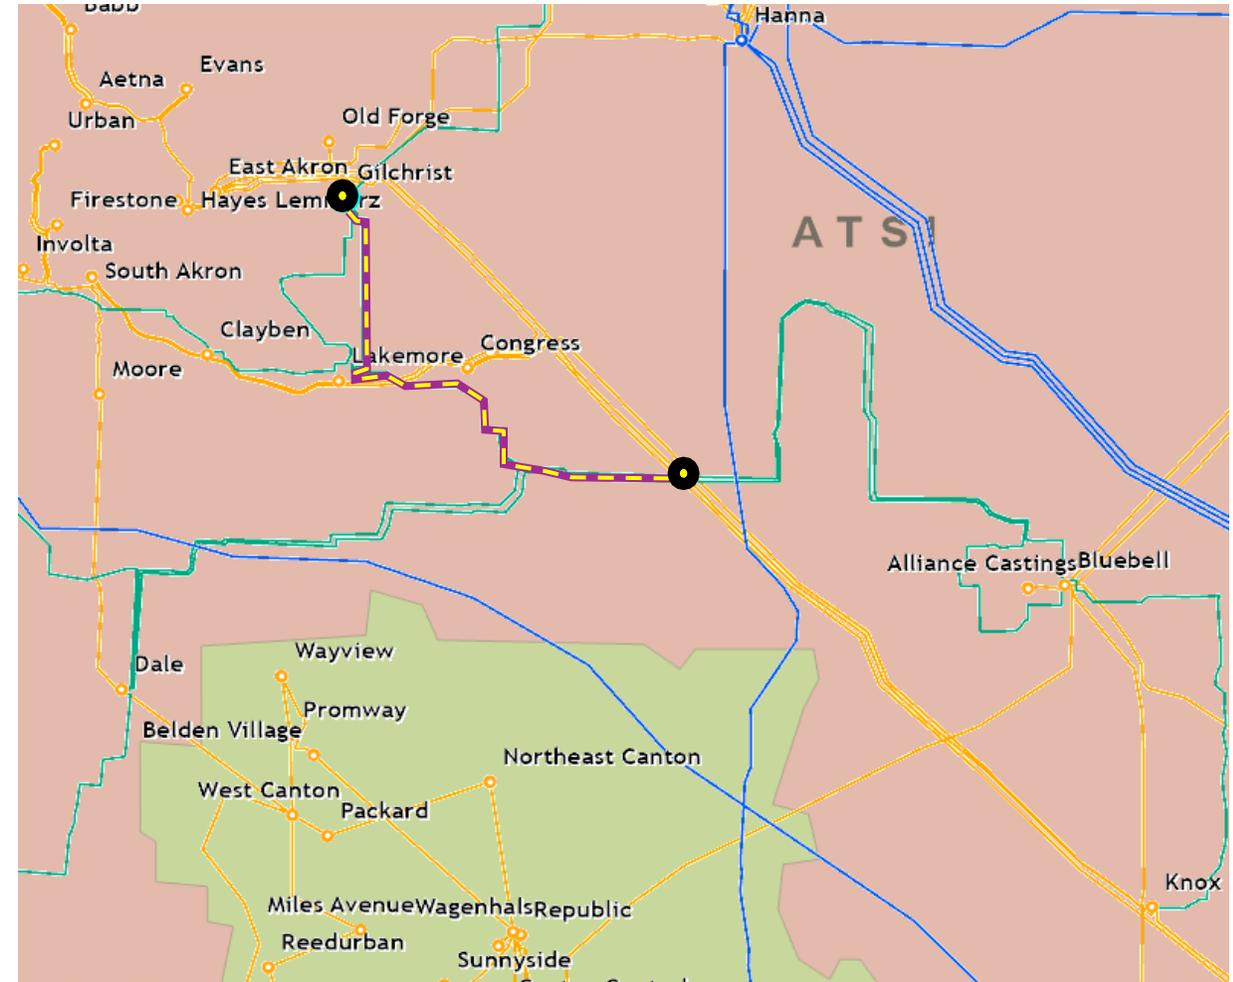
Need Number: ATSI-2026-009

The Gilchrist - Hartville 69 kV Line was constructed approximately 65 years ago and is approaching end of life. It is approximately 14 miles long with 286 wood pole transmission line structures.

Since 2012, the line has experienced 21 unscheduled sustained outages with seven of them related to line equipment.

- Pole fire (2012)
- Crossarm failure (2014, 2022)
- Crossarm brace failure (2017, 2019, 2019)
- Insulator failure (2018)

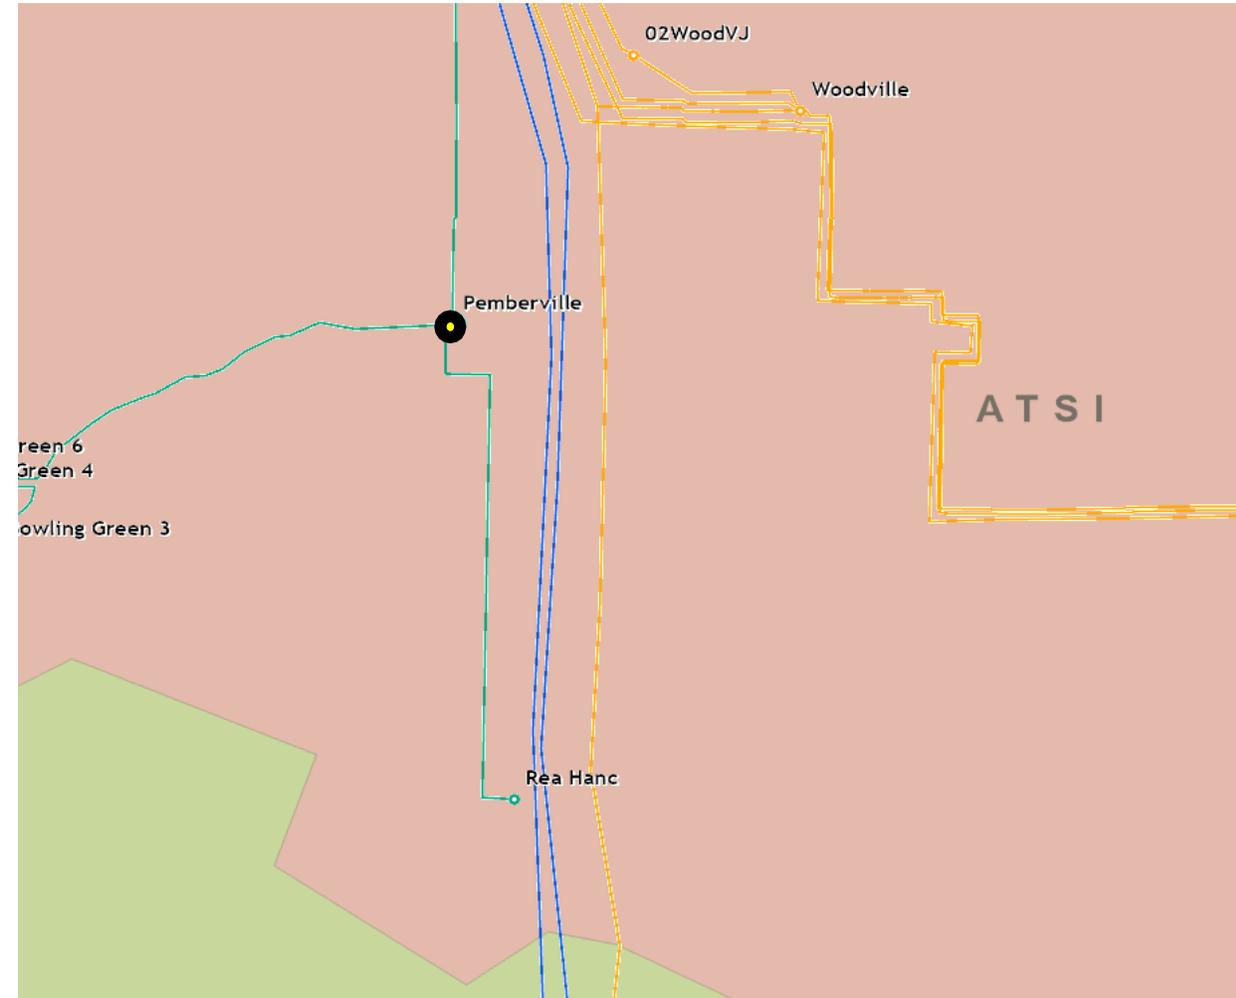
Need Number: ATSI-2026-013
Process Stage: Need Meeting 01/16/2026
Project Driver:
 Equipment Condition/Performance/Risk

Problem Statement:
 The existing Pemberville 69 kV breakers 7286 and 7287 are 61 years old and are approaching end of life. Replacement components for oil circuit breakers are difficult to source leading to non-standard repairs.
