Subregional RTEP Committee – Western FirstEnergy Supplemental Projects APS Transmission Zone

June 17, 2026

Need Number: APS-2026-007
Process Stage: Need Meeting 06/17/2026
Project Driver: Equipment Condition/Performance/Risk

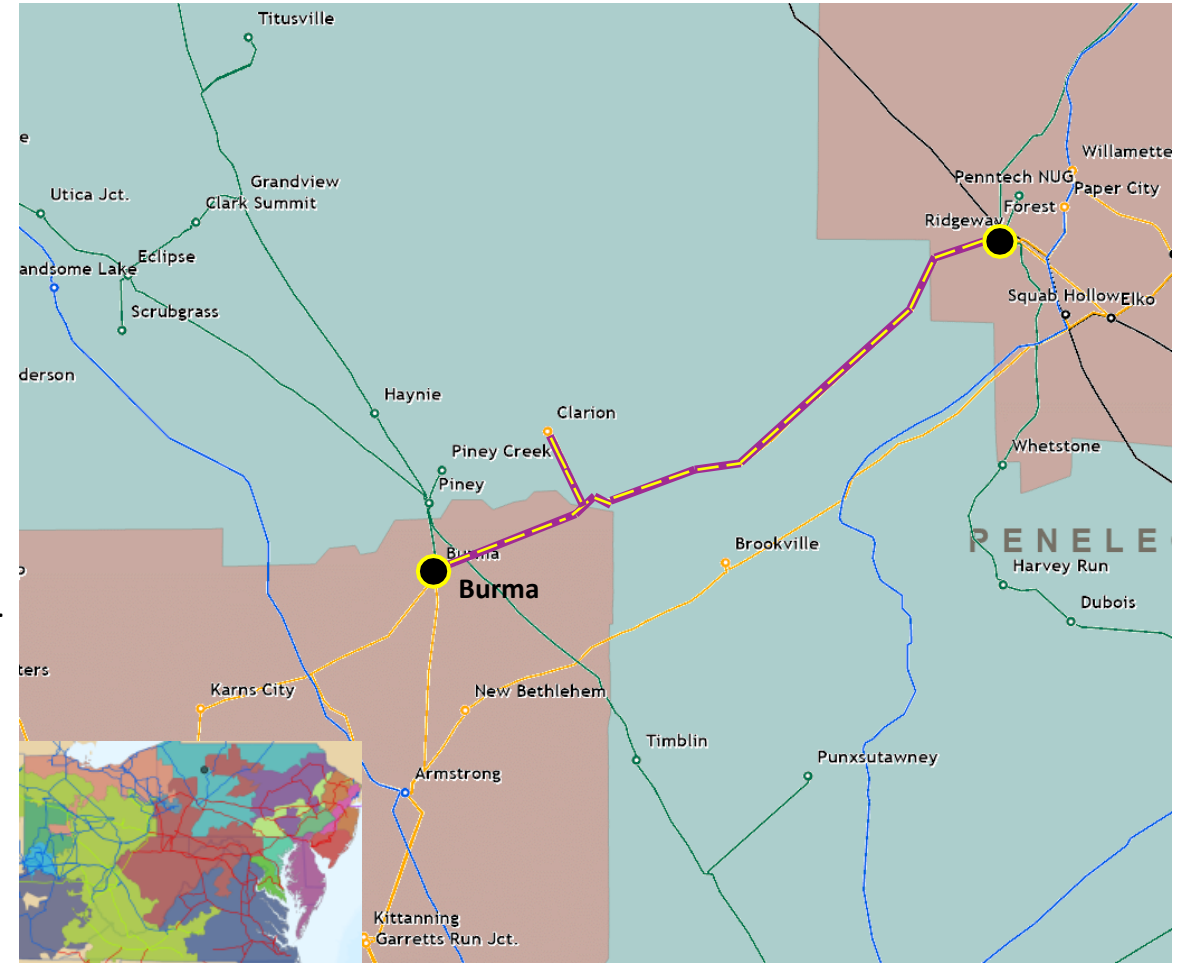
The Burma - Ridgway 138 kV Line was constructed approximately 44 years ago and is approaching end of life. It is 51.4 miles long with wood pole transmission line structures. The loop to Clarion Substation is established where the Burma - Clarion 138 kV Line and the Clarion - Ridgway 138 kV Line are terminated and interconnected through the Clarion Substation. The Clarion loop consists of approximately 3.7 miles of the Burma - Clarion 138 kV Line and 3.7 miles of the Clarion - Ridgway 138 kV Line. The Clarion loop contains 71 wood pole structures, which are approximately 48 years old and also approaching end of life.

Per recent inspections, the line is exhibiting deterioration. Inspection findings include:

- 13 structures are phase-raised of which one phase-raised structure is on the Clarion loop.
- 54 structures require repairs to insulators and related hardware, indicating that components are reaching end of life.
- 86 structures failed inspection due to sound, woodpecker damage, top rot, decay, cracking, and/or delamination of cross-arms of which 22 are on the Clarion loop.
- The transmission line is equipped with Lapp Polypace type insulators which have been the subject of multiple failures due to poor condition and poor design.

The line has experienced six unplanned sustained outages over the last five years. Four outages occurred in 2025, and one outage was related to failure of polymer insulators on the line.
