Western Sub Regional RTEP: AEP Supplemental Projects

June 17, 2026

AEP Transmission Zone M-3 Process Hillsboro, OH/Wildcat, OH

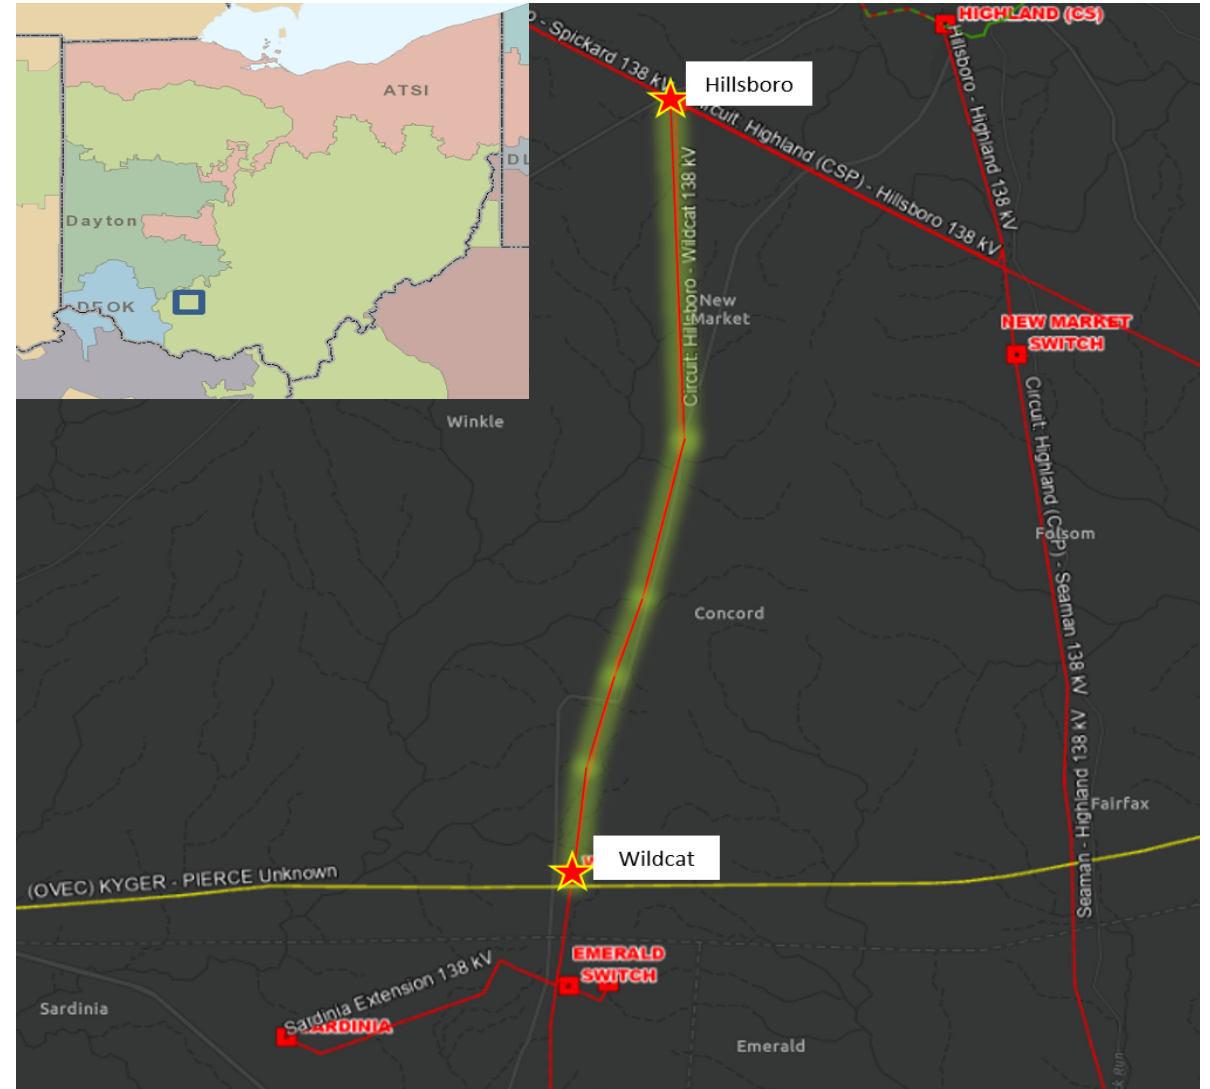
Need Number: AEP-2026-OH021

Hillsboro-Maysville 138kV Line

The Hillsboro - Maysville line asset is 12.39 miles long originally constructed in 1951. The line consists primarily of original single circuit wood pole structures with original vintage 477KCM ACSR 26/7 Hawk conductor and is made up of the Kenton (LGE-KU)-Sardinia 138kV and Sardinia-Wildcat 138kV circuits. From 2019 to 2025 there has been 1 permanent outage on the Kenton (LGE-KU) - Sardinia 138kV circuit. Over the same timeframe, there have been 2 permanent outages on the Sardinia - Wildcat 138kV circuit. As of 2025, there are 54 structures with at least one open structural condition, which relates to 21% of the structures on the line. Structure condition causes: broken crossarms, rot top on crossarms, damaged poles, rot top on poles, woodpecker damage, and broken X-braces. The Transmission Line Engineering assessment determined the insulators and the shielding is inadequate for current AEP standards, which can lead to poor lightning performance and flashover events.

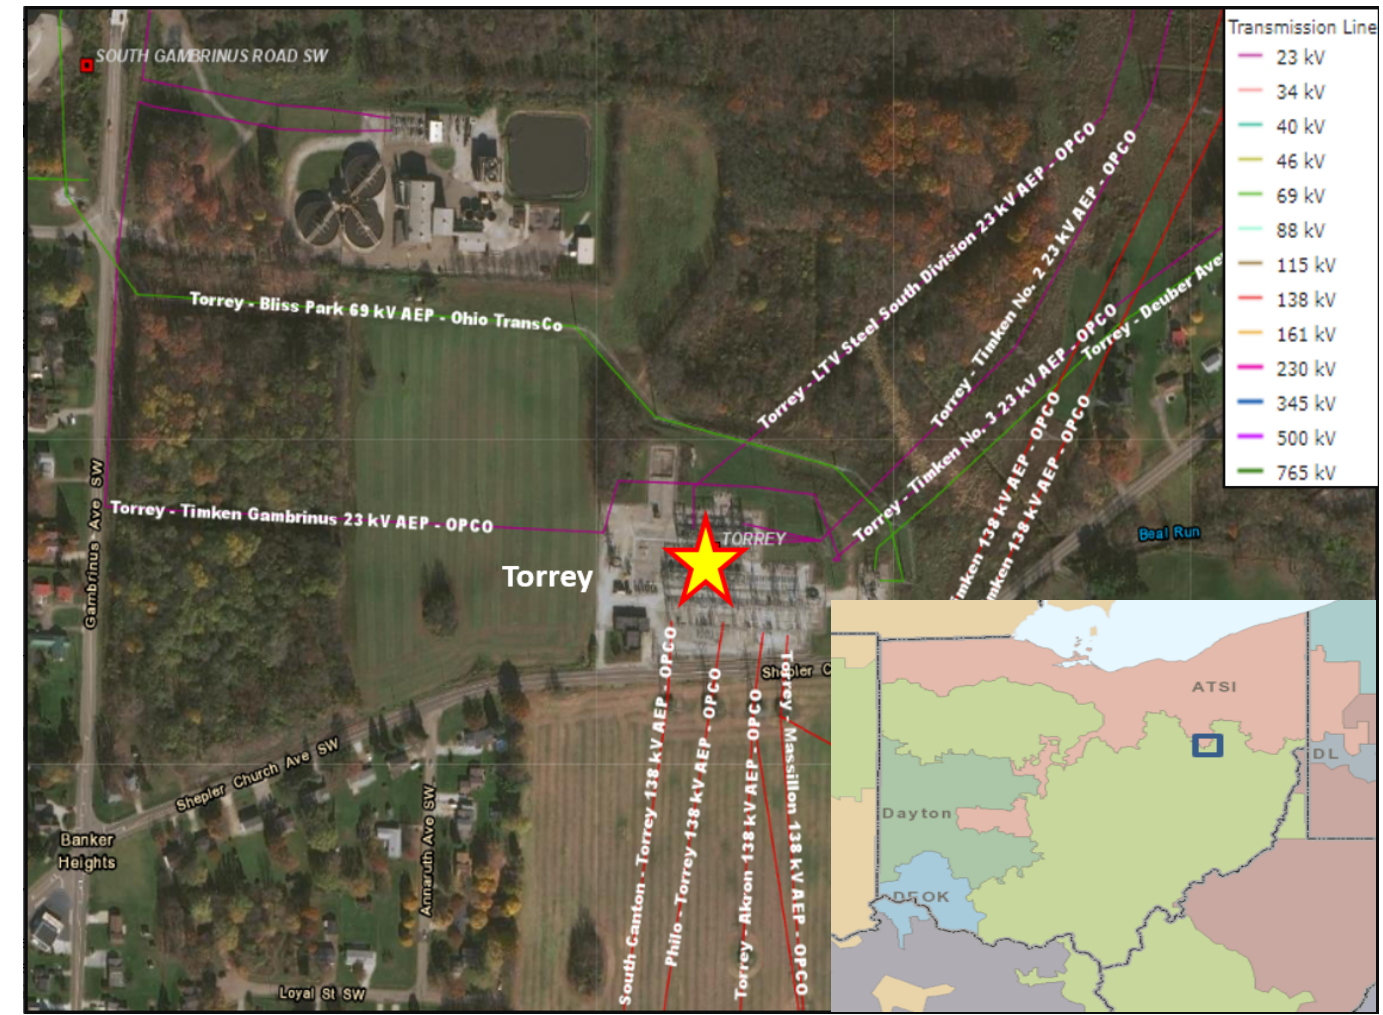
Need Number: AEP-2026-OH025

Torrey Station

23 kV Circuit Breakers BB, F, G, J, L, O, Q, & Z

138/23/12kV Transformer Bank 1 Phases 1, 2 & 3:

Currently, 112 of the 132 relays (85% of all station relays) are in need of replacement. There are 85 of the electromechanical type and 22 static types which have significant limitations with regards to fault data collection and retention. In addition, these relays lack vendor support. There are also 4 microprocessor relays commissioned between 1997 and 2002 that have firmware that is unsupported. The 1940's 23kV bus work is within reaching distance, presenting a safety hazard to field crews, and has cap-and-pin insulators throughout.

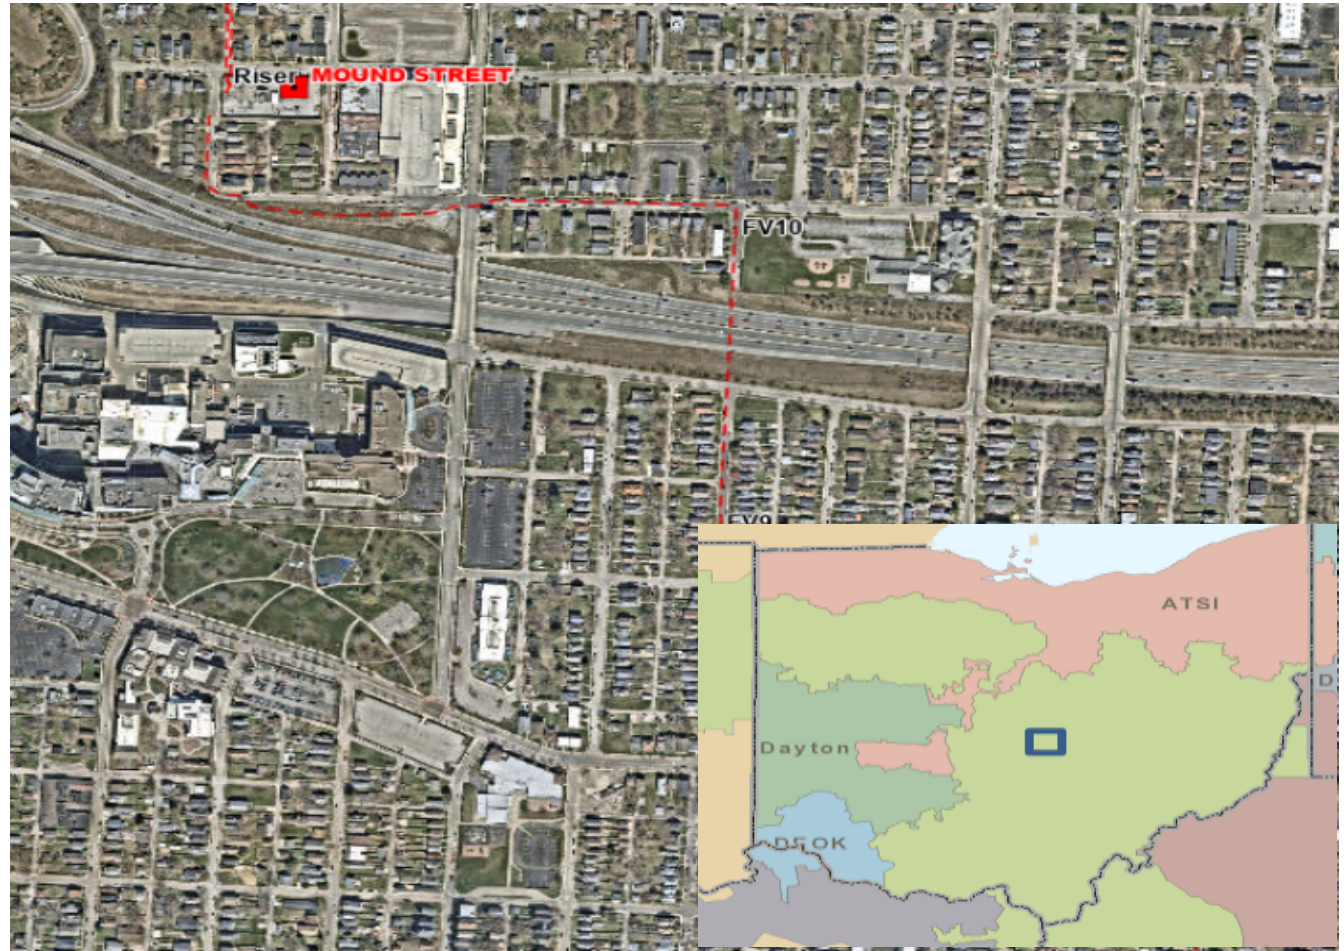
Need Number: AEP-2026-OH026

AEP OH Distribution has requested a new delivery point south of the existing Mound Street station. Peak demand is expected to be 15 MVA with a requested date of 12/31/2030.

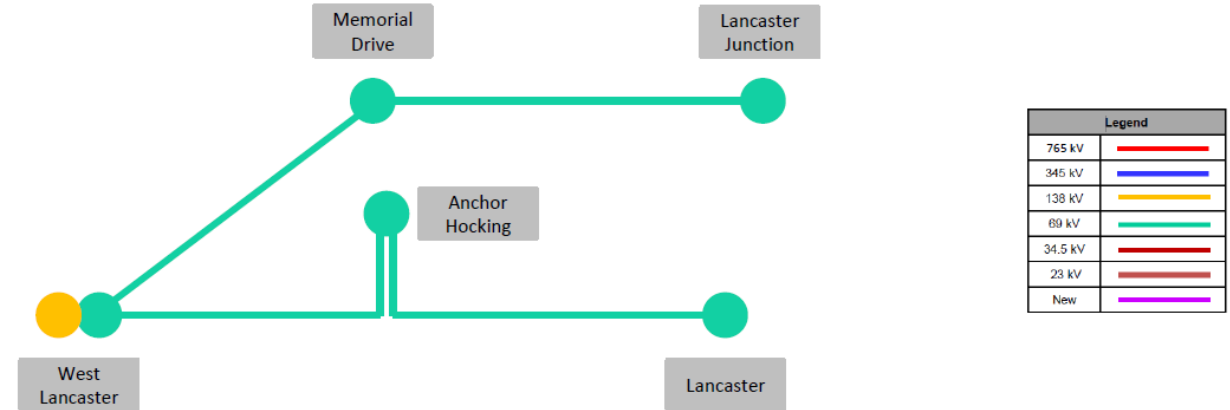
Need number(s): AEP-2024-OH031, AEP-2024-OH044

West Lancaster - Anchor Hocking 69kV Line: Retire 1.3 miles of 69kV line from West Lancaster to Anchor Hocking station. Rebuild 3.2 miles of 69kV line from West Lancaster to Anchor Hocking stations. 2 miles of the rebuild will be double circuit that includes the West Lancaster - Memorial Drive 69kV line. The remaining 1.2 miles will be single circuit line before entering Anchor Hocking station. . Estimated Cost: \$20.7 M

West Lancaster - Memorial Drive 69kV Line: Retire 3.0 miles of 69kV line from West Lancaster to Memorial Drive station. Build 1.4 miles of greenfield single circuit 69kV line from where the West Lancaster - Anchor Hocking and West Lancaster - Memorial Drive lines were double circuit.. Estimated Cost: \$11.1 M

Memorial Drive Switching Structure: Replace the existing Memorial Drive phase over phase switching structure.. Estimated Cost: \$0.697 M

West Lancaster - South Baltimore 138kV Line: Raising four 138kV line structures due to two crossings of the 69kV double circuit rebuild.. Estimated Cost: \$1.1 M
