PECO 2025
Submission of Supplemental Projects for
Inclusion in the Local Plan

Need Number: PE-2024-004

- Install 6th Byberry 138/13 kV 62 MVA transformer with high side breaker

PECO Transmission Zone M-3 Process
Byberry #150 138kV Circuit Breaker Replacement

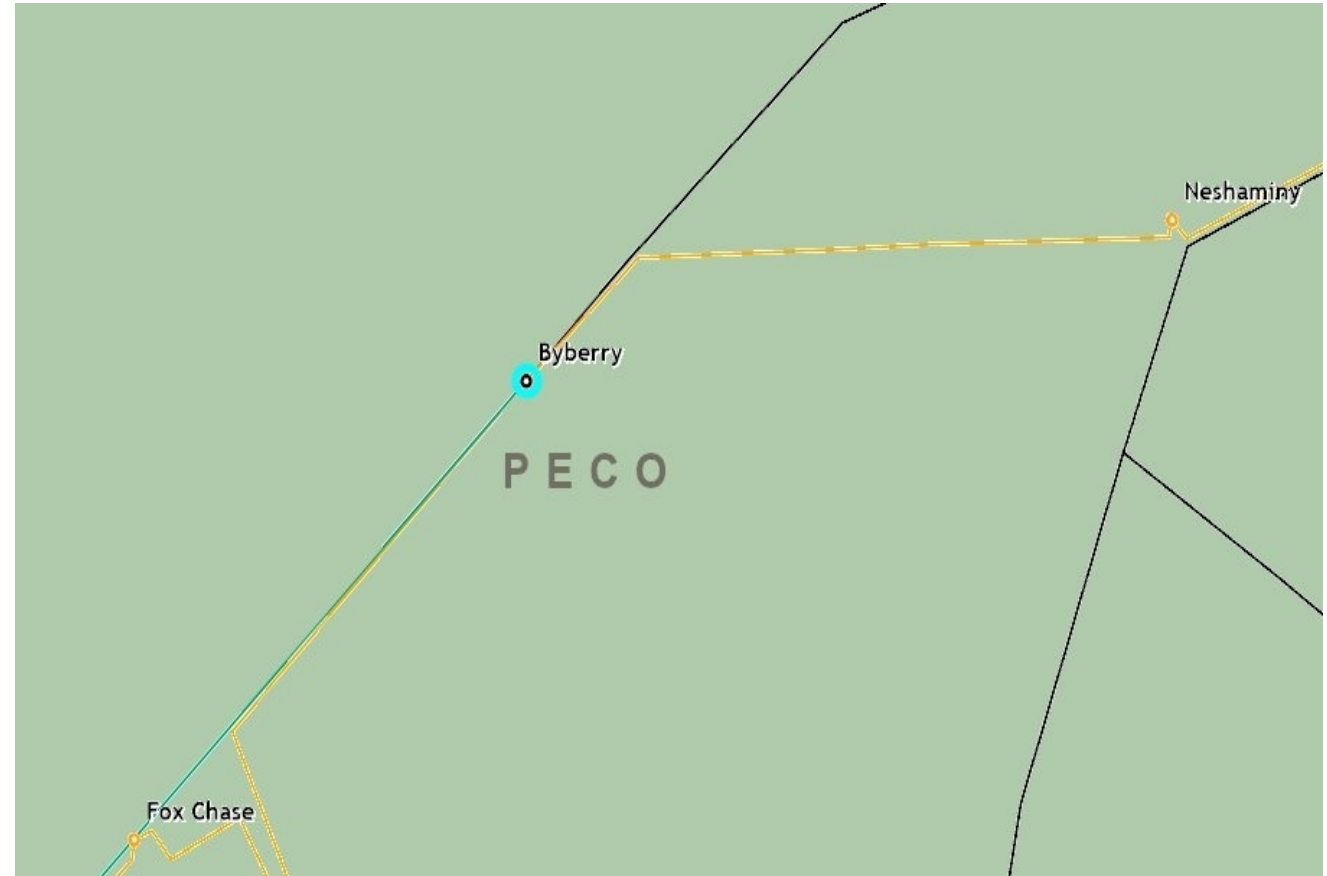
- PECO Distribution Capacity Planning requested additional capacity in the North Philadelphia region to accommodate load growth of 15 MVA by 6/1/2028. Existing distribution facilities do not have enough capacity to accommodate this load growth.

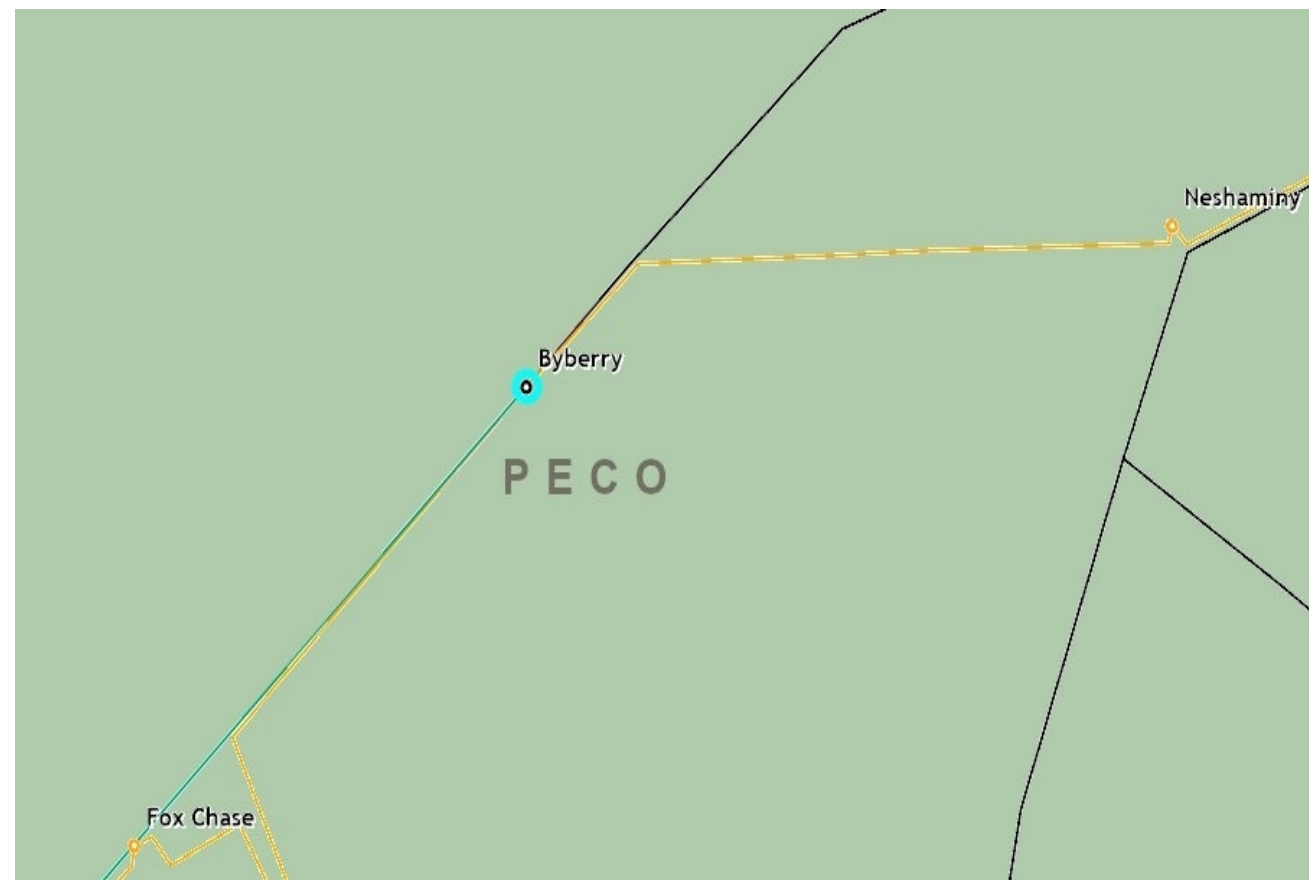
- Byberry #150 138 kV circuit breaker was installed in 1959. It is in deteriorating condition, has a lack of replacement parts and has elevated maintenance costs.

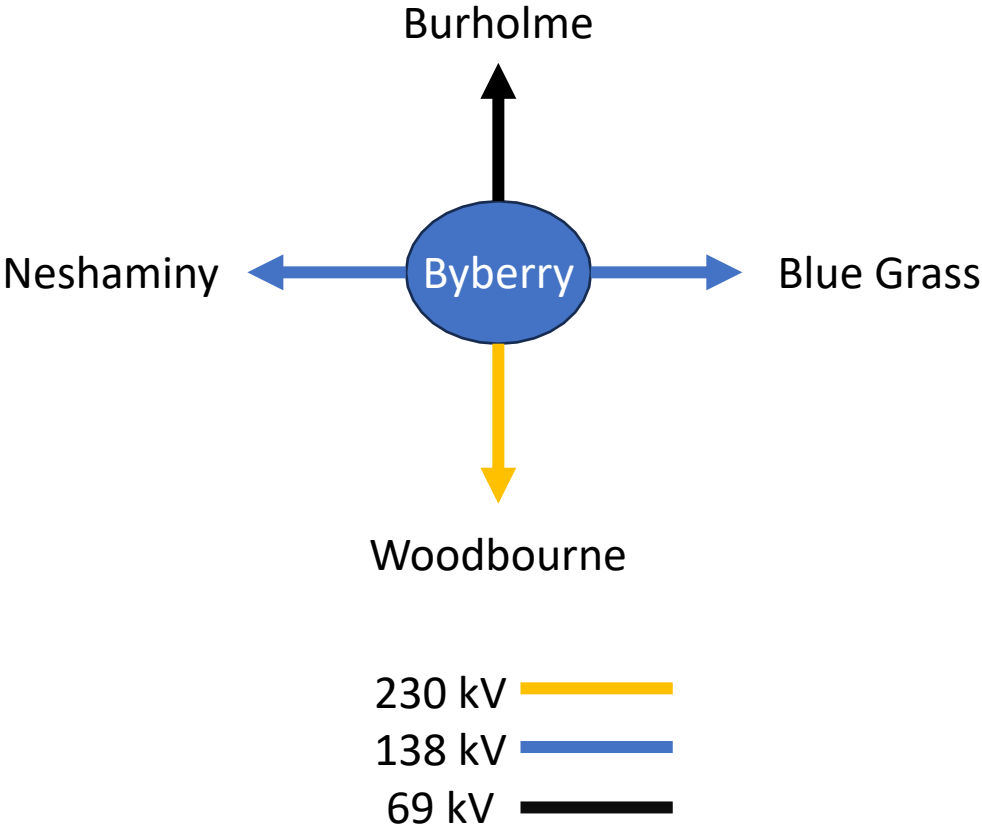
Replace Byberry circuit breaker #150:

- Existing rating: 1600A, 42kA
- Proposed rating: 3000A, 63kA

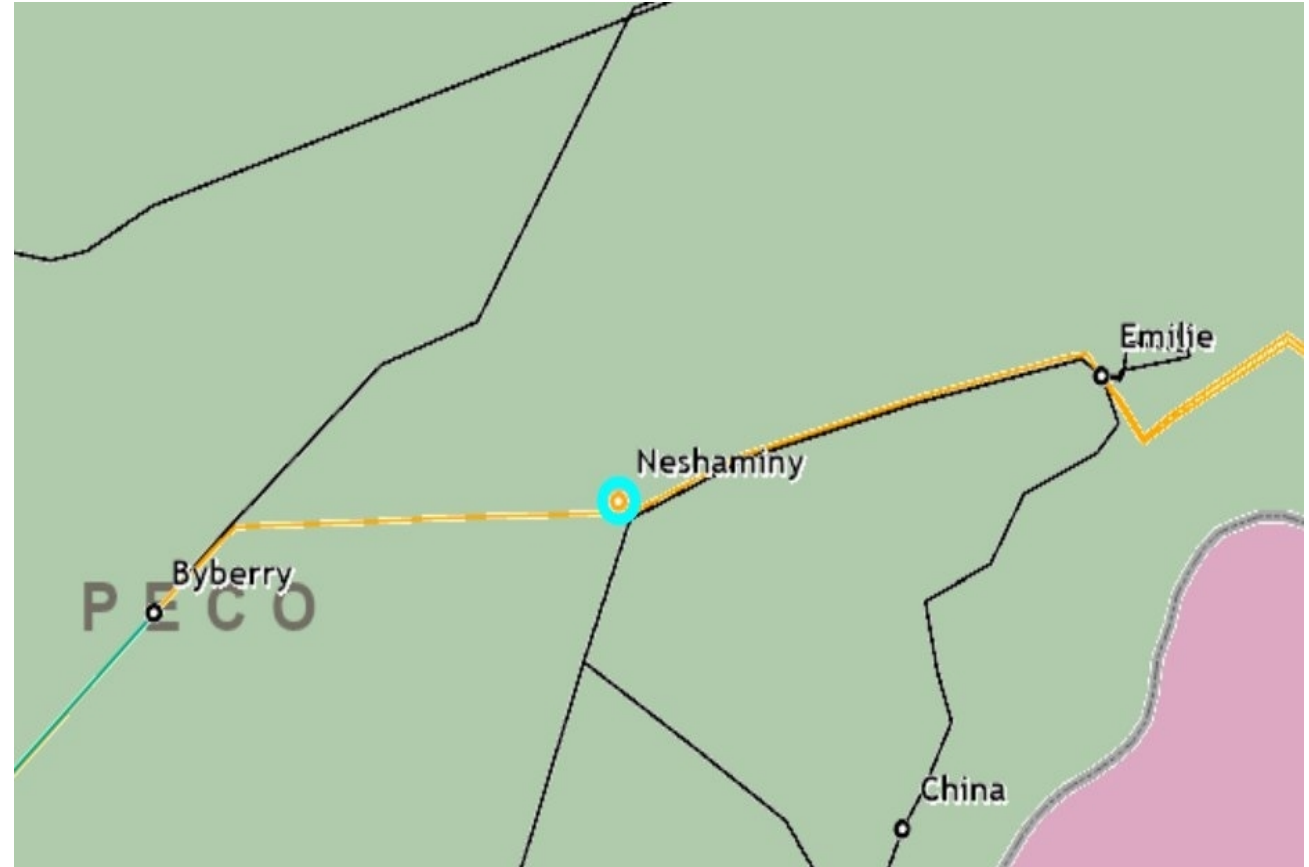
- Neshaminy 138 kV substation is in a straight bus configuration with three distribution transformers and switchgears. The substation equipment is in deteriorating condition and the configuration of the station results in a complicated non-standard control and protection scheme.

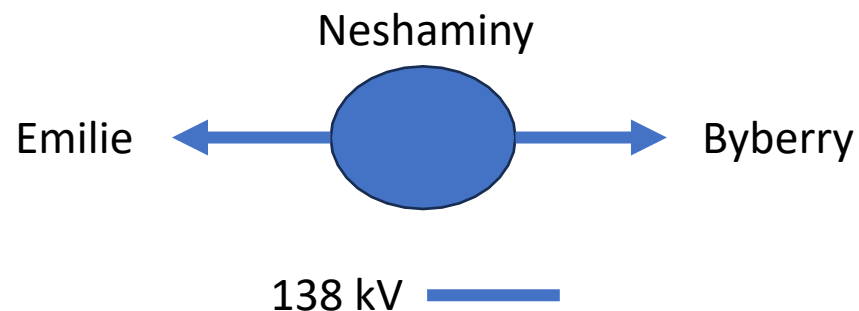
Rebuild Neshaminy 138kV straight bus to a 7 breaker AIS ring bus configuration

- Install two new 138kV circuit breakers #705 and #905 with associated buses, switches, and protection equipment.
- Remove the #175 138kV circuit breaker and associated relay equipment
- Remove specialized protection scheme upon completion of new ring bus

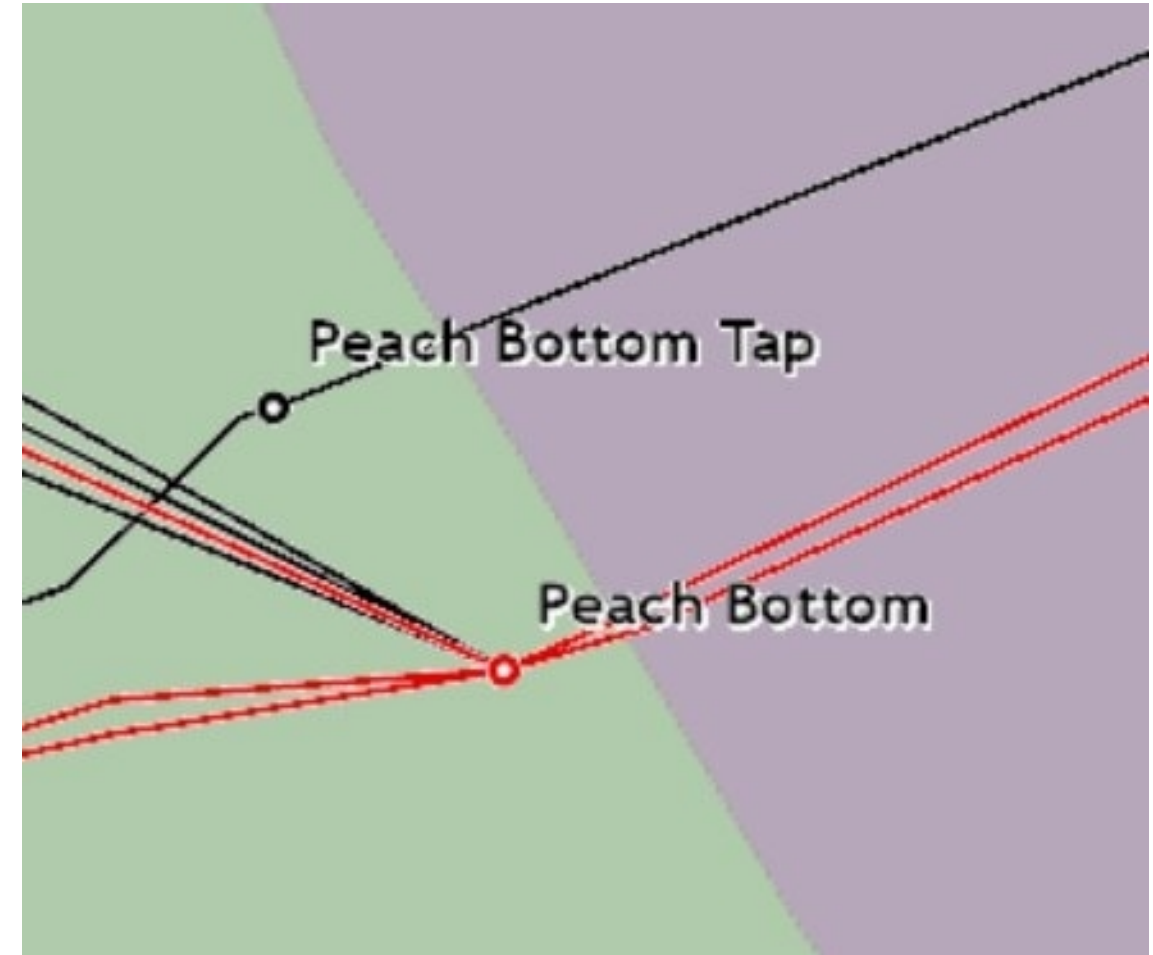
- Peach Bottom Unit #2 has obsolete relays and are being phased out of the system. It is becoming difficult to service existing electromechanical relays.

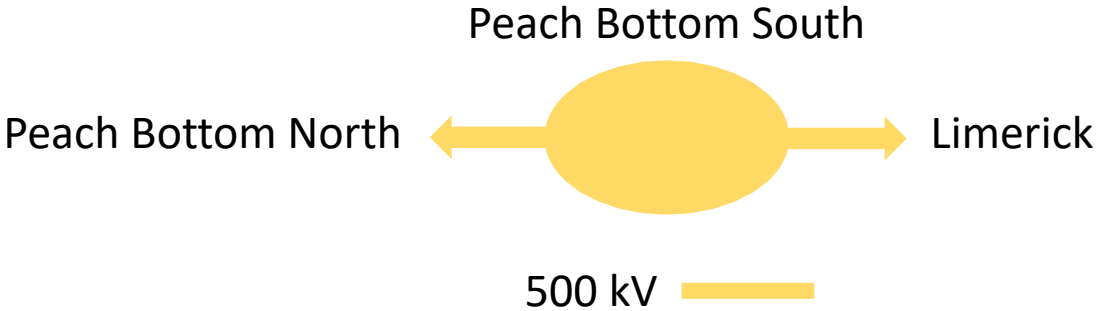
Upgraded Peach Bottom CB #225 relays and metering equipment, along with corresponding CT tap settings. These changes increased the Peach Bottom Bus Tie #2 ratings as seen below:

Existing ratings MVA)	SN/SE	WN/WE
Peach-Bottom Bus Tie #2	2477/2860	2598/3022
New Ratings (MVA)	SN/SE	WN/WE
Peach-Bottom Bus Tie #2	2598/3022	2598/3022
