Sub Regional RTEP Committee Western Region AEP

November 29, 2018

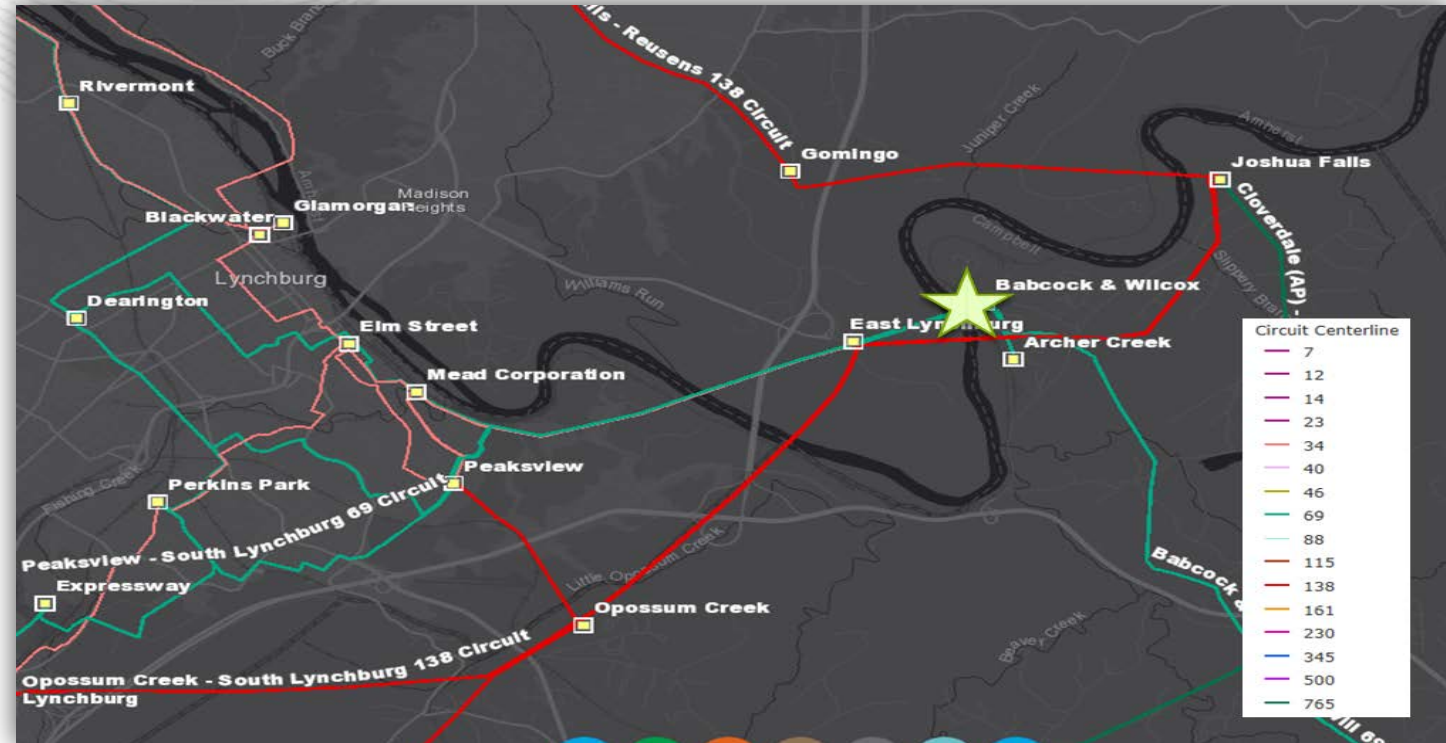
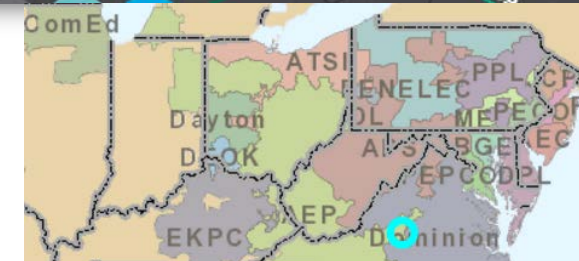
Babcock & Wilcox (B&W) requested to upgrade their existing 12 kV service to 69 kV and be served directly from the B&W 69 kV bus. Expected peak demand is approximately 16 MVA.

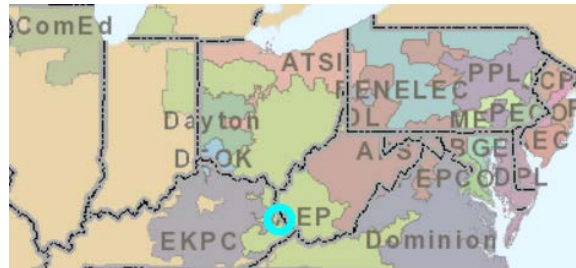
Capacitor switchers ‘BB’ and ‘CC’ at Inez station are Mark V model which no longer support modern relaying packages. Mark V’s have been historically prone to mechanism failures and are being replaced system wide where possible. S&C circuit switcher ‘AA’ at Inez station is an S&C 2030 type with no gas monitor.

The Inez 138 kV yard was designed as a breaker and a half station, but the ‘B’ string was never completed leaving dissimilar zones of protection between the #1 bus and 20+ mile Inez to Johns Creek 138 kV circuit. Dissimilar zones of protection also exist between the 138 kV bus #2, 138/69 kV transformer #1, and the 138 kV circuit to the Martiki coal service point.

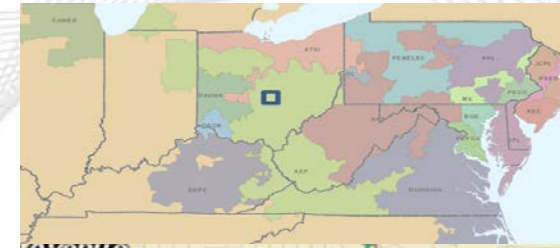
- A study of the current physical loading capability of the structures along the Astor-Shannon-Groves & Shannon – Bixby 138 kV circuits revealed that many of the poles are currently overloaded under NESC Heavy Loading Conditions. Additionally, the line structures are unable to handle the addition of telecom fiber, which is needed to improve communications in this area.

- 36% of poles on the Astor-Bixby 138 kV circuit show overloading.
 - 29% of poles on the Bixby – Shannon 138 kV circuit show overloading.
 - 20% of the poles on the Shannon – Refugee 138 kV circuit show overloading.

- 58% of poles on the Refugee – (Future) Brice 138 kV circuit show overloading.
 - 35% of poles on the (Future) Brice – Astor 138kV circuit show overloading.
-

- Primarily 1952 wood poles (57% of total line)
 - Conductor is all from 1952
 - 43 (out of 155) structures on the circuit have at least 1 open condition (28%), with a total count of 63 open conditions.
23 reported closed conditions – 1 forestry, 4 conductor, 18 structure

- No outage history (0 CMI/CI)
 - The Astor-Groves-Shannon 138 kV circuit is a three-terminal line, which limits sectionalizing and can cause mis-operations and over tripping.

- Astor 138 kV Station has ground switch MOAB's on both 138/13 kV transformers. Ground switch MOABs cause intentional high side faults, which can damage nearby equipment.

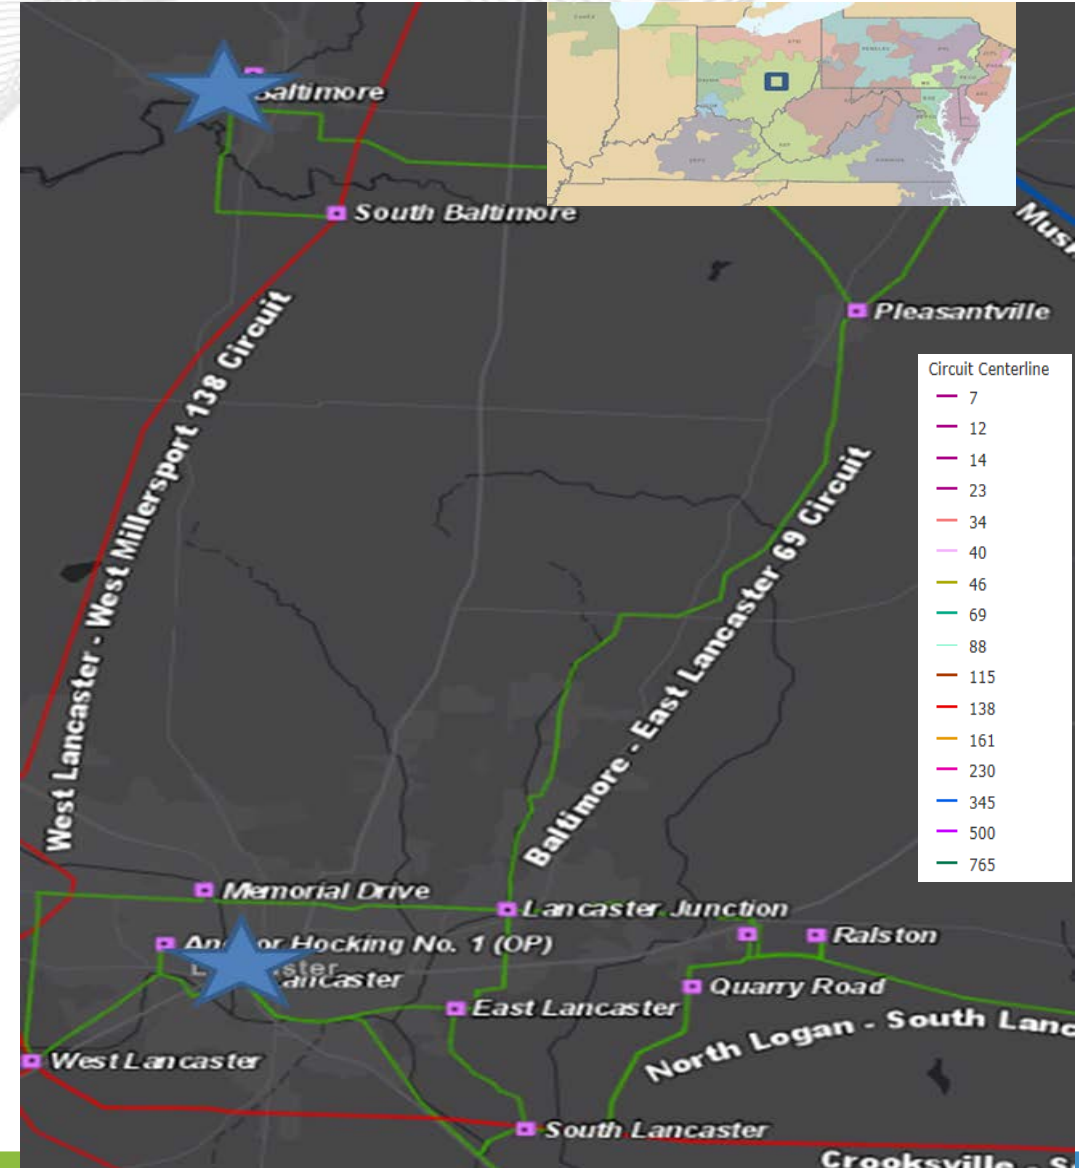
- Baltimore 69kV CBs E and F are oil type breakers (vintage 1951) and have been identified for replacement due to lack of spare part availability, historical reliability, and lack of vendor support. Oil breakers are difficult to maintain due to oil handling requirements. Oil spills can occur during maintenance and fixes. The breakers have experienced the following fault operations: CB E (5), CB F (5).

- Baltimore currently has 20 electro-mechanical relays employed. EM relays have limited spare part availability, a lack vendor support, no SCADA functionality, and no fault data collection ability.

- Lancaster 69kV CBs B and D are oil type breakers (vintage 1989) and have been identified for replacement due to lack of spare part availability, historical reliability, and lack of vendor support. Oil breakers are difficult to maintain due to oil handling requirements. Oil spills can occur during maintenance and fixes. The breakers have experienced the following fault operations: CB B (4), CB D (18).

- Lancaster currently has 46 electro-mechanical relays employed. EM relays have limited vendor support, lack SCADA functionality, and don't offer fault data collection.

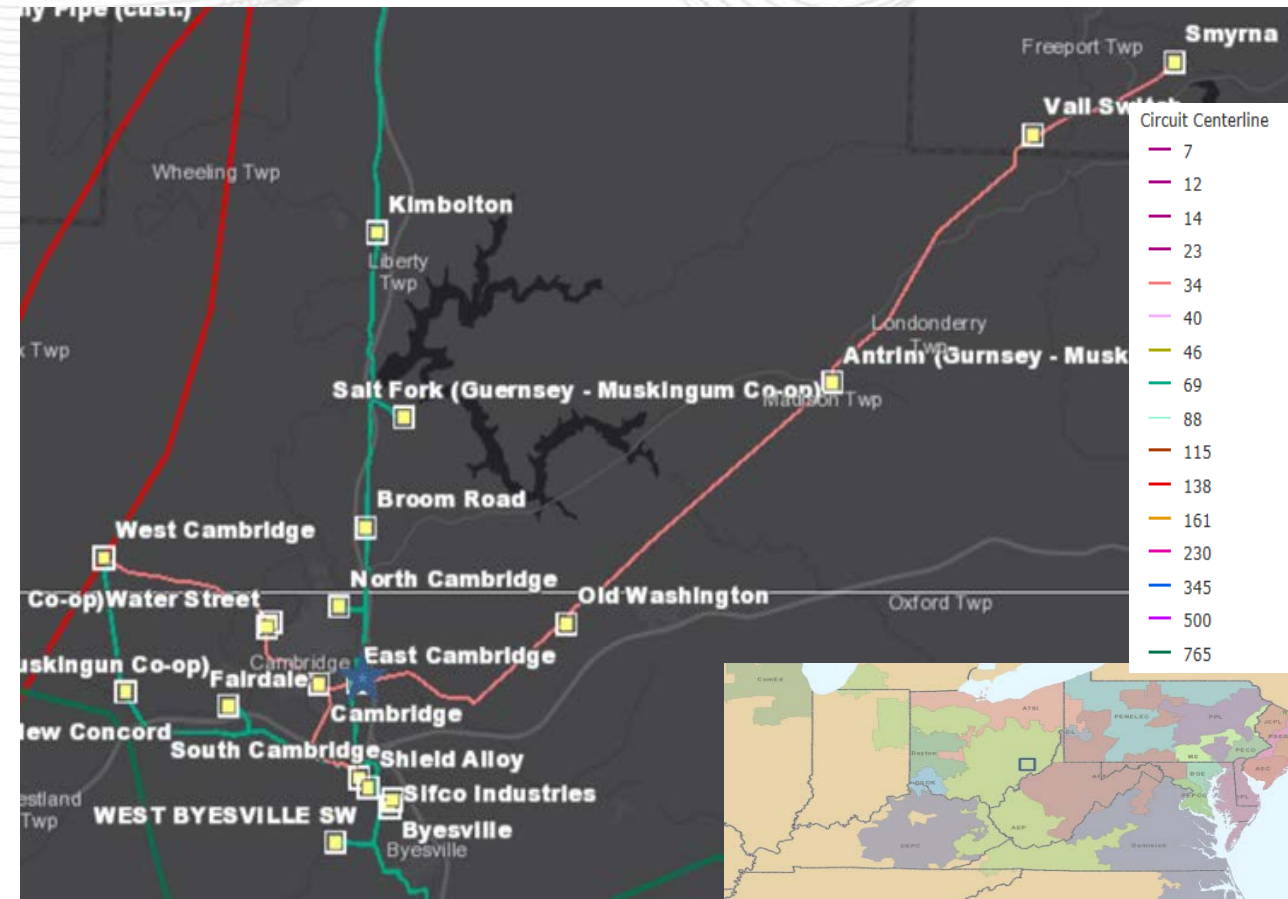
- East Cambridge 34.5kV CB “D”, 69kV CB “A” and 69kV CB “C” are vintage (1970-1975) circuit breakers. Oil breakers are difficult to maintain due to oil handling requirements and risk of oil spills during maintenance and failures. In addition, these CB’s have exceeded the manufacturers recommended fault operations: CB A (8), CB C (28), and CB D (91).
- East Cambridge circuit switcher AA (vintage 1970) is recommended for replacement due to reliability concerns and lack of spare part availability.
- East Cambridge currently has 36 electro-mechanical relays employed. EM relays have limited spare part availability, a lack vendor support, no SCADA functionality, and no fault data collection ability.

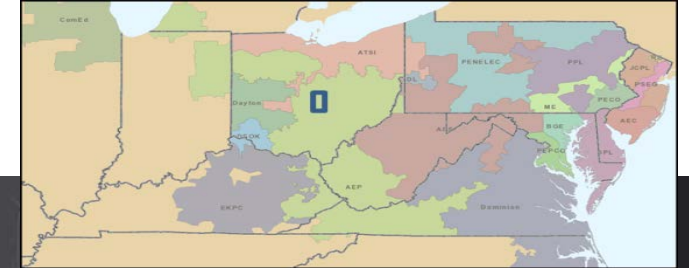
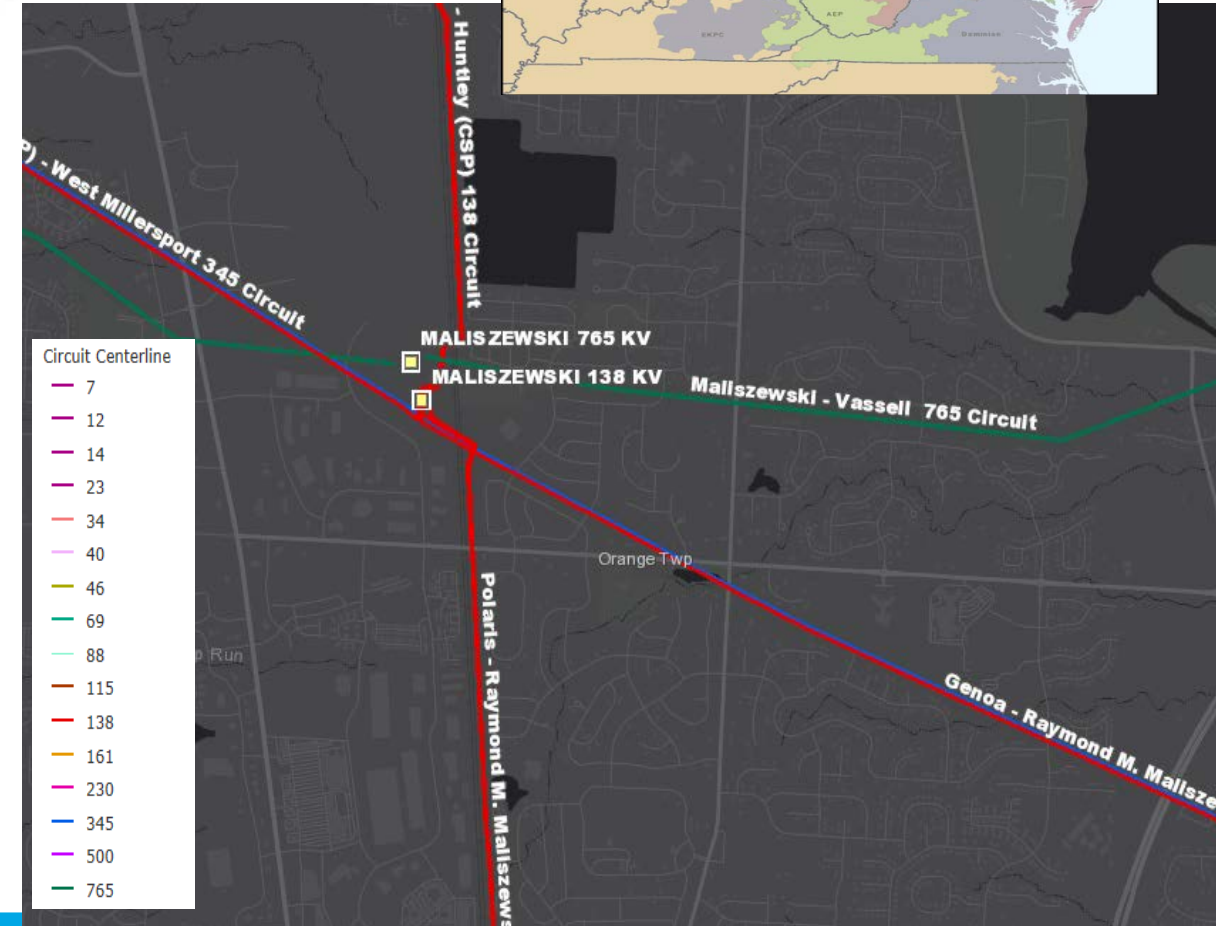
The 138kV riser is currently the Most Limiting Series Element on the 765/138 kV transformer at Maliszewski, reducing the summer normal rating by 170MVA. With customer load requests in the area, we anticipate this limitation overloading in the future.

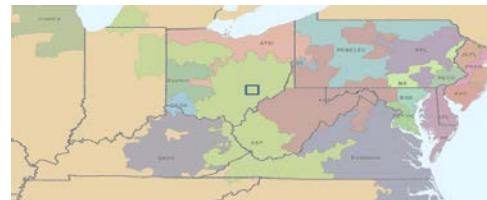
- The New Lexington – East Logan 22.3 mile 69 kV (vintage 1916) was built using wood pole structures with conductors ranging from #1 Copper 3 conductor (31 MVA rating) to 336.4 KCM ACSR 18/1 (73 MVA rating).
- There are 139 open A conditions on this line, including burnt/broken conductors, and broken structures. The New Lexington – East Logan 69 kV circuit has experienced over three million customer minutes of interruption in the past three years.

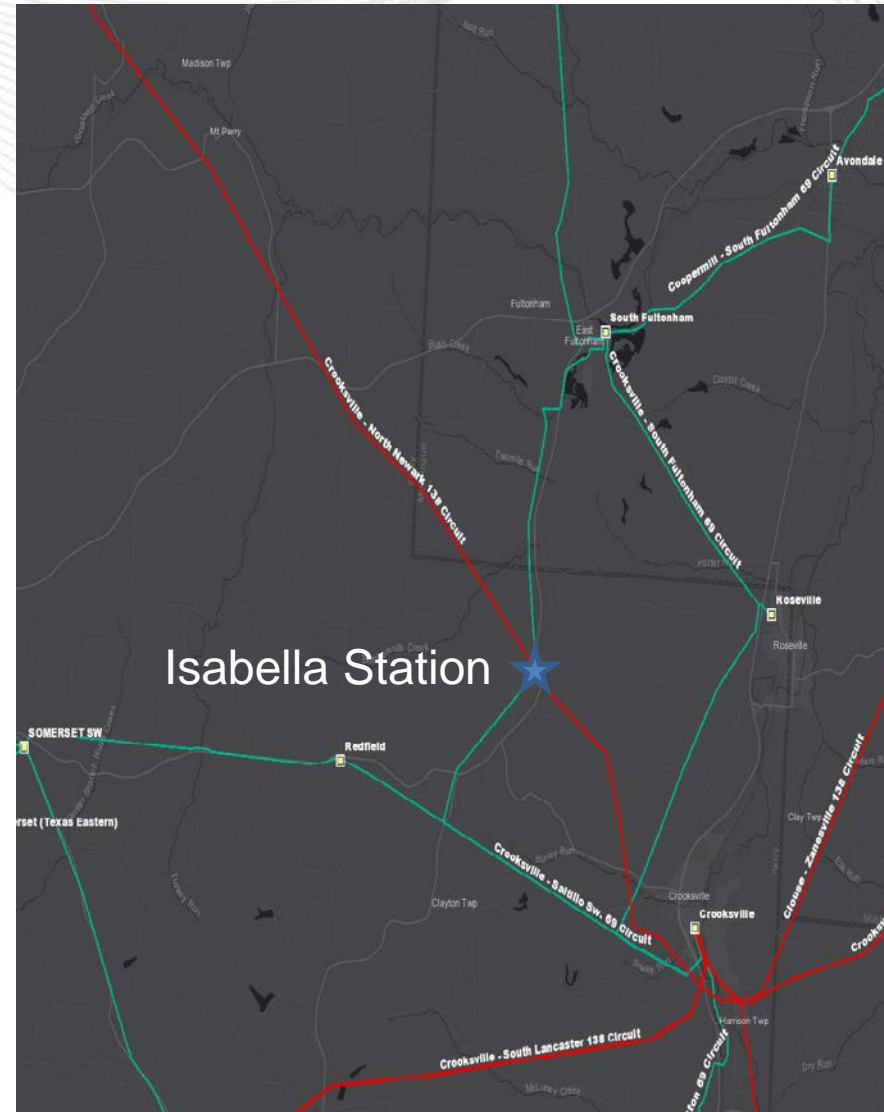
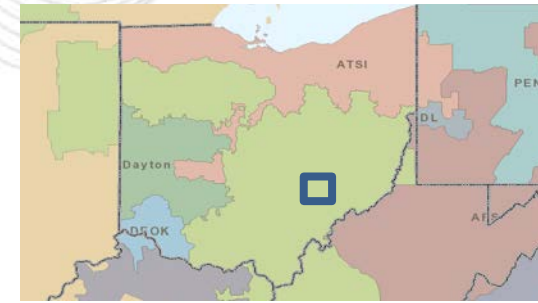
- **Customer Service #1:** AEP Ohio has requested a connection to the Crooksville – North Newark 138 kV circuit. Isabella station will replace their Redfield station. Redfield Distribution equipment is in need of rehab and it is distant from Distribution load centers. The starting load at Isabella will be 3.5 MVA and the ultimate load will be 10 MVA. Load will be transferred load from Redfield and South Fultonham. The existing Redfield 69kV Station has experienced 1,730,000 CMI over a three year period.
- **Customer Service #2:** Roseville is still being evaluated.

- Build a new 138 kV in and out station with Moab switches to connect to the Crooksville – North Newark 138 kV circuit.
- Build a new 0.17 mile 138 kV extension to Isabella Station.

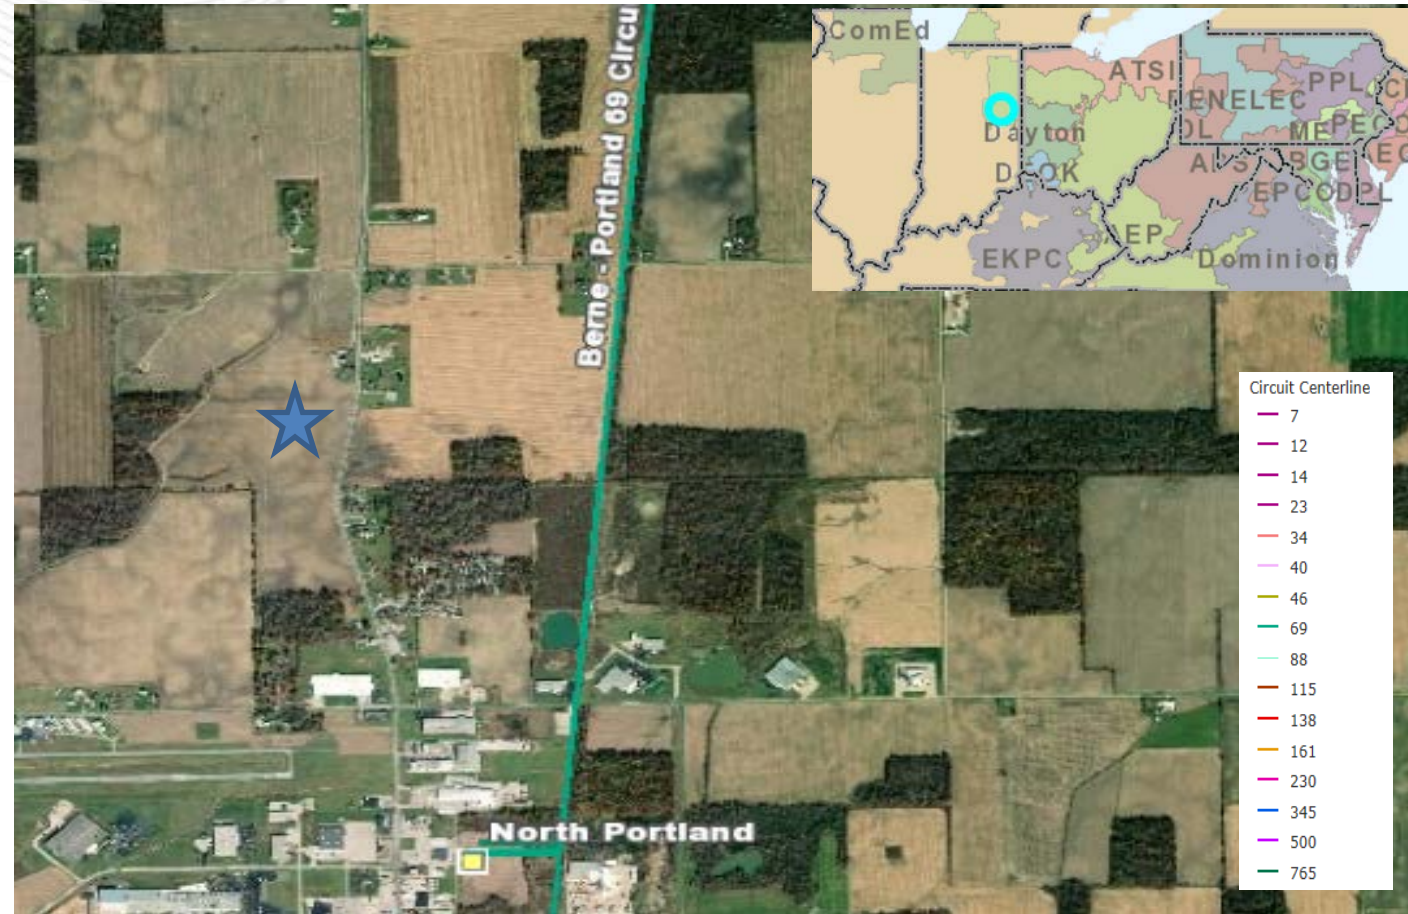
A customer has requested connection of a 2.3MVA load off of the Berne – Portland 69kV line.

Install a 3-way PoP switch called Bockoven Switch with line MOABs with automatic sectionalizing.

Install 0.5 mile extension to customer with 556 ACSR conductor.

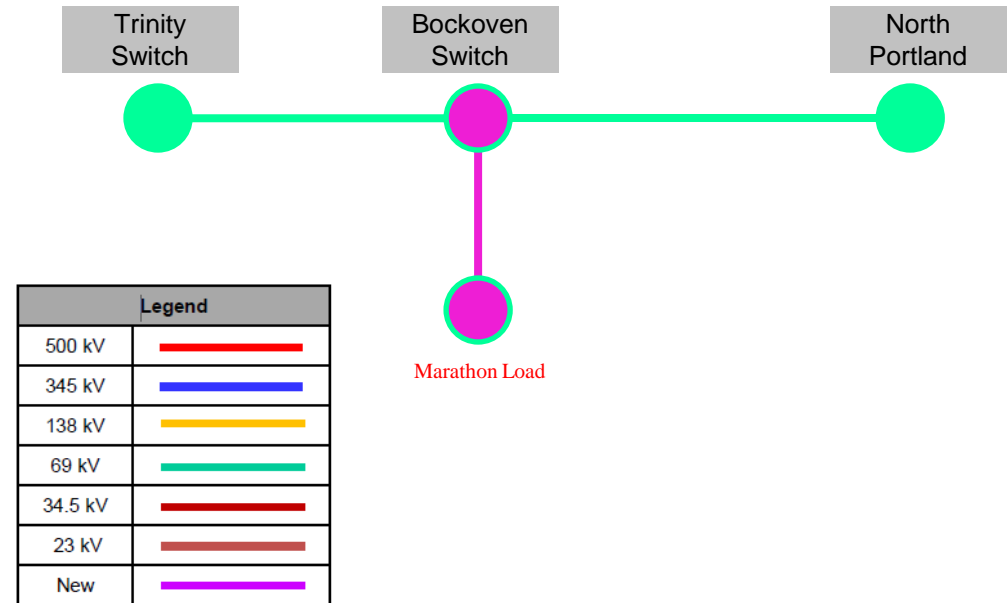
The Berne – Portland line is a significantly exposed line on the edge of AEP’s territory. With almost 2.79 Million CMI on this circuit, mostly due to weather and vehicle events, automatic sectionalizing of this line is required.
