SRRTEP Committee Western AEP Supplemental Projects

August 29, 2019

AEP Transmission Zone M-3 Process Marmet, West Virginia

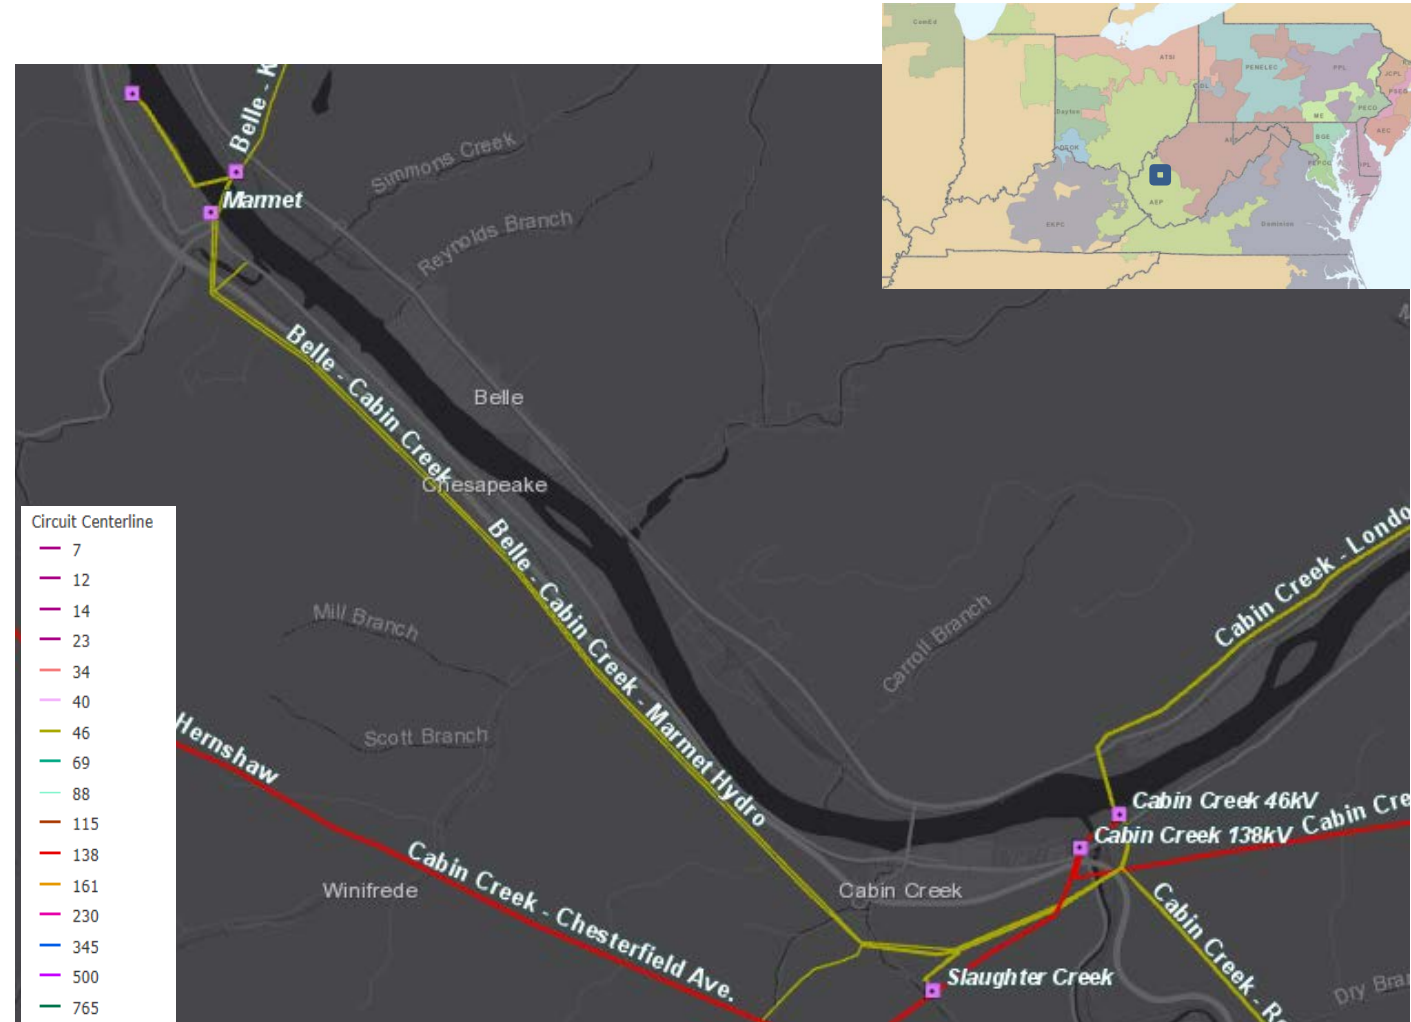
Belle – Cabin Creek – Marmet Hydro 46 kV Circuit (7.58 miles)

- Majority of the circuit is constructed with 1930s lattice structures.
- Between 2015-2018 the circuit experienced 4 momentary and 3 permanent outage resulting in approximately 24 k customer minutes of interruption
- There are currently 13 open conditions associated with the structures and hardware and include heavy rust, broken insulators and damaged shield wire hardware.
- The line does not comply with current NESC Standards.
- Most structures are situated on an extreme side hill, which also sits above the WV Turnpike which presents a significant danger/risk should the structures fail.
- This line parallels the Belle – Cabin Creek – Marmet line, need AEP-2019-AP028.

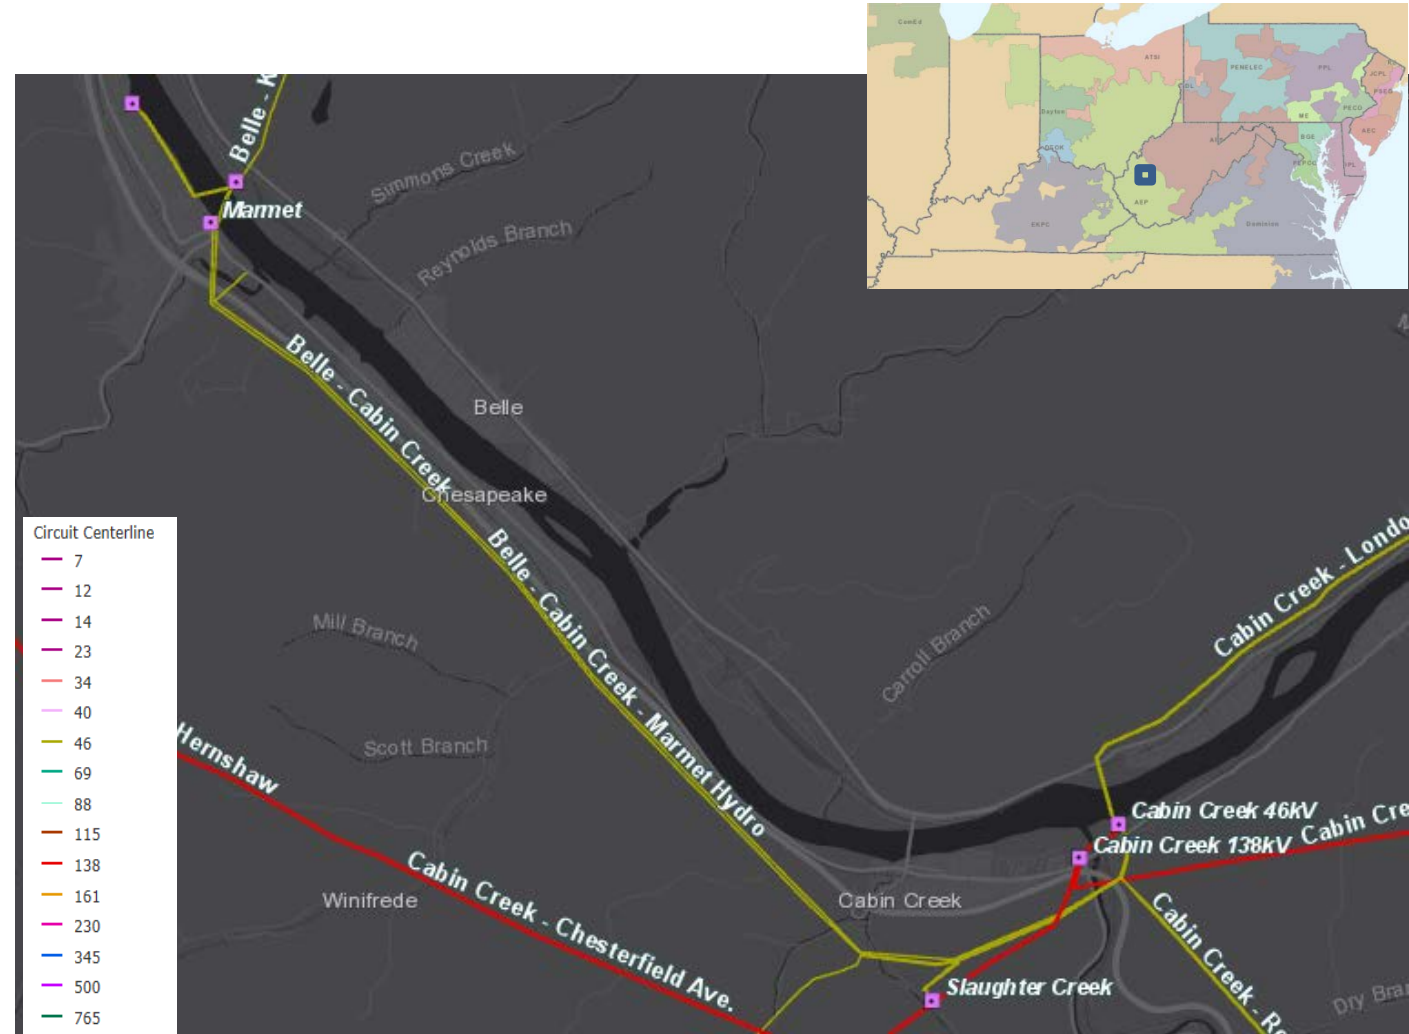
Belle – Cabin Creek 46 kV Circuit (7.14 miles)

- Majority of the circuit is constructed with 1930s lattice structures.
- Between 2015-2018 the circuit experienced 6 momentary and 2 permanent outage resulting in approximately 242 k customer minutes of interruption
- There are currently 13 open conditions associated with the structures and hardware and include heavy rust, broken insulators and corroded shield wire.
- The line does not comply with current NESC Standards
- Most structures are situated on an extreme side hill, which also sits above the WV Turnpike which presents a significant danger/risk should the structures fail.
- This line parallels the Belle – Cabin Creek – Marmet line, need AEP-2019-AP027.

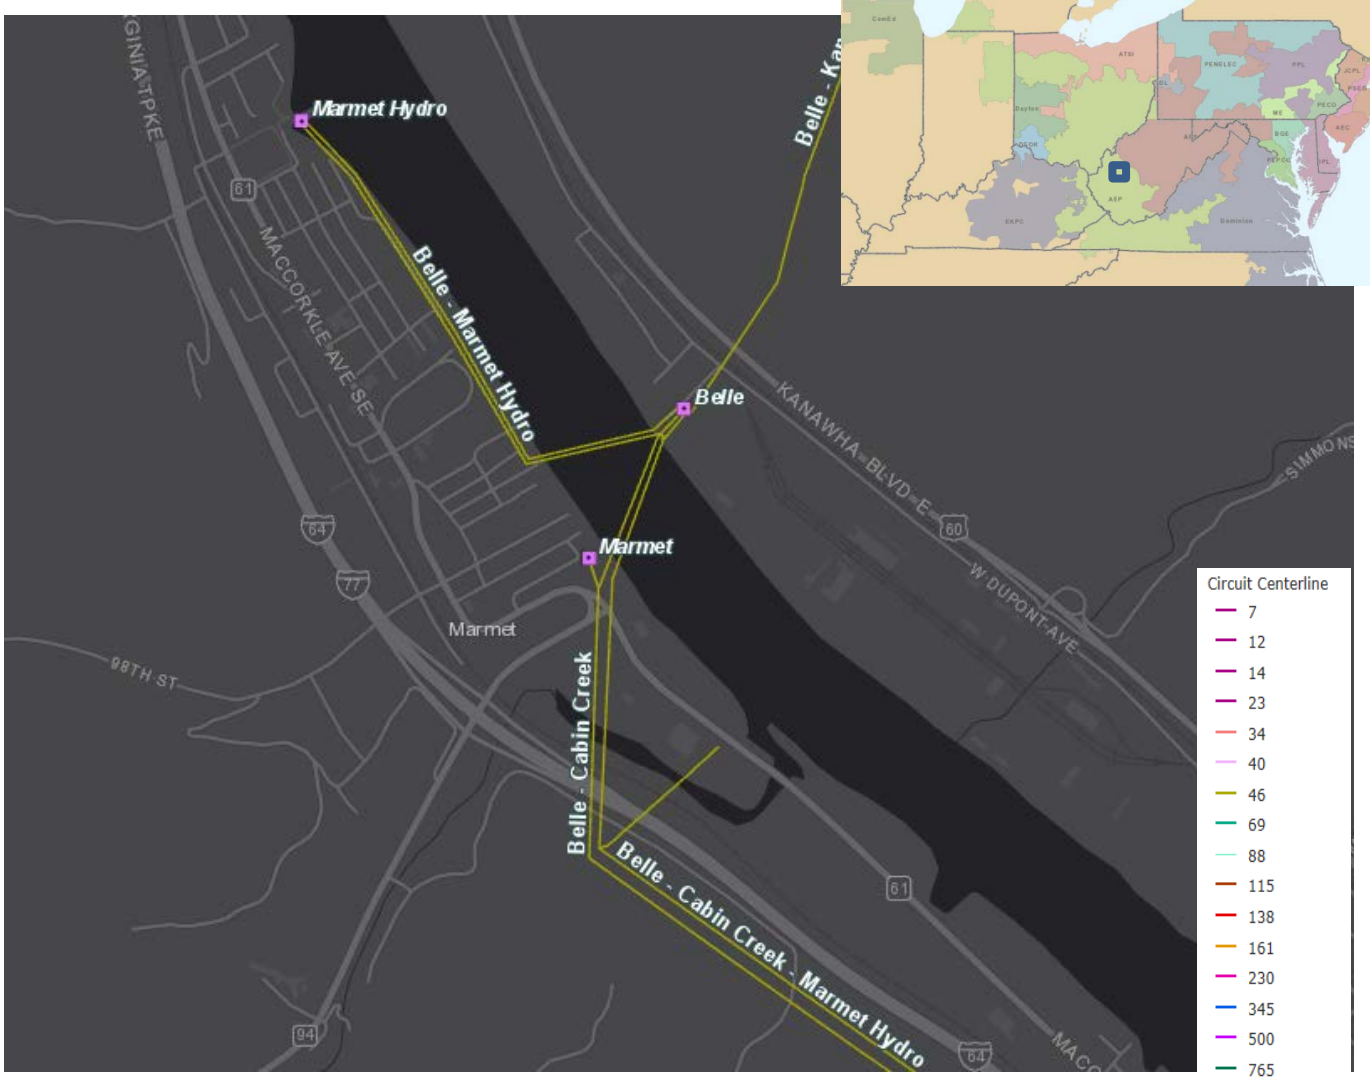
- Marmet Hydro is currently served off a hard tap on the Belle – Marmet Hydro – Cabin Creek 46 kV circuit
 - Hard taps are difficult to maintain due to required outages or temporary jumper configurations in lieu of a switch.
 - Hard taps result in extended outages to customers due to the inability to sectionalize faulted facilities.

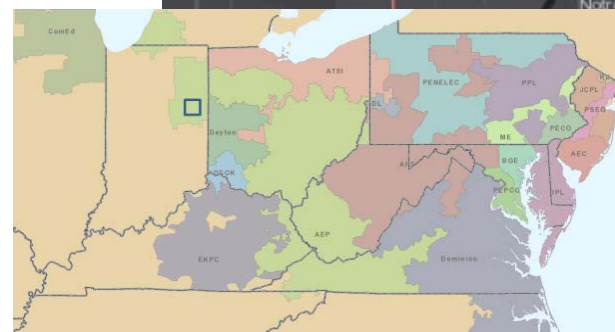
South Bend – Niles 69 kV Line (~11.47 Miles)

- 1968 vintage wood pole construction
- Forced Momentary outages: 5
- Forced Permanent outages: 3
- Total structure related open conditions – 47
- Unique structure count with open conditions – 44
- Insect Damage, Rotten Poles, Broken/Burnt cross-arm, Woodpecker holes, broken/burnt insulators, stolen/broken ground wires, broken guy strain insulators and cracked stub pole.
- More than three in-line sectionalizing MOABS

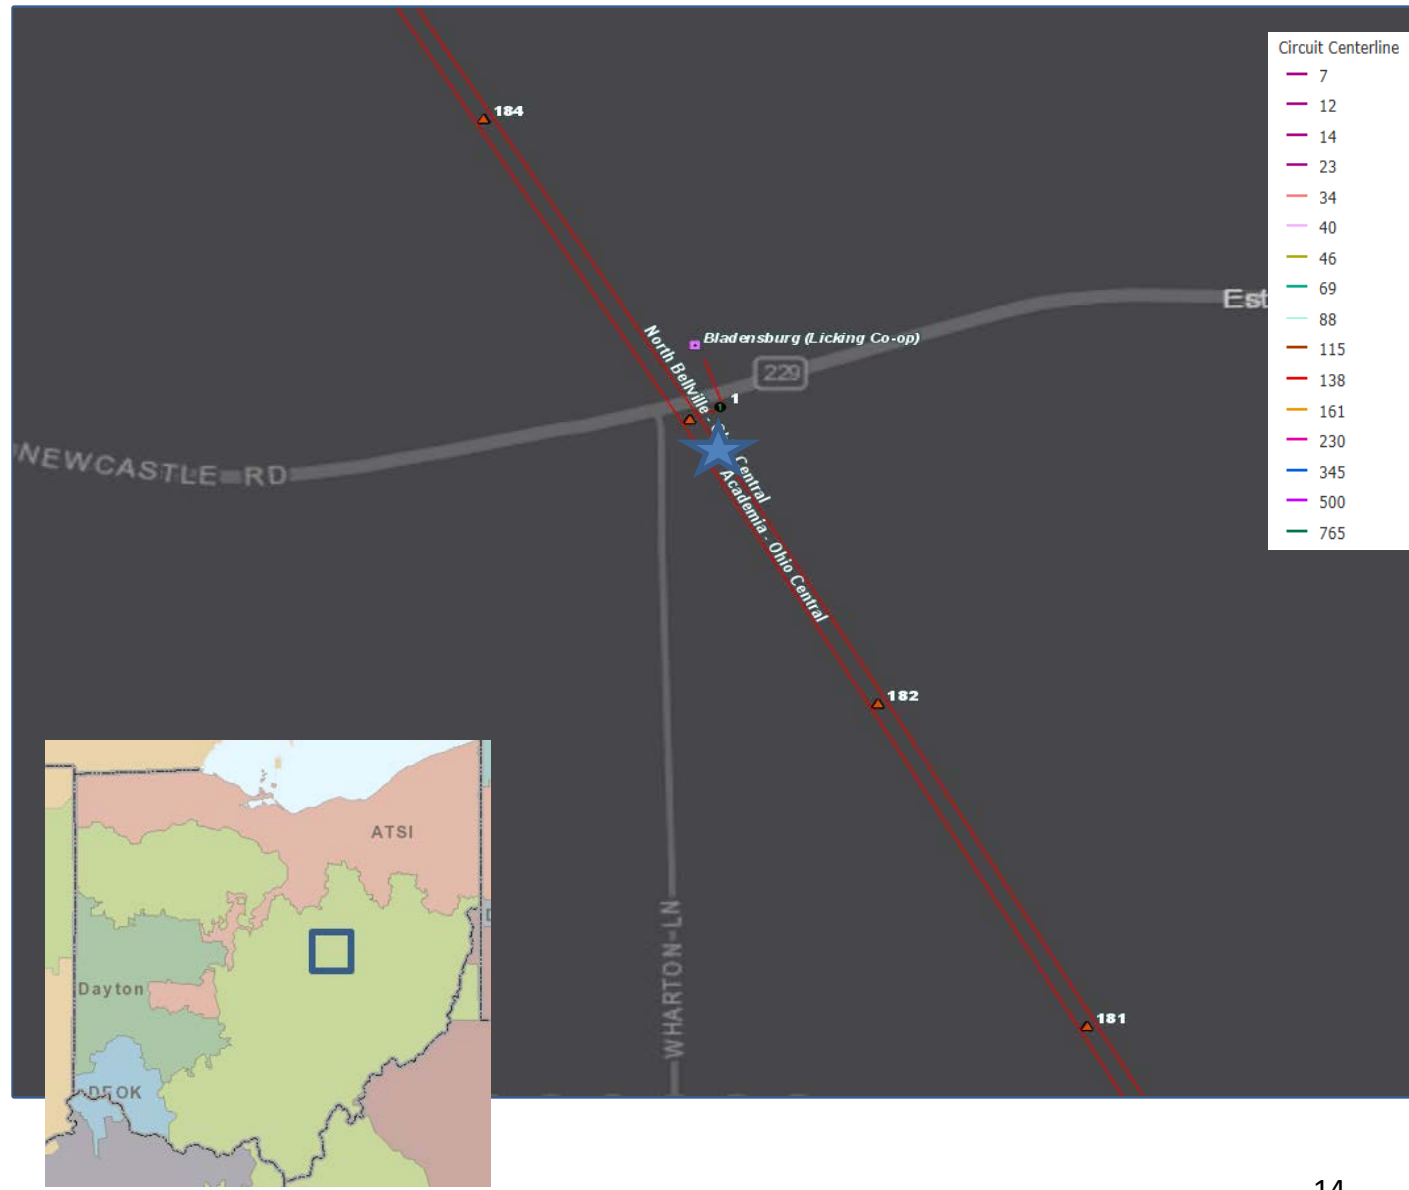
- The Bladensburg Licking Rural Electrification Co-op (LRE) 138 kV delivery point, connected to the 45 mile North Bellville – Ohio Central 138 kV circuit, has a load of 3.9 MW peak demand serving 1449 customers. The Bladensburg load is 100% transferrable but under high loading conditions transferring loads can take several hours. For heavy loading periods LRE has experienced areas of low voltage while transferring loads.
- The Blandensburg delivery point has experienced approximately 553,000 minutes of CMI over the last 5 years.
- This delivery point is connected to the North Belleville – Ohio Central 138 kV circuit via a hard tap which limits operational flexibility and the effectiveness of protection schemes. In addition, it is difficult to coordinate maintenance efforts because the line cannot be removed from service without either a customer outage or temporary jumper configuration.

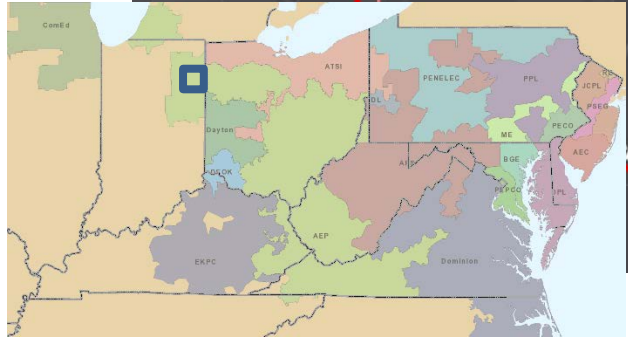
Robison Park – Haviland 138 kV Line (~12 Miles)

1926 vintage steel lattice line construction

There are currently 56 open conditions, future conditions are expected due to the type of construction and condition as the structures and conductor age.

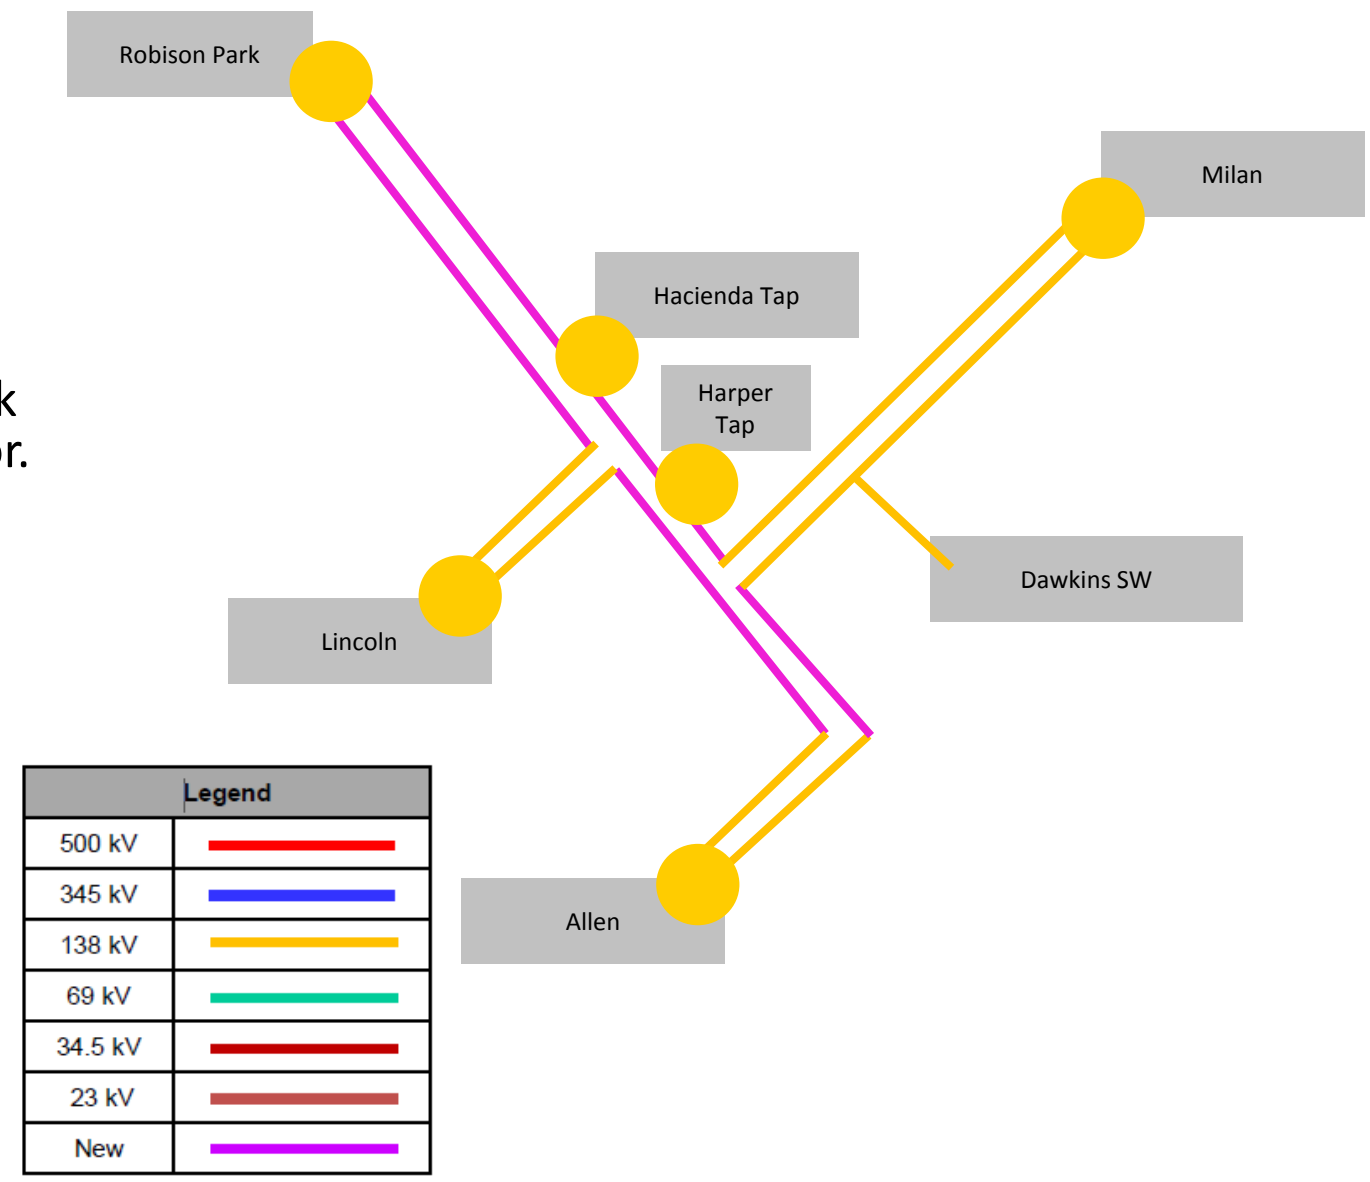
Allen – Rob Park 138kV line:

Rebuild 12 miles of the 138kV Allen – Robison Park double circuit line using 795 ACSR Drake conductor.
