***Generator Interconnection
System Impact Study Report***

***PJM Generation Interconnection Request
Queue Position #AB2-067***

Kammer-Vassell 765 kV

June 2017

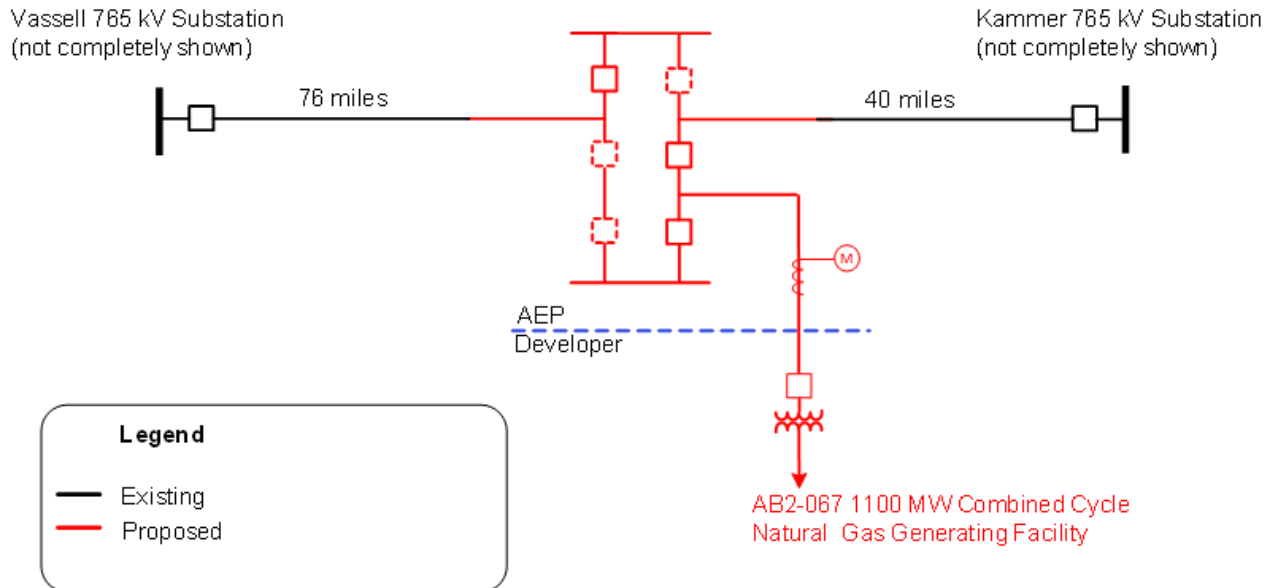
**Figure 1: Point of Interconnection (Kammer - Vassell 765 kV)
Single-Line Diagram**

AB2-067 765 kV Switching Station

Guernsey Power Station, LLC proposes to install an 1100.0 MW (1100.0 MW Capacity) 2x1 Combined Cycle Natural Gas generating facility in Guernsey County, OH (see Figure 2). The generating facility will interconnect to a newly proposed three (3) circuit breaker 765 kV switching station connecting to AEP's Kammer – Vassell 765 kV circuit (See Figure 1).

To accommodate the interconnection on the Kammer – Vassell 765 kV circuit a new three (3) circuit breaker 765 kV switching station physically configured in a breaker and half bus arrangement but operated as a ring-bus will be constructed 40 miles east of the Kammer 765 kV substation (see Figure 1). Installation of associated protection and control equipment, 765 kV line risers, SCADA, and 765 kV revenue metering will also be required. AEP reserves the right to specify the final acceptable configuration considering design practices, future expansion, and compliance requirements.

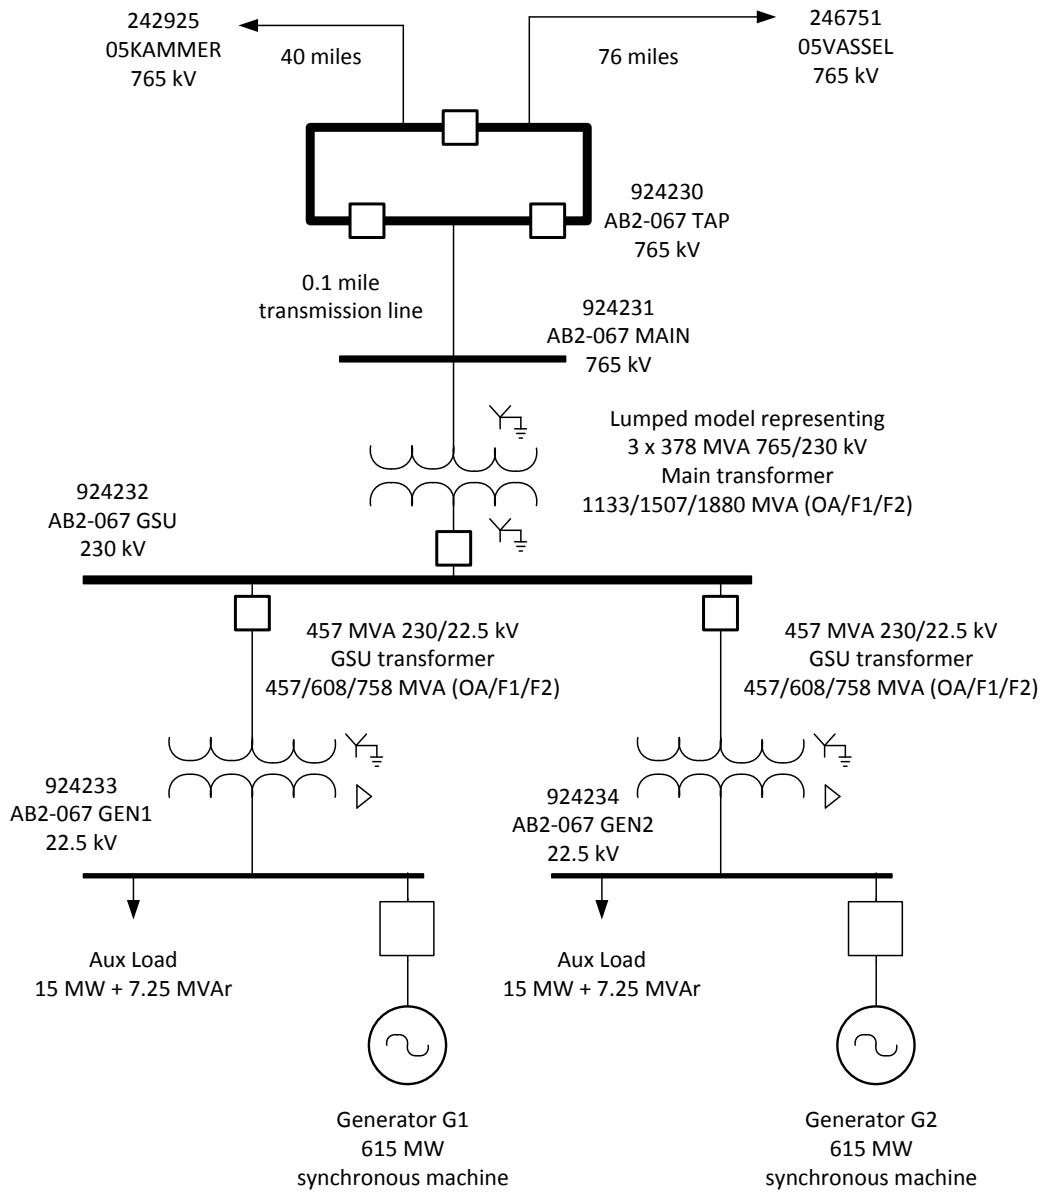
Figure 1: AB2-067 Plant Model

AB2-067 consists of 2 x 615 MW 1x1 single shaft combined cycle generator. AB2-067 will be connected to the POI via a 765/230 kV main collector transformer and two 230/22.5 kV transformers. AB2-067 connects at a tap of on the Kammer – Vassell 765 kV circuit, as shown in Figure 1.

Impact Study Data	Model
Generators	<p>2 x 615 MW 1x1 single shaft combined cycle generator</p> <p>MVA base = 758 MVA Vt = 22.5 kV</p> <p>Unsaturated sub-transient reactance = 0.23 pu @ MVA base</p>	<p>2 x 615 MW generators</p> <p>Pgen 615 MW Pmax 615 MW Pmin 0.0 MW Qgen -15.86 MVar Qmax 372.0 MVar Qmin -197.3 MVar Mbase 758 MVA Zsorce 0.00 + j0.23 pu @ Mbase</p>
GSU transformer	<p>2 x 230/22.5 kV two winding transformer</p> <p>Rating = 457/608/758 MVA (OA/F1/F2)</p> <p>Transformer base = 457 MVA</p> <p>Impedance = 0.0022 + j0.11 pu @ MVA base</p> <p>Number of taps = 5 Tap step size = 2.5%</p>	<p>2 x 230/22.5 kV two winding transformer</p> <p>Rating = 457/608/758 MVA (OA/F1/F2)</p> <p>Transformer base = 457 MVA</p> <p>Impedance = 0.0022 + j0.11 pu @ MVA base</p> <p>Number of taps = 5 Tap step size = 2.5%</p>
Main transformer	<p>3 x 765/230 kV single phase transformers</p> <p>Rating = 378/502/626 MVA (OA/F1/F2)</p> <p>Transformer base = 378 MVA</p> <p>Impedance = 0.0024 + j0.12 pu @ MVA base</p> <p>Number of taps = 5 Tap step size = 2.5%</p>	<p>Lumped equivalent model representing 1 x 765/230 kV two winding (three-phase) transformer</p> <p>Rating = 1133/1507/1880 MVA (OA/F1/F2)</p> <p>Transformer base = 1133 MVA</p> <p>Impedance = 0.0024 + j0.12 pu @ MVA base</p> <p>Number of taps = 5 Tap step size = 2.5%</p>

Auxiliary load	30 MW + 14.5 MVar	15 MW + 7.25 MVar modeled at low side of each GSU
Station load	0.7 MW + 0.5 MVar	Not modeled to ensure correct MFO
Transmission line	Length = 0.1 miles	Modeled as zero impedance line
